OPEN-FILE REPORT OFR 09-01

GEOLOGIC CHARACTERIZATION OF THE BLACK HILLS DAM SCOTTSDALE, ARIZONA

Prepared for the City of Scottsdale

by
Brian F. Gootee
AZGS Research Geologist

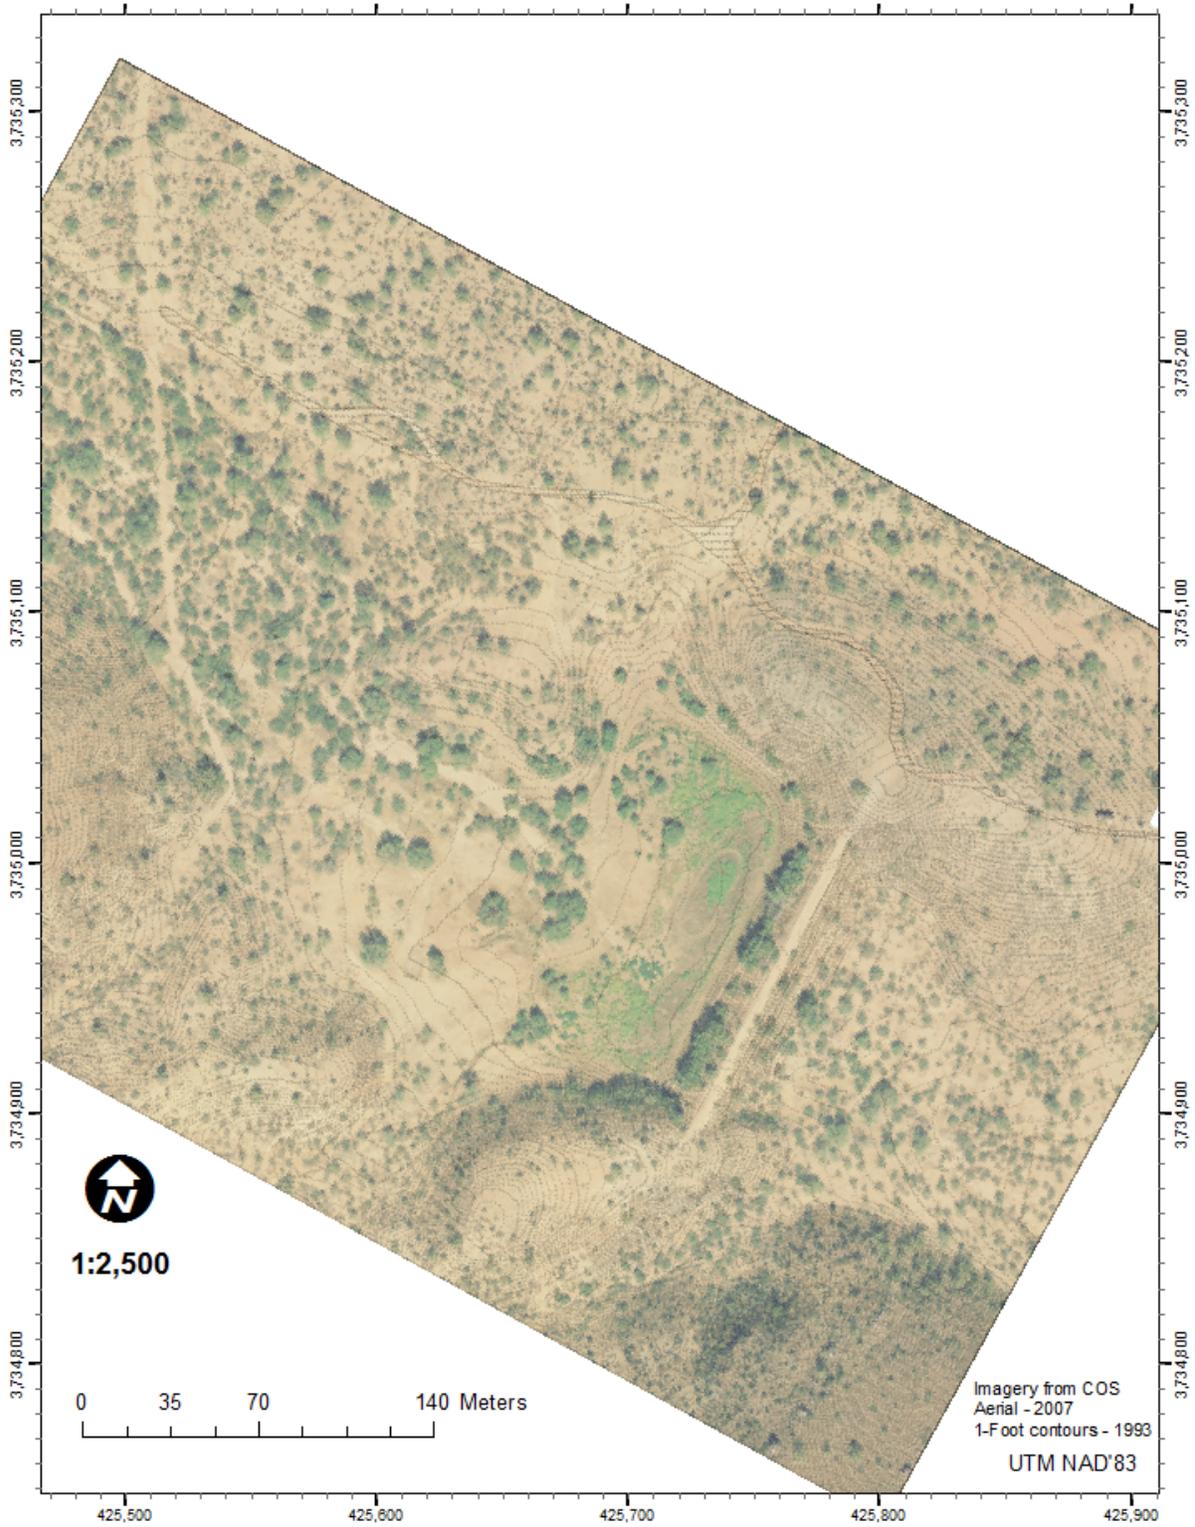
Figure 1. Aerial Topographic Map with one-foot contours. Image courtesy of City of Scottsdale.

Upstream and downstream of the dam and post-dam sediments, the active channel exhibits normal, undisturbed channel morphology and vegetation (Figures 1 and 4). The active channel has a bar and channel morphology. Multiple bars or islands across the channel width consist of a mix of sand, gravel, cobble, and boulders separated by sandy channels composed of predominantly decomposed-granite sand or grus. Vegetation is dense and consists of mesquite trees and dense shrub communities. The active channel appears undisturbed and is interpreted to represent the former pre-dam channel morphology.

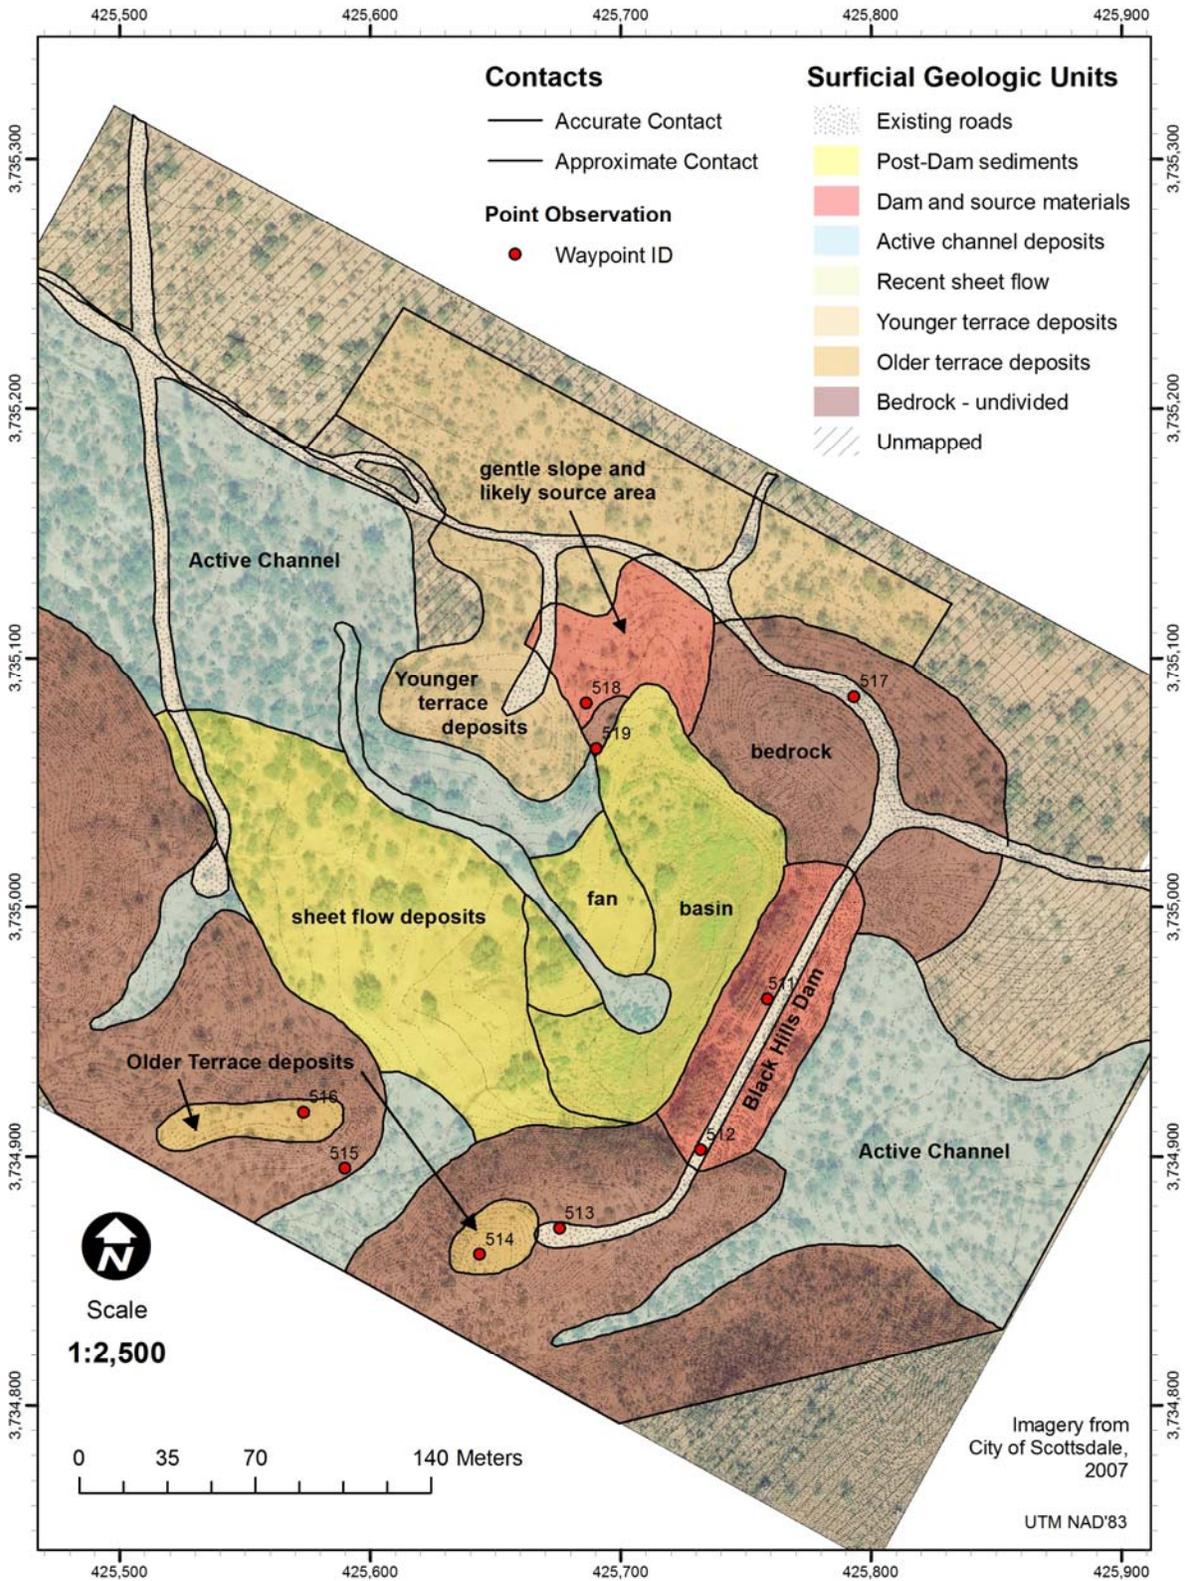
Figure 2. Geologic map of the Black Hill Tank dam area in the same spatial extent shown in Figure 1.

For the purposes of meeting project goals the following areas of the Black Hills Dam site were observed on an April 21, 2009 site visit with the City of Scottsdale representatives. Figure 2 illustrates the relationships between the geology of the site area and dam/post-dam deposits.

Relatively thin stream terrace deposits were observed overlying bedrock on both sides of the wash. Additionally, the eastern end of the dam is buttressed against an outcrop of quartzite bedrock; the dam's west end is buttressed against granitic bedrock (Figure 2).

On the southwest side of the wash granite bedrock was observed at the surface in small, localized outcrops covered by loose hillslope deposits and older stream terraces (Figure 2). Three small tributary channels are eroded in-between granite outcrops, two upstream and one downstream of the dam. The tributary channels exhibit typical vegetation and slopes and show no signs of previous modification by scrapers or dozers. Older stream terrace deposits cap bedrock on the southwest side of the channel. These older stream deposits, which have well-developed clay horizons indicative of an age greater than 10,000 years, also show no signs of human-caused disturbance.

On the northeast side of the wash a branch of an existing dirt road ends on a flat surface near waypoint ID 518 (Figure 2). This surface is formed on stream terrace deposits approximately one to two meters thick, which are composed of decomposed granite sand (grus) and 10 to 20% sub-angular to sub-rounded, cobble-size clasts of quartzite. As with the stream terraces on the southwest side of the wash, a clay horizon is present, indicating that the stream

terrace deposit is older than 10,000 years old. This deposit overlies granite bedrock near waypoint ID 519 (Figure 2). Immediately southwest of here toward the active channel along the same terrace deposit, the slope is 14 to 17 degrees. This steep slope has abundant and well-developed vegetation. A low saddle is present at the end of the road near waypoint 518 and a gully incised into the west side of this terrace drains into the active channel. A gentle 3-degree slope drains east into the dam's basin (Figures 2 and 3, labeled "likely source area"). This gentle slope lacks abundant and mature vegetation in contrast to the surrounding deposits of similar age and composition. In addition, the opposing drainages and difference in slope are atypical for this age and type of deposit adjacent to an active wash. The aerial image from 1962 shows this slope lacked vegetation even then (Figure 4).

Post-dam sedimentation from the main and side-channels are shown in Figure 2. These sediments consist of coarse sand from decomposed granite and lack gravel and cobbles. Sediment thickness is unknown. A preliminary analysis of slopes in the active channel upstream and downstream of the basin area suggests some sediment was scoured from the basin area for use in construction of the dam, and this area subsequently filled with post-dam sediment.

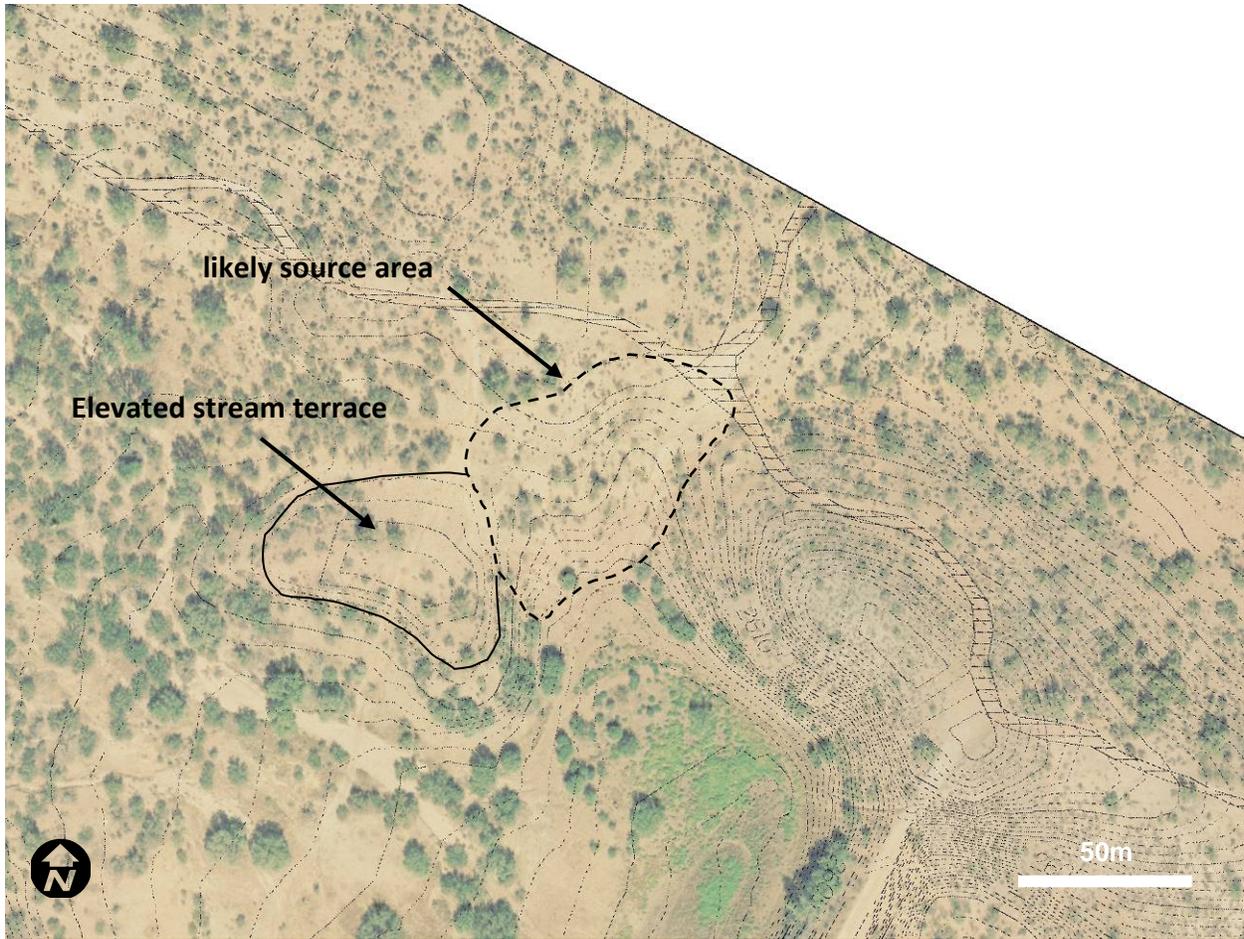
Based on the composition of the terrace deposit, lack of developed vegetation, and atypical drainage and slope, the area labeled "gentle slope" is interpreted to be one likely source for the earthen dam material.

Figure 3. Enlarged area of the elevated stream terrace and relatively gentle, unvegetated slope. Interpreted to be one likely source area for dam materials. Contours are one-foot. Images provided by City of Scottsdale. Scale in meters.

If materials from the Black Hills Dam are redistributed locally, one option could be to distribute the dam-materials upstream to the former likely source area between the terrace and bedrock knob, above the 100-year floodplain. In addition, the adjacent elevated stream terrace shown in Figure 3 could be considered as an additional site to place some of the dam-sediments.

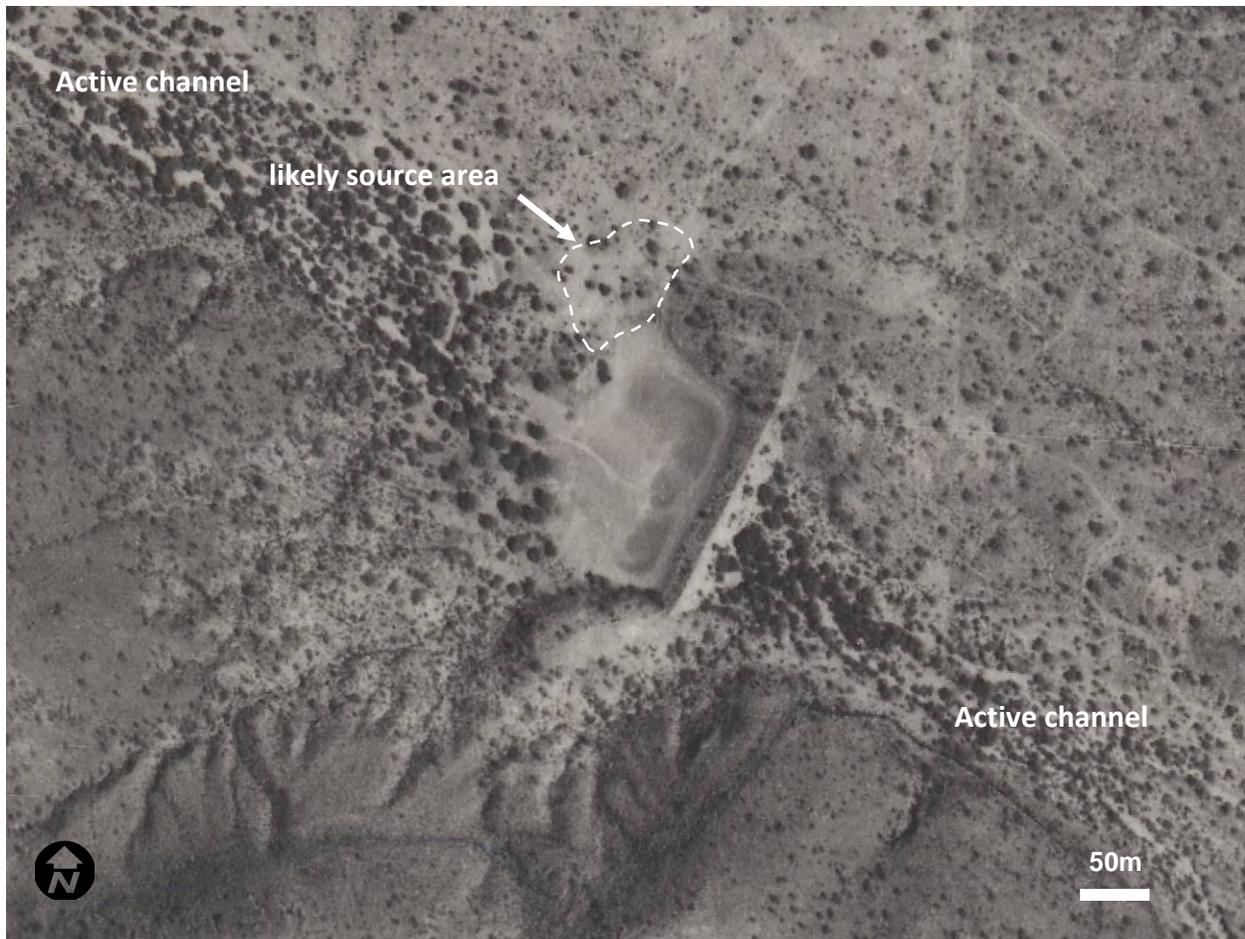
Figure 4. 1962 aerial imagery. Arrow and area show a gentle slope lacking vegetation, interpreted to be a likely source area for dam materials. Also note the density and growth of trees and shrubs both upstream and downstream of the dam area in the active channel. (Photo taken Sept. 30, 1962, ASU archives). Scale in meters.
