A NEW EARTH FISSURE
NEAR WINTERSBURG,
MARICOPA COUNTY, ARIZONA

Arizona Geological Survey
Open-File Report 01-10

Raymond C. Harris
Arizona Geological Survey

November 2001

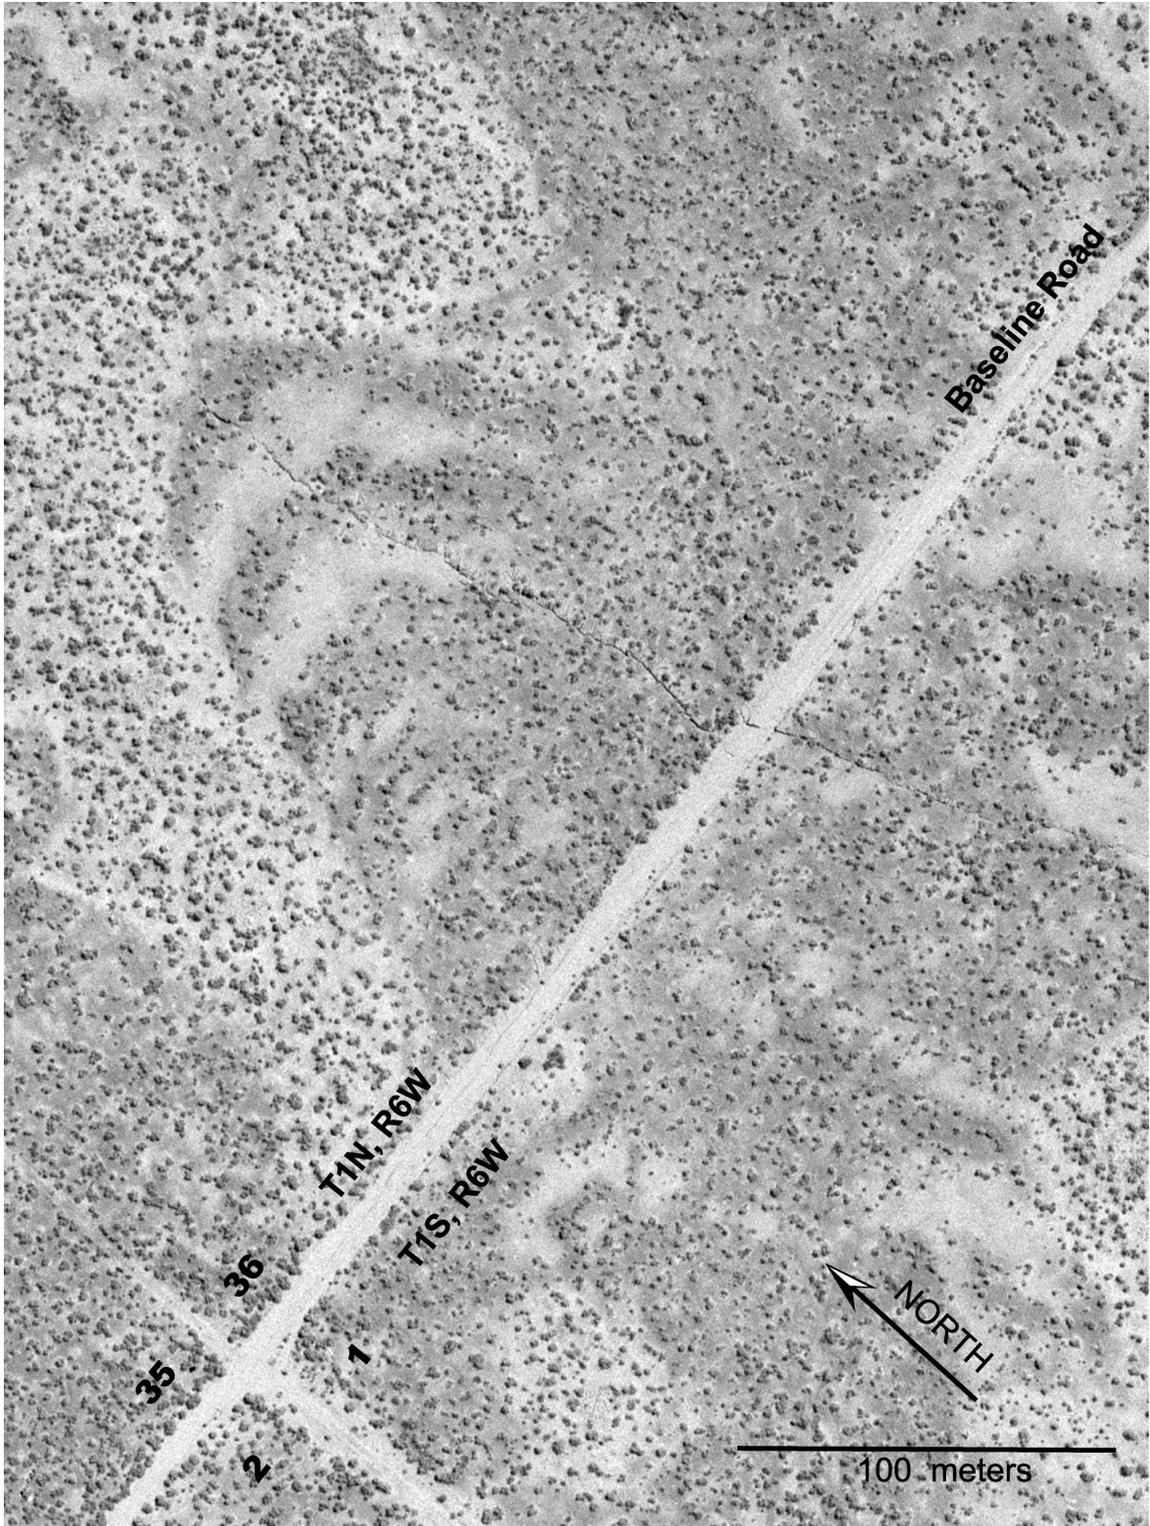
The fissure is nearly north-south and is 307 m (1007 ft) long (Figure 4). The fissure is very young, with narrow, steep sides and a highly irregular apparent depth ranging from <1 foot to >8 feet over short distances. In two locations the fissure is en echelon (Figure 5), with NW-SE steps. There is no discernable vertical offset across the fissure.

Figure 4. Detailed aerial view of new earth fissure.

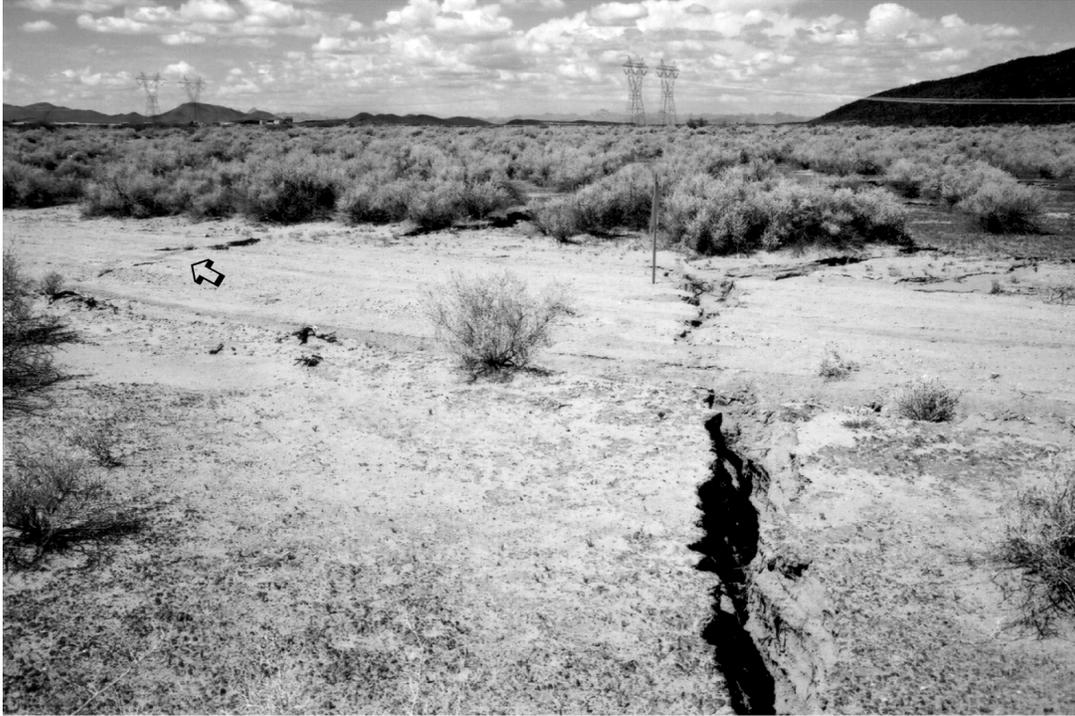
Figure 5. En echelon section of earth fissure crossing Baseline Road, looking NW. Fissure is 6-12 inches wide here. Second earth fissure crosses road at far left (arrow).

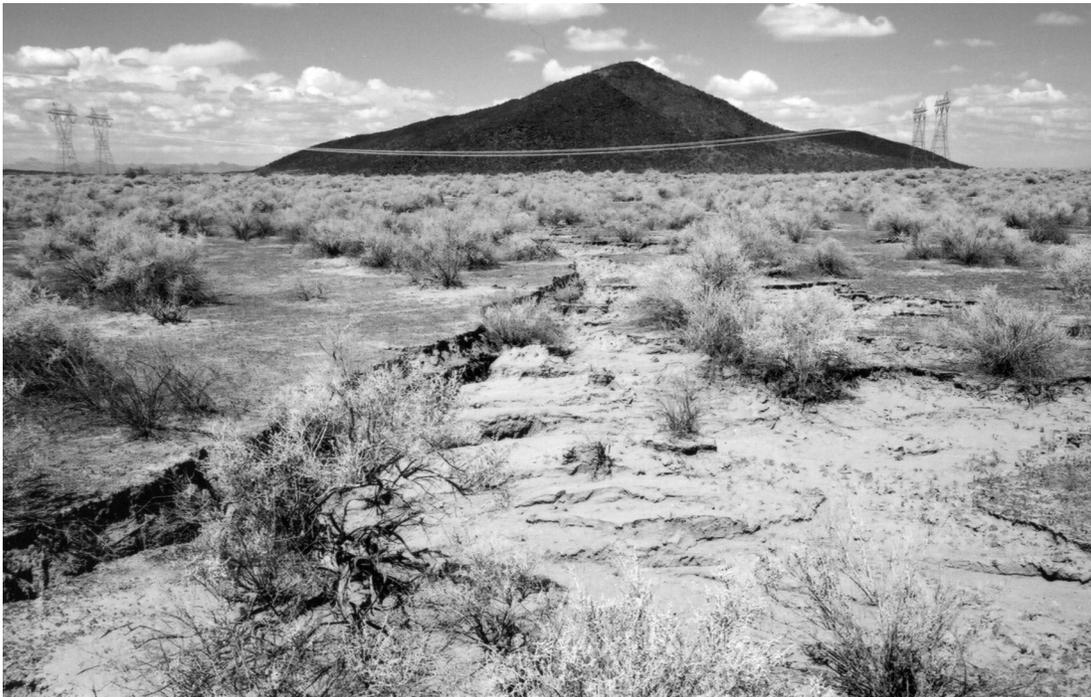
At the time of the first visit in mid September, little material had sloughed off into the fissure, only enough to open a narrow trench. Erosional downcutting of 4-12 inches has created miniature badlands up to 10 feet wide on the uphill (east) side of the crack (Figure 6). At the time of a follow-up visit in early November, the edges of fissure were noticeably rounded off from a small rainstorm the previous day. Much of the fissure had been partially filled in but there had not been enough runoff to enlarged it.

Figure 6. Section of earth fissure north of Baseline Road, showing erosion on uphill (east) side. Fissure is 12-18 inches wide, 1-6 feet deep in this section.

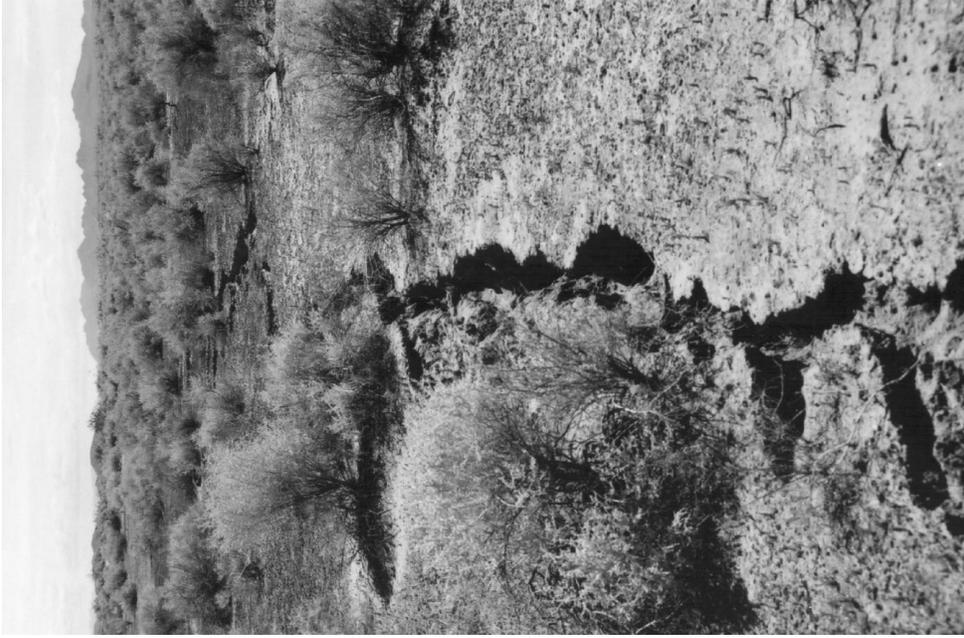
Figure 7. Typical section of earth fissure south of Baseline Road, looking south. Fissure here is 6-12 inches wide, with minor erosion on uphill (east) side.

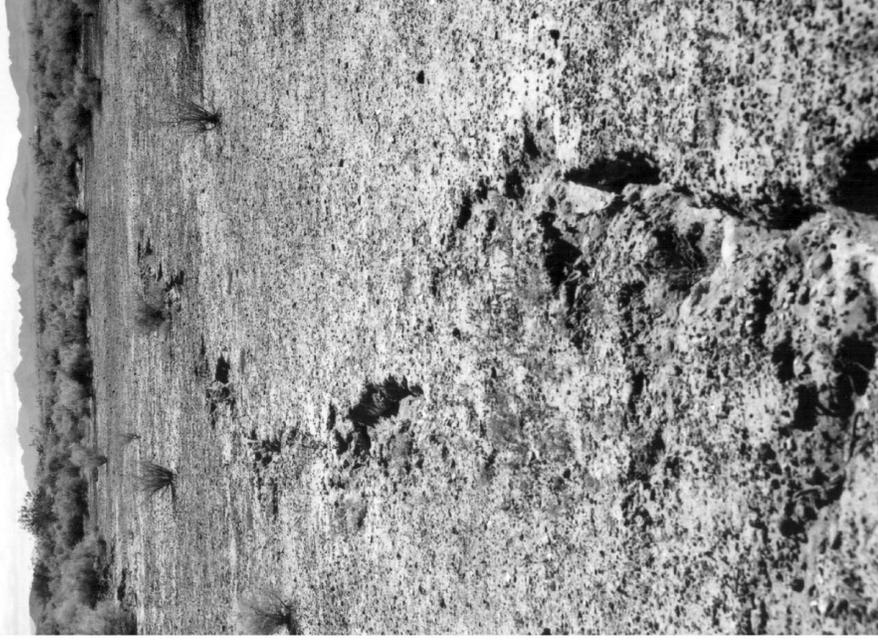
Both ends of the fissure are characterized by a gradual fading of the trench to miniature grabens and then to a hairline crack. The final 50 feet of both ends are slightly curved. Typical segments of the fissure are shown in Figures 7 and 8.

Figure 8. South end of earth fissure, looking south. Fissure decreases in size from 6-10 inches in foreground to hairline crack near far end of clearing.

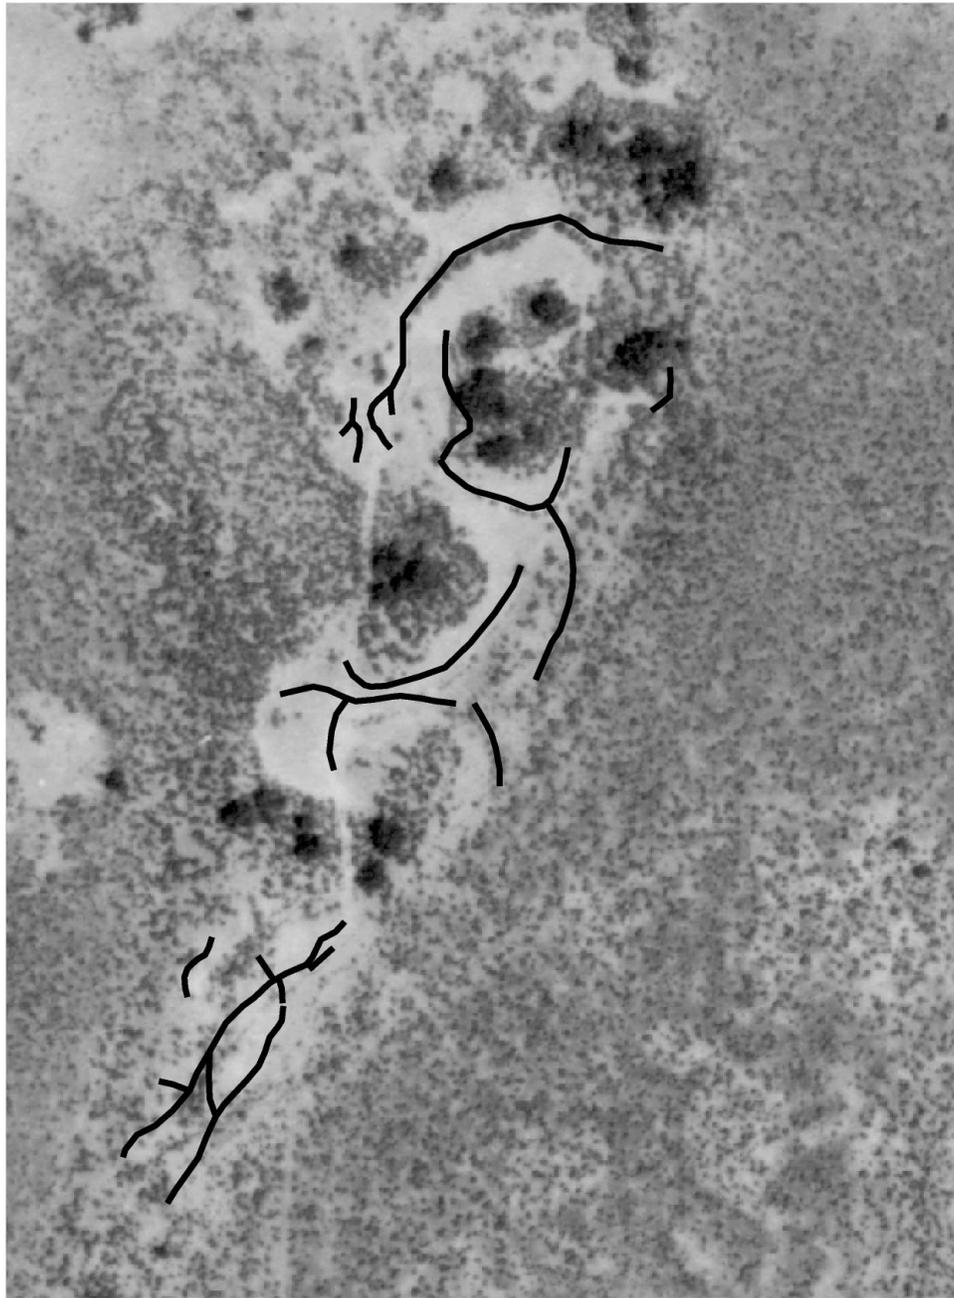
Northwest of the new earth fissure is a small area of giant desiccation cracks, plotted in detail in Figure 9. The polygonal cracks are probably not related directly to the earth fissure, but do share the aspect of their opening at the surface in response to heavy rain. (In this report, the term *fissure* is reserved for earth fissures caused by subsidence from groundwater pumping. Ruptures resulting from desiccation are called *cracks*.) Similar polygonal desiccation cracks are found in several locations in southeastern Arizona, such as Willcox (Anderson, 1978; Holzer, 1980) and along Interstate 10 between Bowie and San Simon (Holzer, 1980; Harris, 1997). Photos in Figures 10-16 show typical features of these desiccation cracks.

Figure 9. Area of giant polygonal desiccation cracks, northwest of new earth fissure. These cracks are similar in size and shape to other known desiccation cracks in southeastern Arizona.

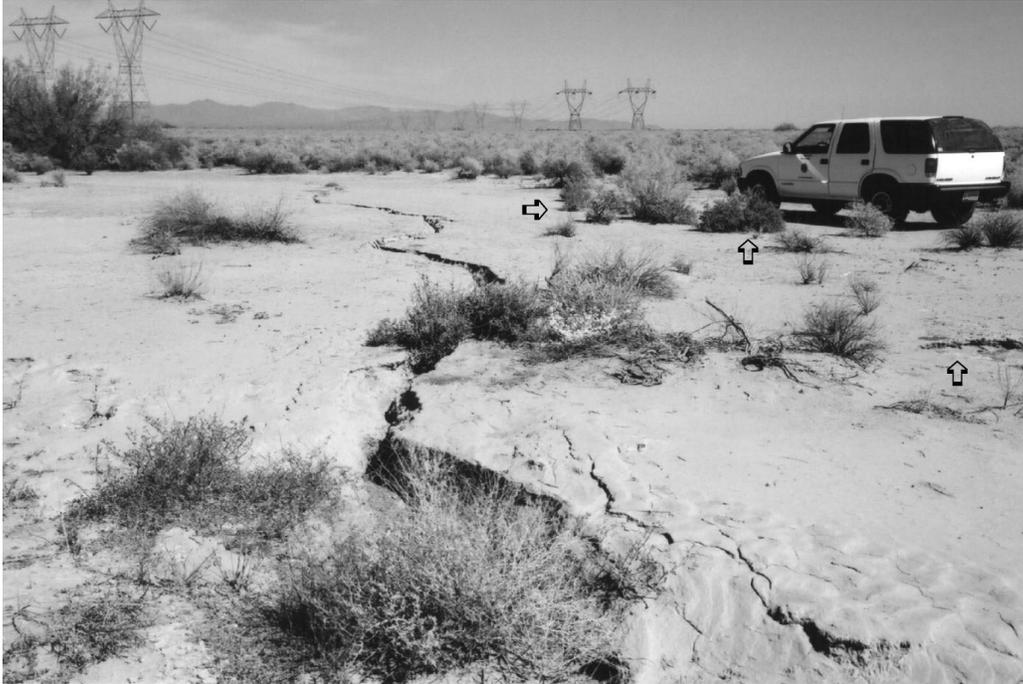
Figure 10. New generation desiccation crack (center), with lack of vegetation. An older, reactivated crack is defined by the alignment of mature vegetation on the left side of the vehicle. A third crack (center right edge) joins the large crack at the center of the photo.

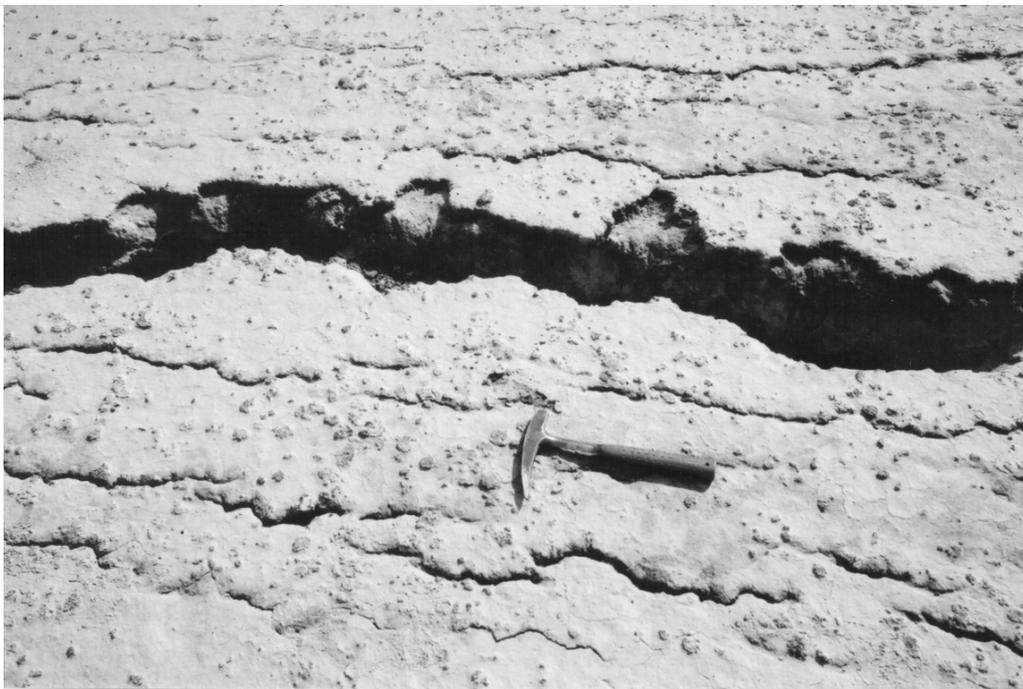
Figure 11. Close up of large, new crack shown in Figure 10, above. Parallel small cracks indicate further collapse and enlargement of the crack is likely in the event of another heavy rain.

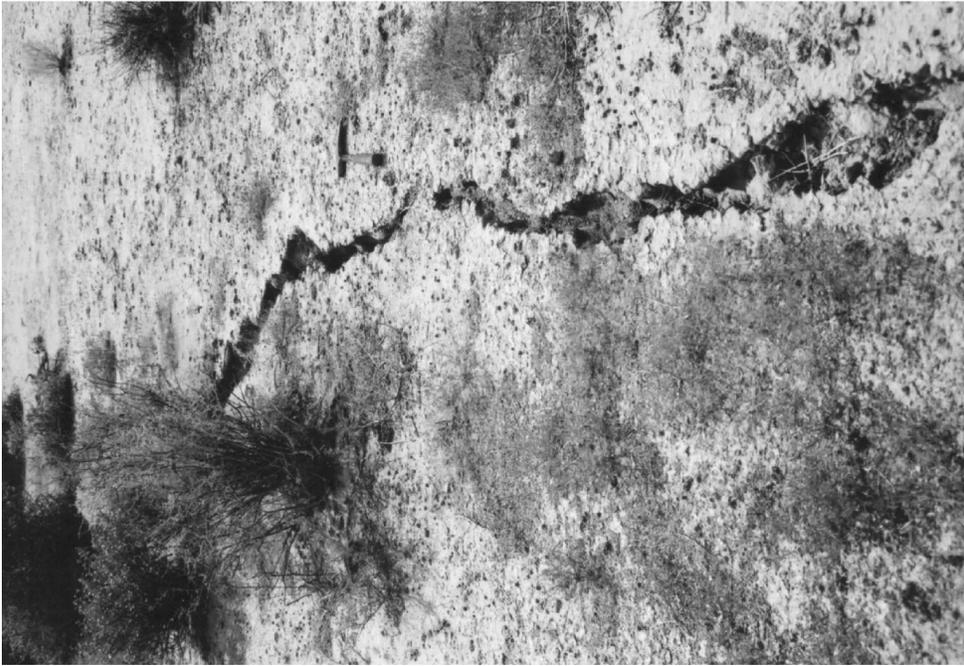
Figure 12. New desiccation crack, with vertical sides, sharp angles, and lack of vegetation. Rock hammer for scale.

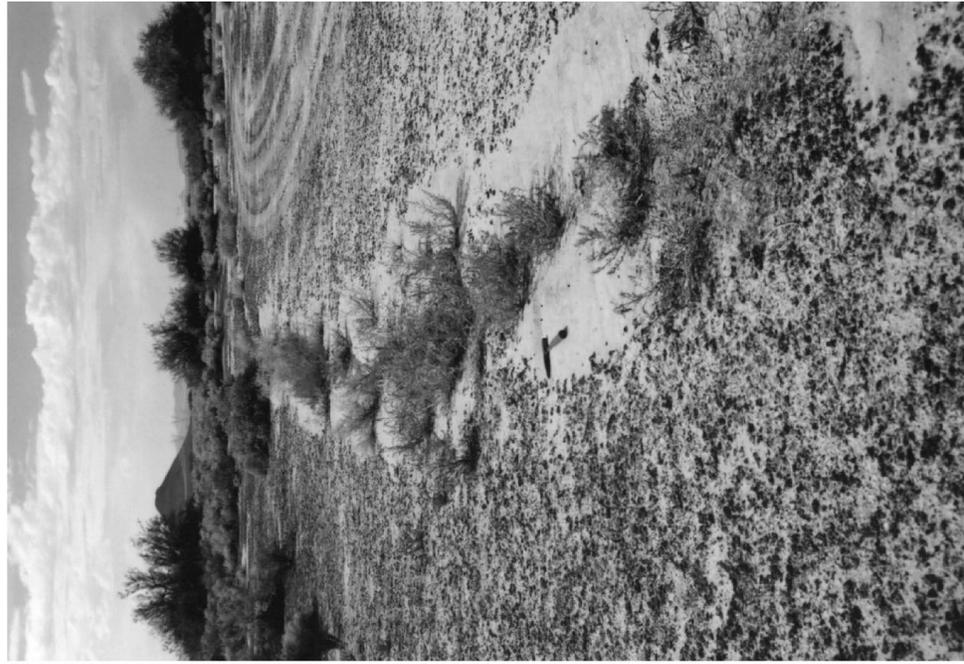
Figure 13. Older generation desiccation crack with well-developed vegetation alignment. Rock hammer for scale.

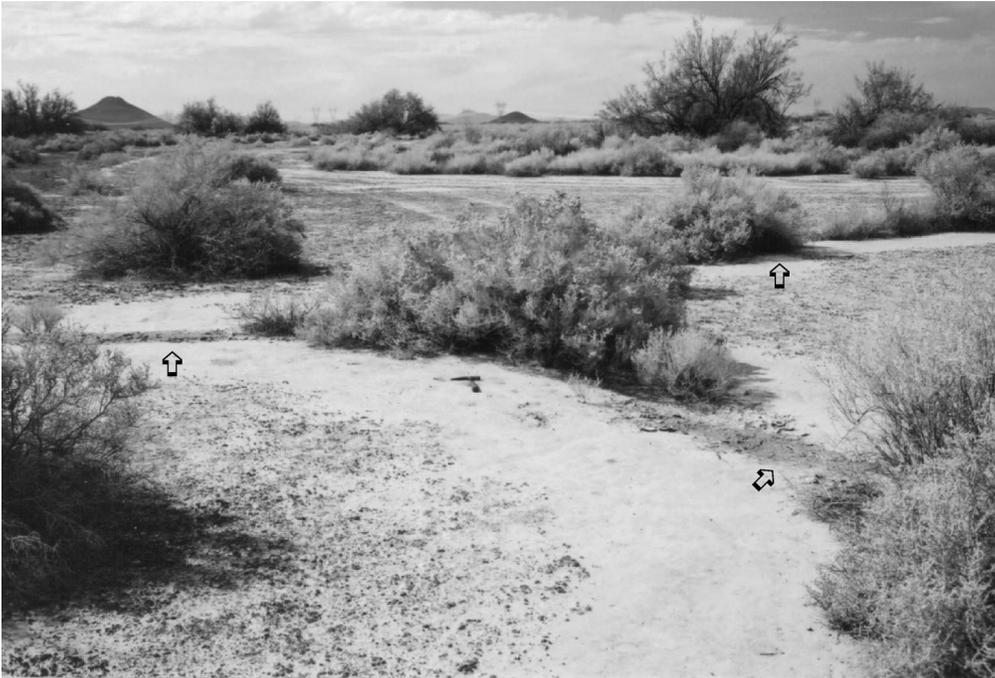
Figure 14. Junction of desiccation cracks by hammer at center of photo. Arrows point to three separate cracks. Note alignment of mature vegetation in the cracks, indicating that the cracks are old features, recently reactivated.

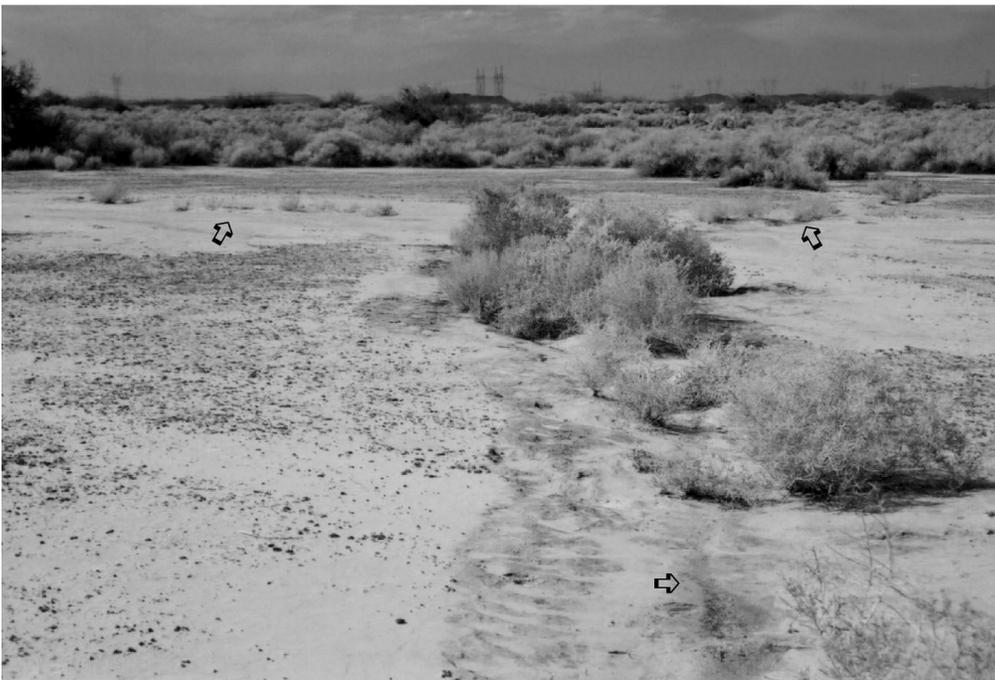
Figure 15. Junction of three cracks (arrows) at center of photo. Alignment of mature vegetation indicates this is at least the second cycle of cracking.

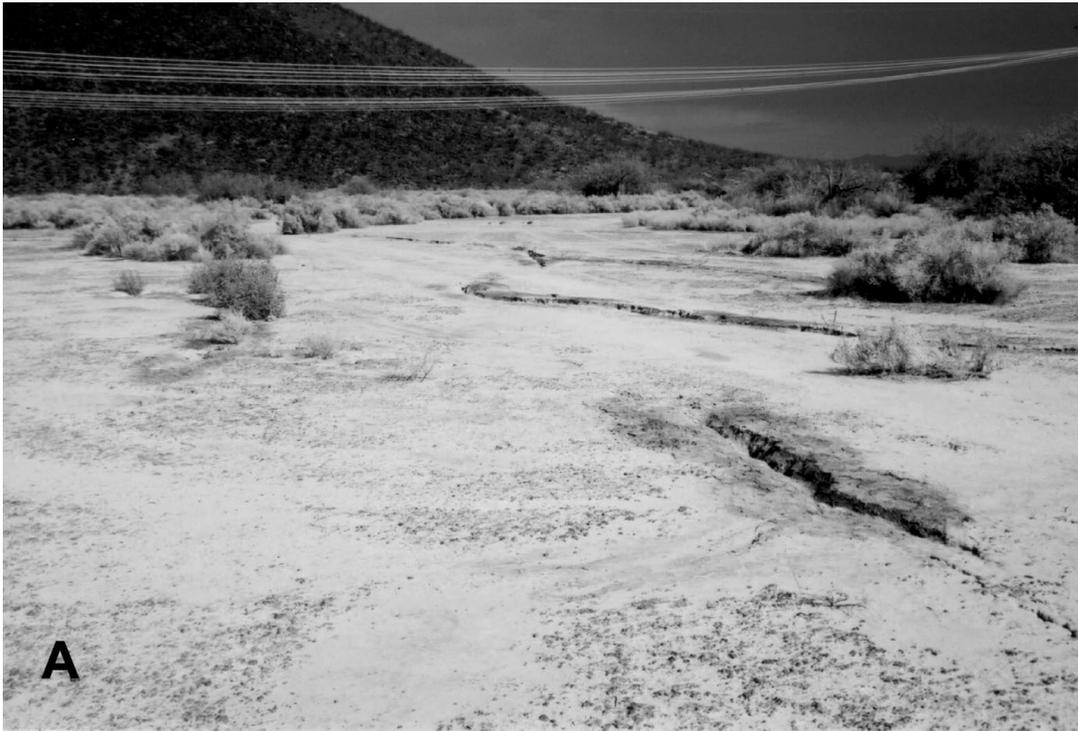
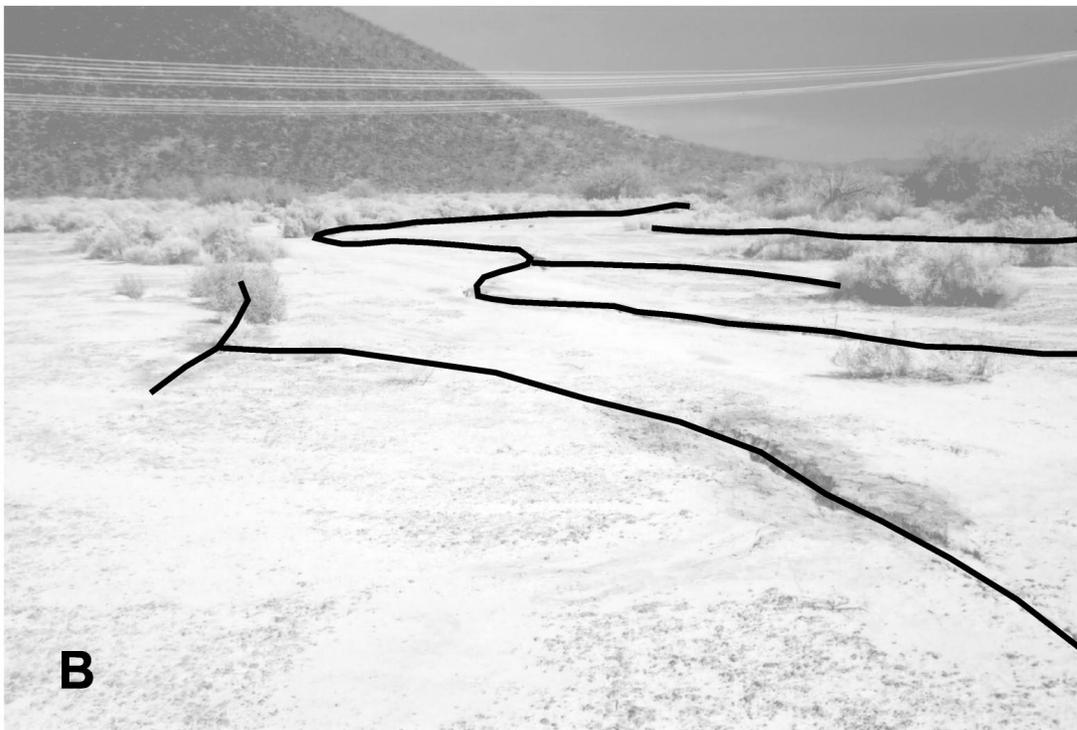
Figure 16. **(A)** View of northern-most group of desiccation cracks. **(B)** Trace of cracks plotted. Note new cracks in foreground lack vegetation, whereas older cracks in background are marked by very mature vegetation alignments.
