ADDITIONAL GIANT DESICCATION
CRACKS NEAR WINTERSBURG,
MARICOPA COUNTY, ARIZONA

by
Raymond C. Harris

Arizona Geological Survey
Open-File Report 03-07

November 2003

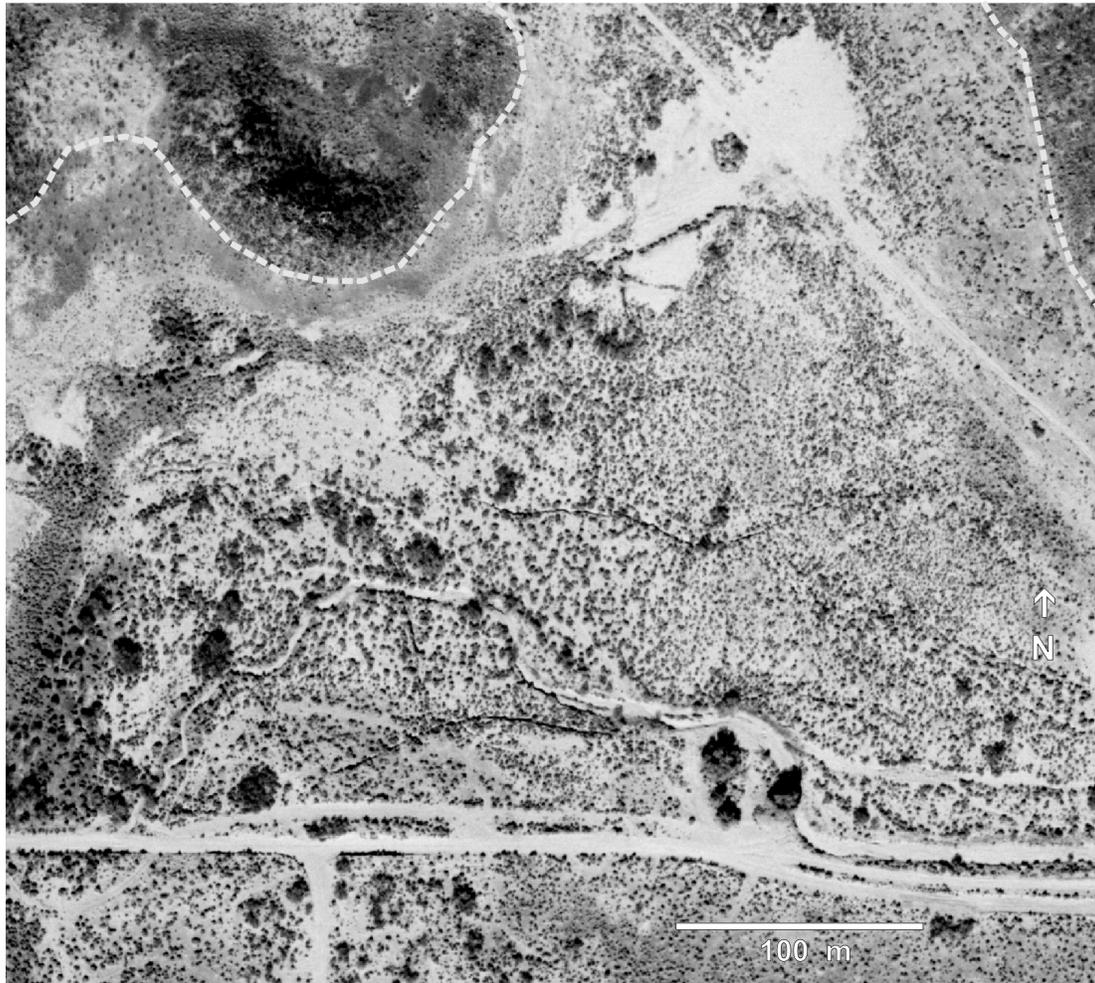
In a few segments of the northeastern most cluster the cracks themselves are large enough to be obvious on aerial photos even though they are too new to have vegetation in them. A 2000 aerial view of the northeastern area is shown in Figure 4. The nearly east-west

crack immediately north of the road is visible on the 1996 USGS Digital Orthophoto Quarter-Quadrangle (DOQQ) aerial photo and on a 1979 BLM aerial photo. The alluvium-bedrock contact is delineated by the white dashed line on Figure 4.

Figure 4. Aerial view of northeastern part of main cluster of cracks. Photo taken 2001 by Maricopa County.

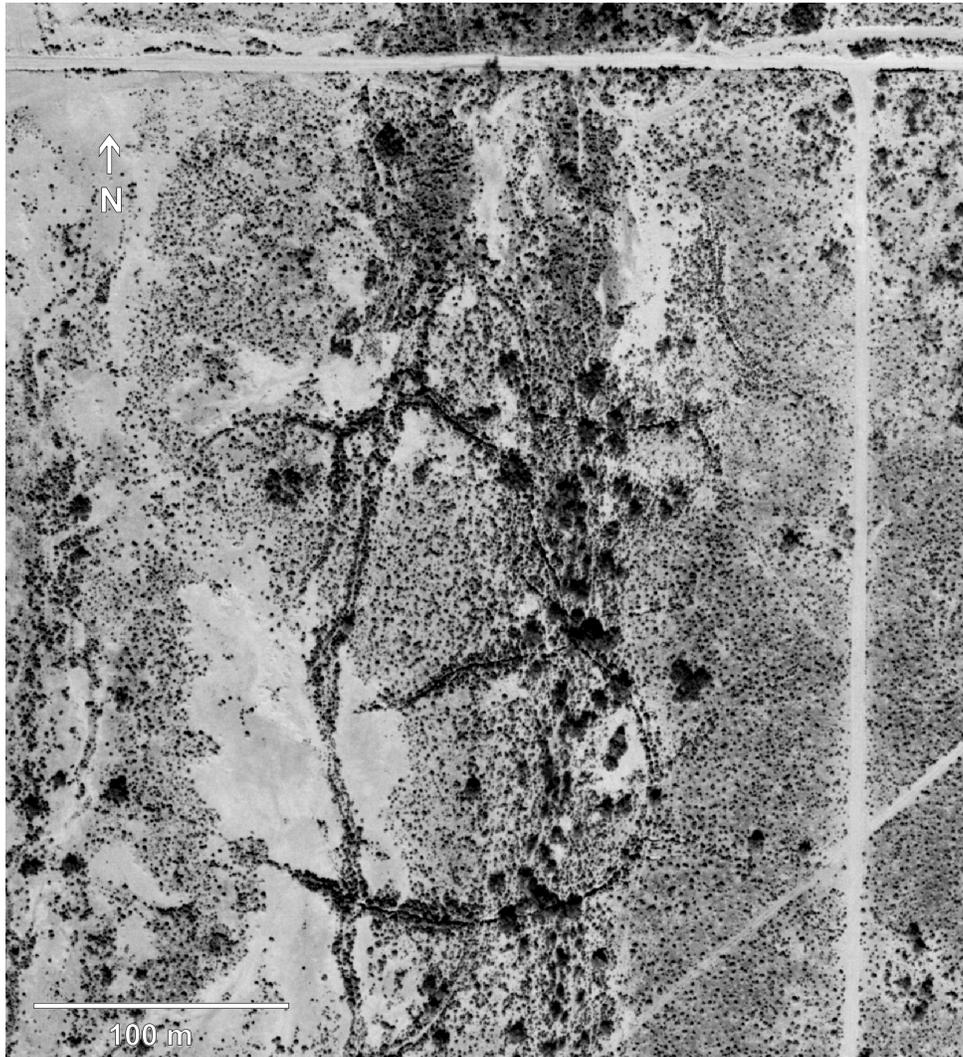
Figure 5 shows a detailed aerial view of the southern half of the main cluster. The widest and deepest cracks form a pattern similar to a '3' on the 2001 aerial photo. This segment of the cluster is visible on BLM aerial photos taken September 8, 1979 (Figure 6), but is easily missed on the 1996 USGS DOQQ because of the washed-out exposure of that photo.

The section that looks like the number '3' is the widest of the cracks in this area. By itself, this section could easily be mistaken for an earth fissure because of its width and

Figure 5. Close-up aerial view of the southern part of the main cluster. The section that resembles the number '3' is the largest and oldest of the cracks. The long N-S dark line is vegetation along a wash. Photo taken 2001, Maricopa County.

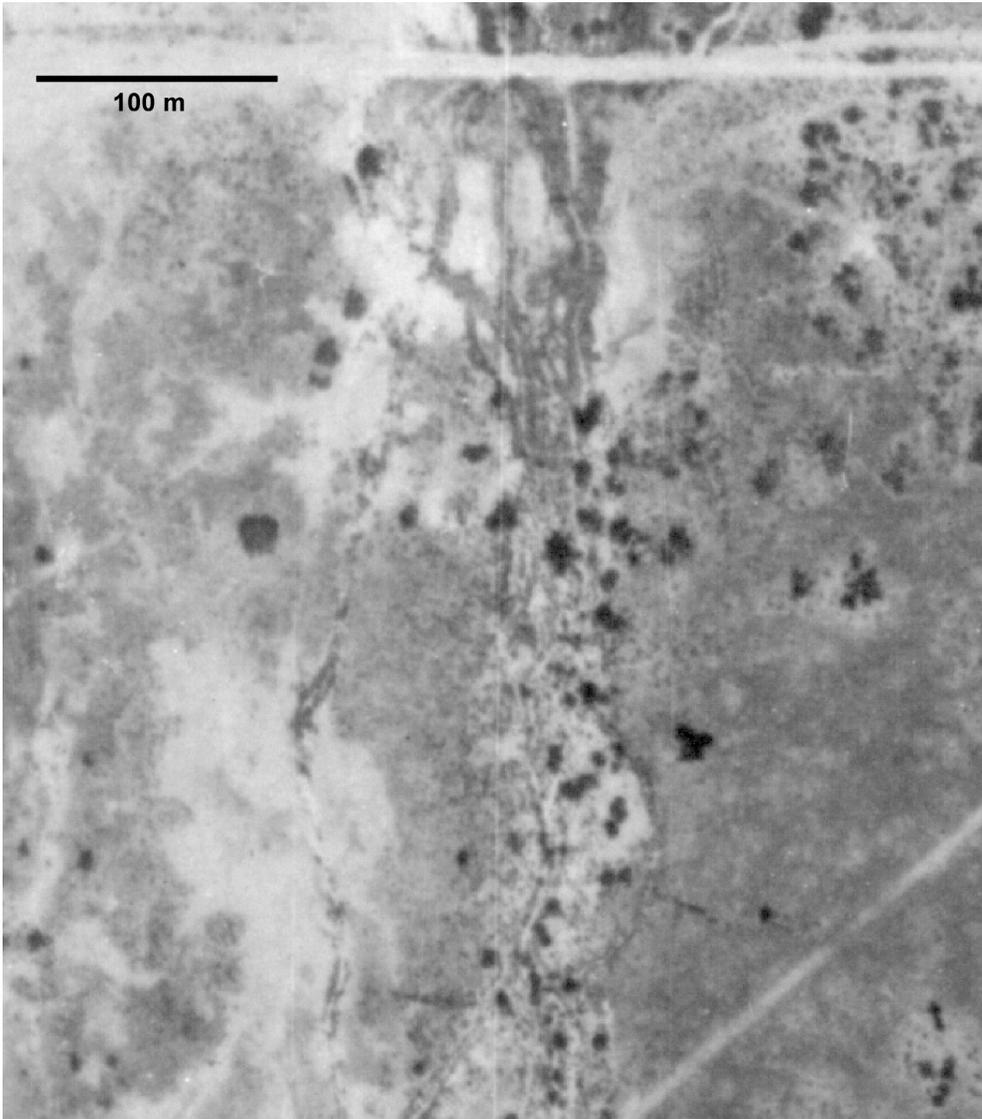
Figure 6. Southern part of main cluster as it appeared in 1979. Area same as shown in Figure 5. Part of the crack that resembles the number '3' formed some time before this 1979 photo.

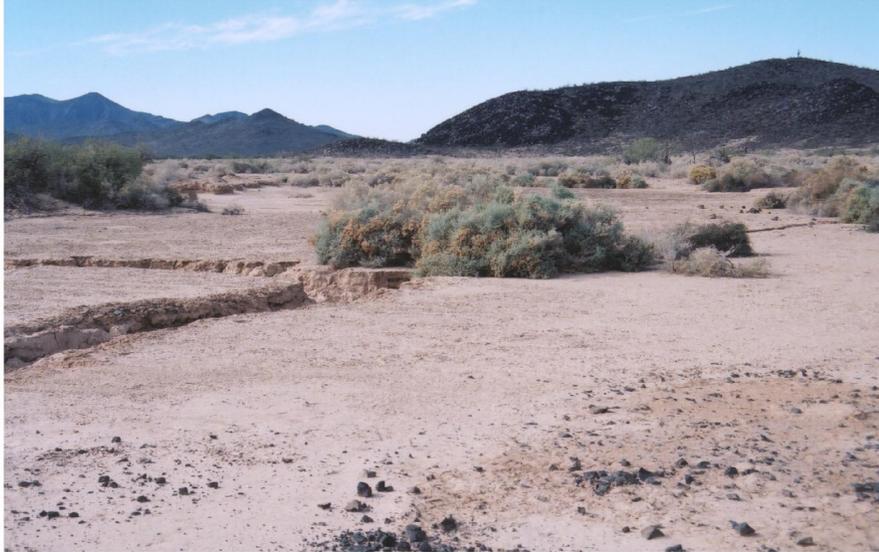
Figure 7. Intersection of cracks near northwestern end of main cluster, Winter 2002.

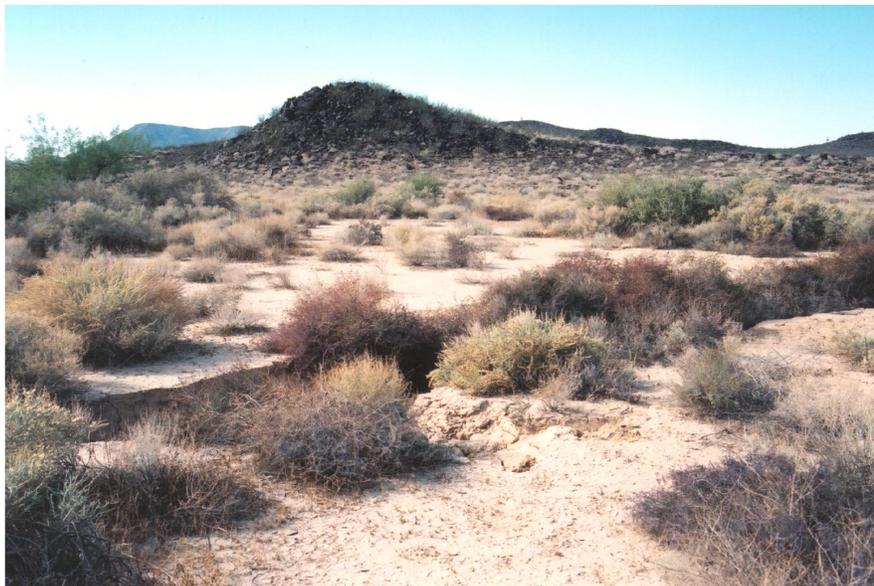
Figure 8. Crack near outcrop at northern end of main cluster, Winter 2002. This crack has multi-stage history, as shown by older vegetation in renewed crack.

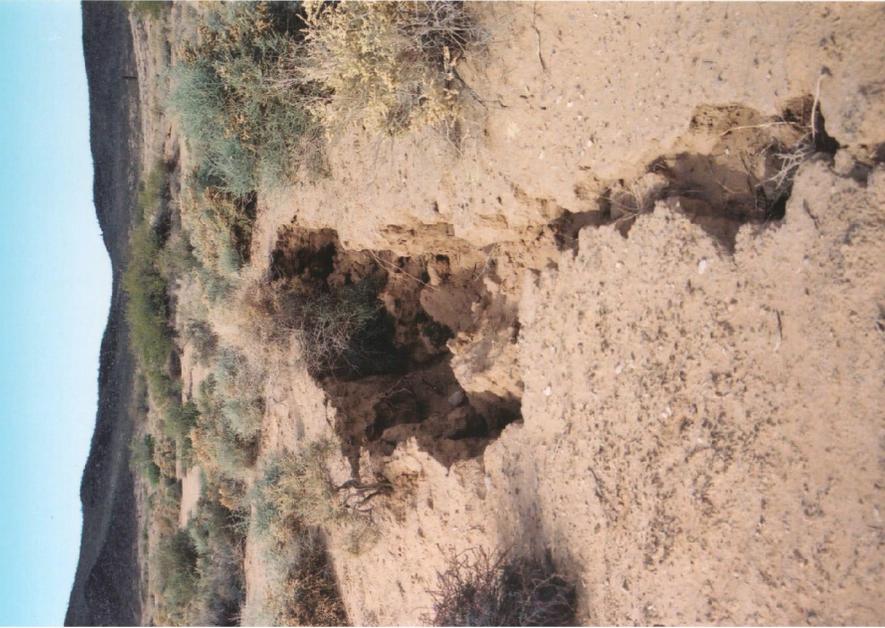
Figure 9. Crack near northwestern end of main cluster displays highly variable width and depth along its course.

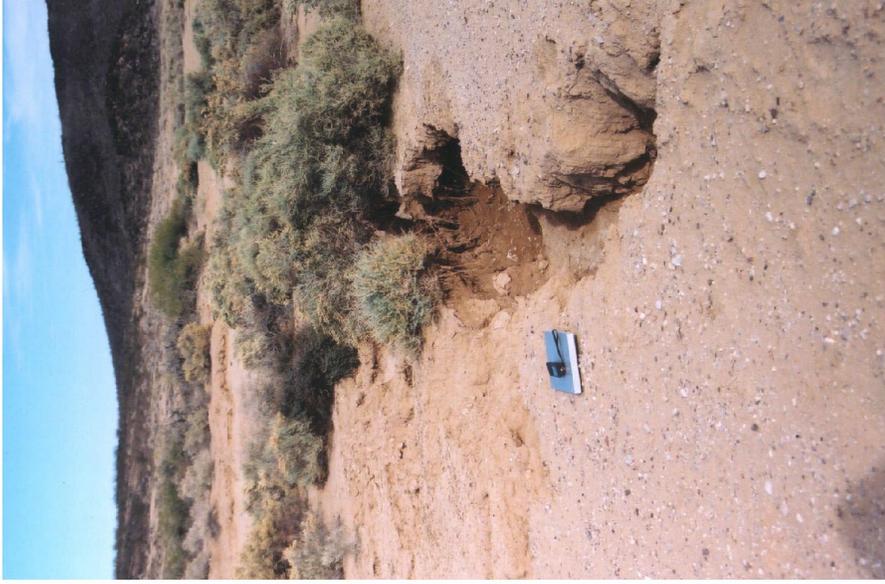
Figure 10. Typical crack, near north end of main cluster.

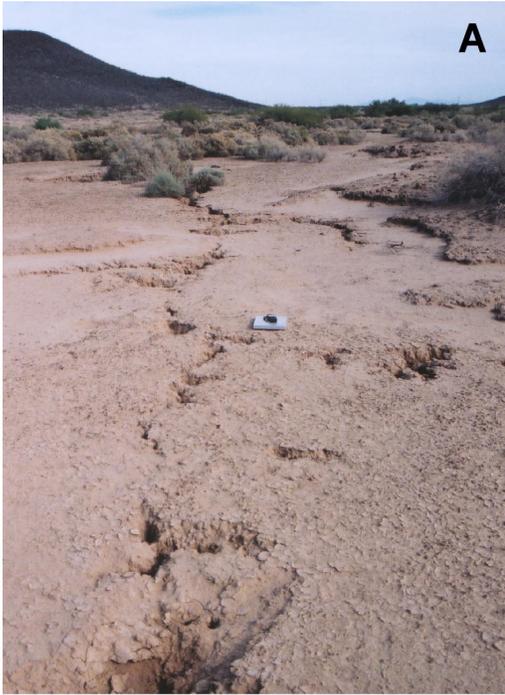
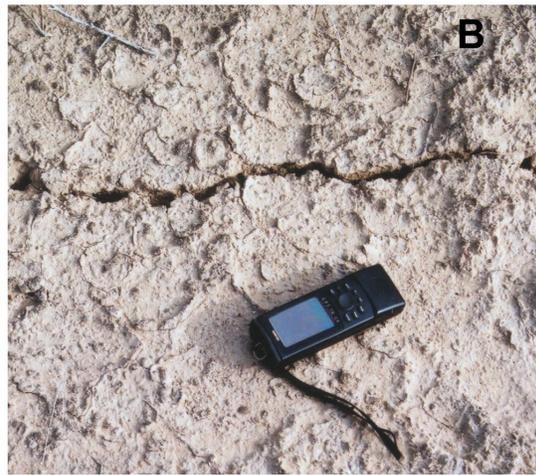
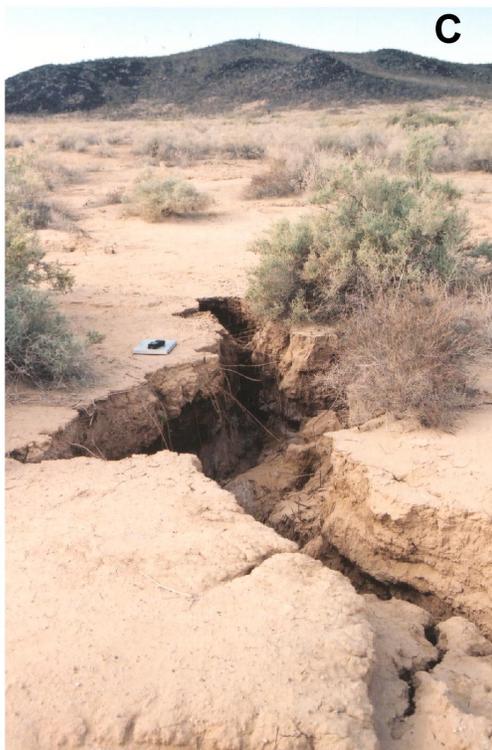
Figure 11. Changes along a crack at northwestern end of cluster. Intersection of cracks is at clipboard in center of photo A, looking east. The crack trending right (south) from the clipboard turns into a hairline crack (photo B) within 20 meters. South of (B), the crack appears suddenly as a large collapse hole (photo C), looking north.

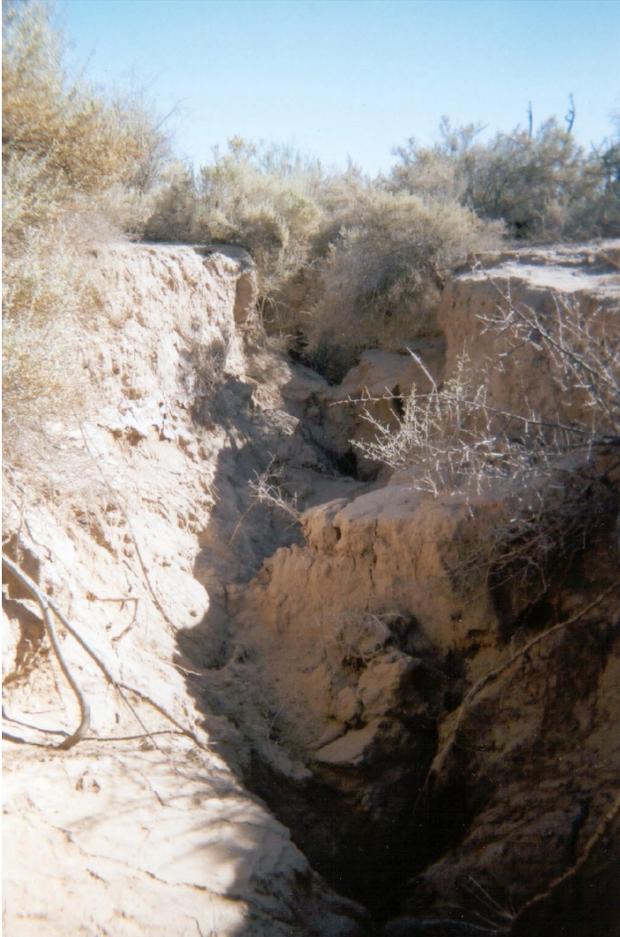
Figure 12. View of widest crack. This section is in southeastern part of crack that resembles a '3'. The crack here is 6-8 feet wide.

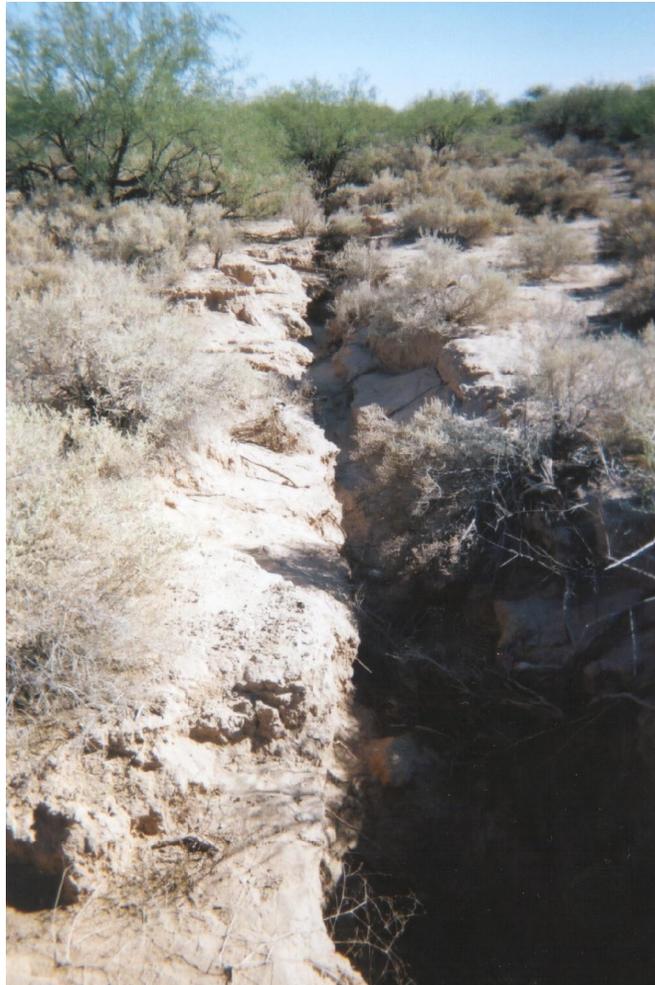
A short segment near the south end of the main crack is faintly visible on the 1979 BLM photos, indicating that cracking was in progress by that time. This segment has been recently re-activated (Figure 13). Most of the southern group appears to be young and active. According to local residents, the part of the crack that disrupted the road opened the previous summer, which presumably dates it to the time of opening of previously described desiccation cracks and an earth fissure 3 miles southeast of Wintersburg (Harris, 2001). Some work has been done to repair damage to the road from the crack (Figures 14 and 15).

Figure 13. North-south section of main crack in southern cluster.

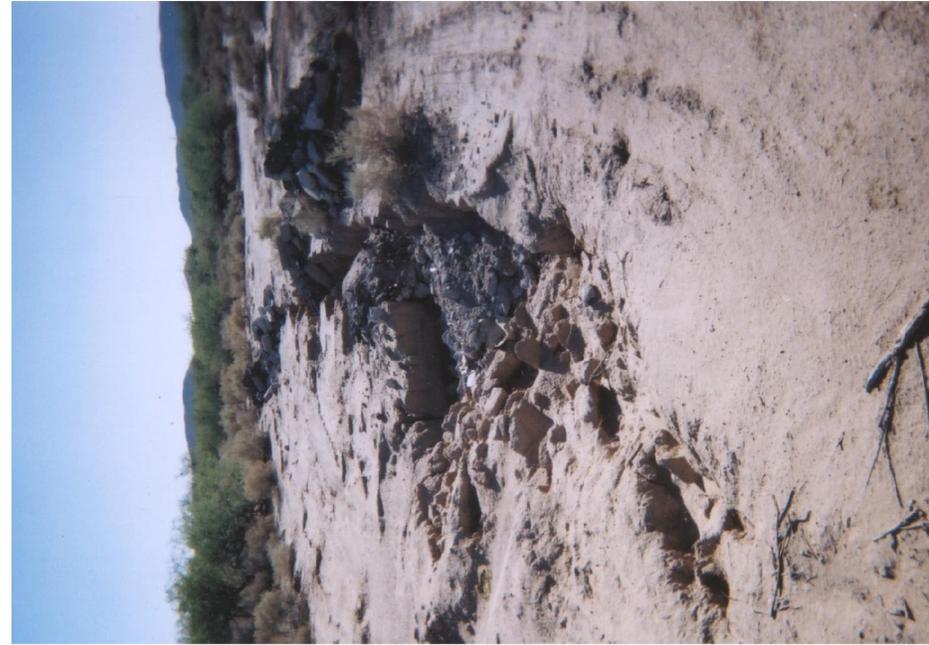
Figure 14. View of southern crack where it crosses a relatively new road. An attempt has been made to fill the crack with debris.

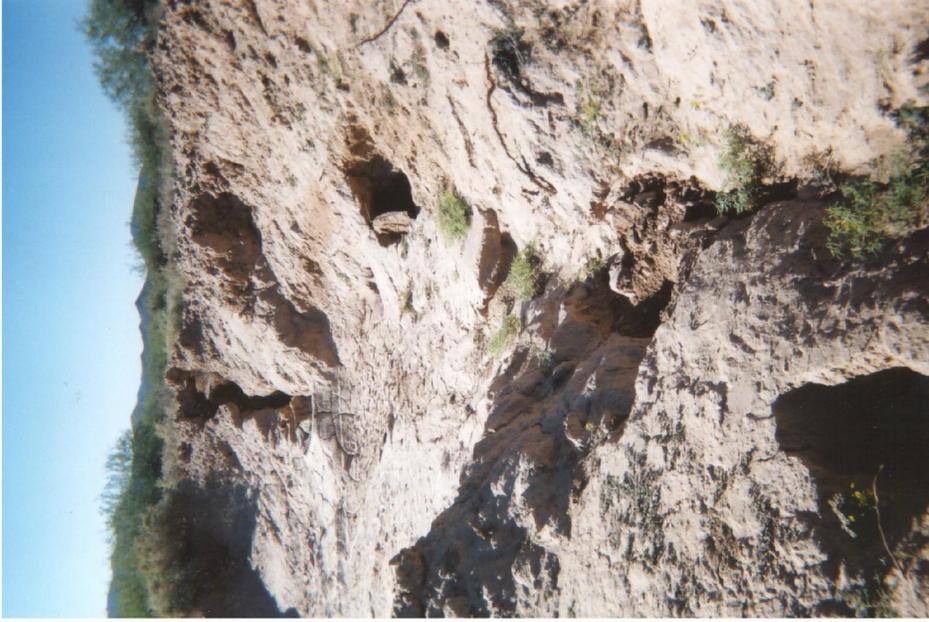
Figure 15. View of southern-most crack near its eastern end. Crack has been partially filled next to road but is starting to open again.

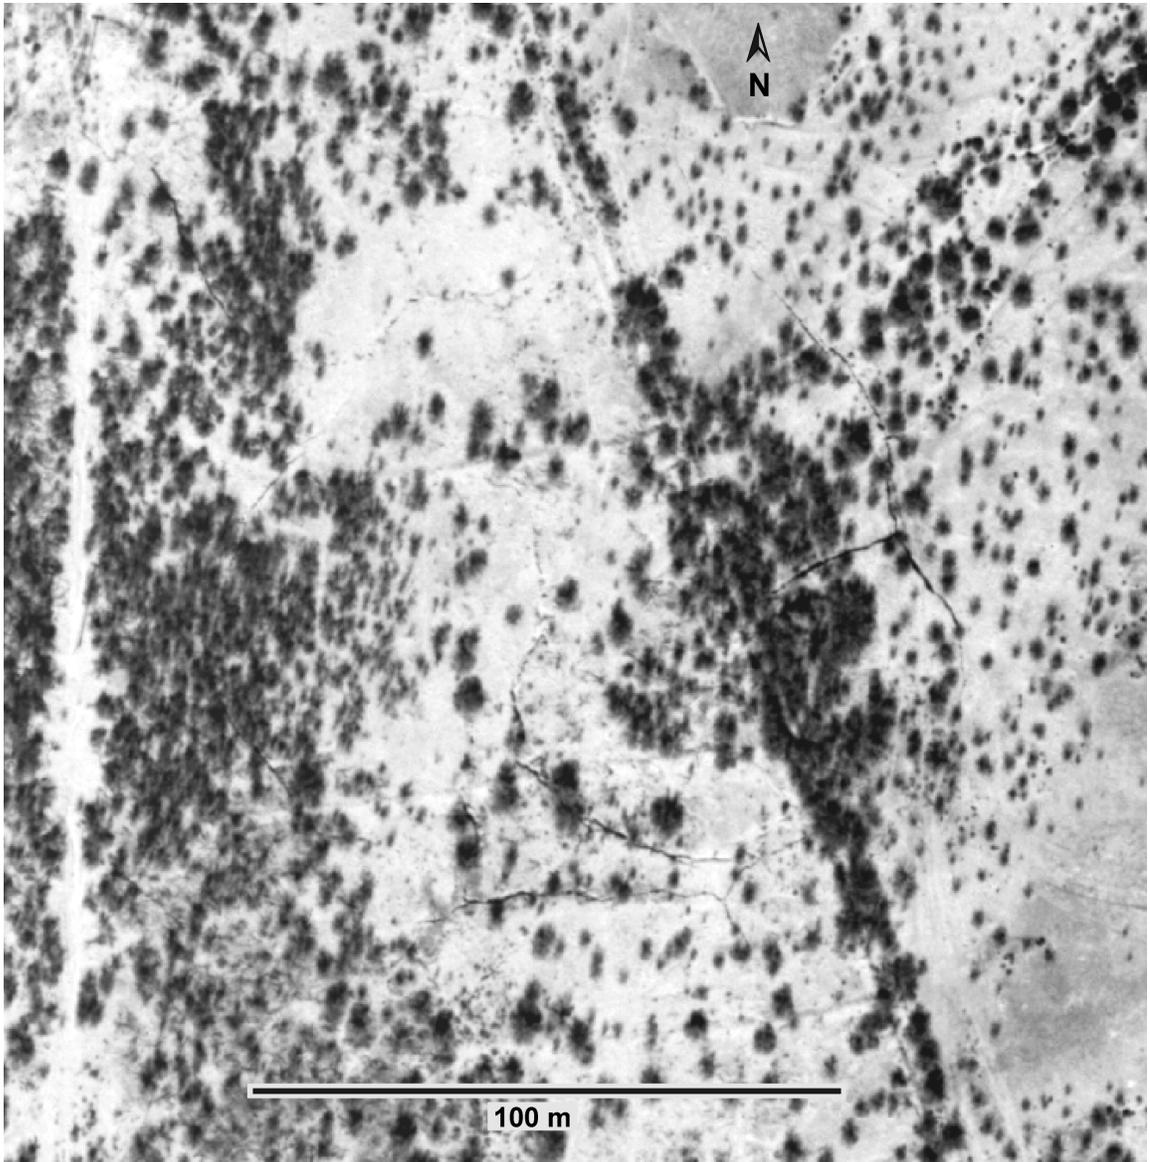
Figure 17. Aerial view of desiccation cracks 6 miles south of Wintersburg.

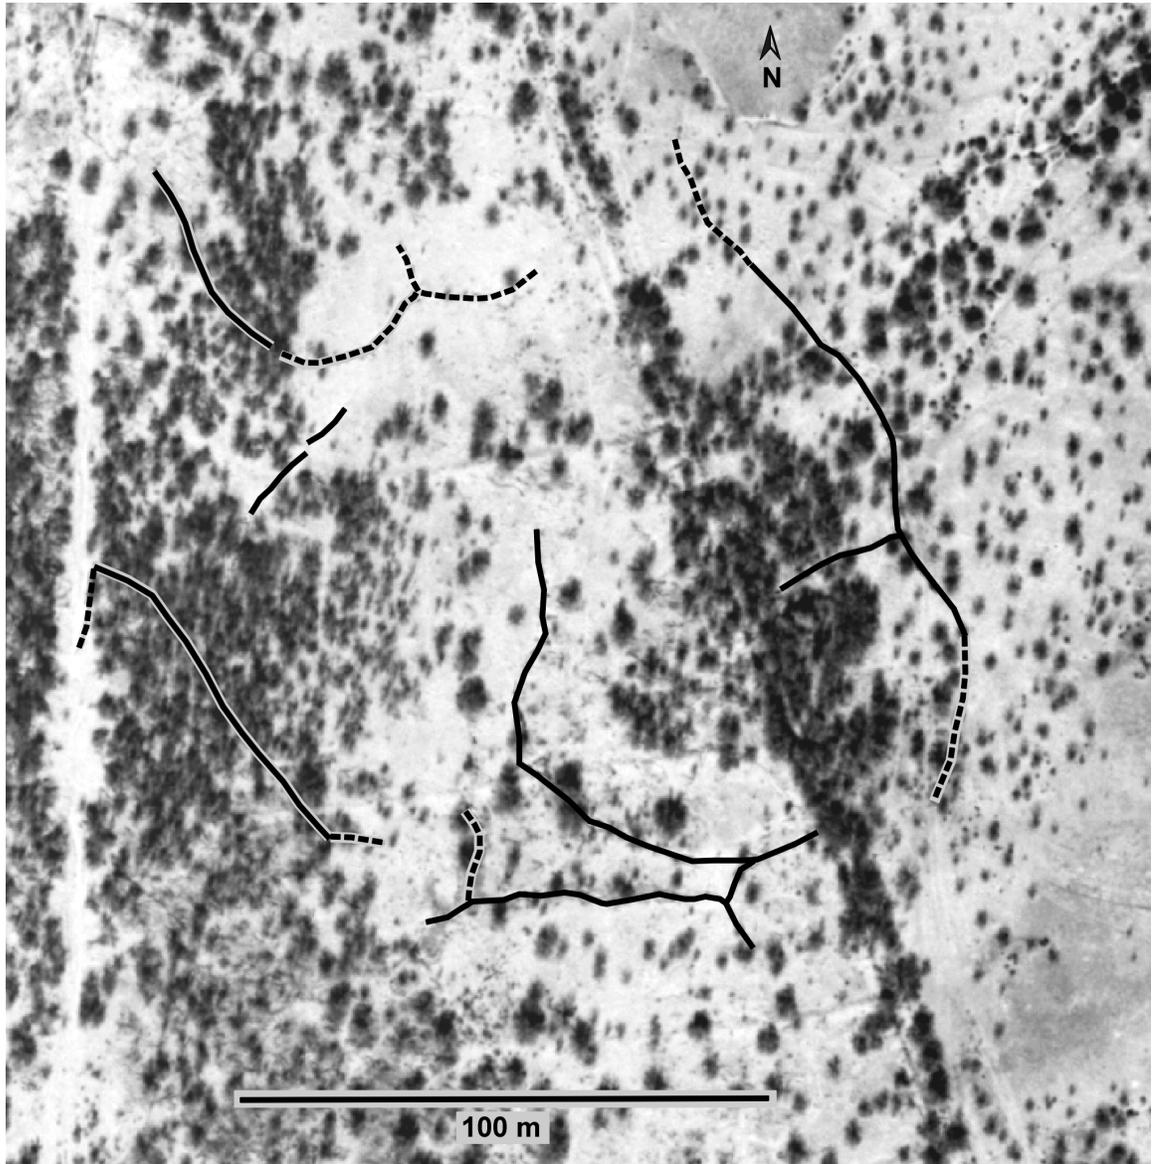
Figure 18. Interpretation of location of desiccation cracks.
Lines dashed where less certain.
