EARTH FISSURES IN THE
BOWIE - SAN SIMON AREA,
COCHISE COUNTY, ARIZONA

Arizona Geological Survey
Open-File Report 97-19

November, 1997

Produced for the Arizona Department of Environmental Quality

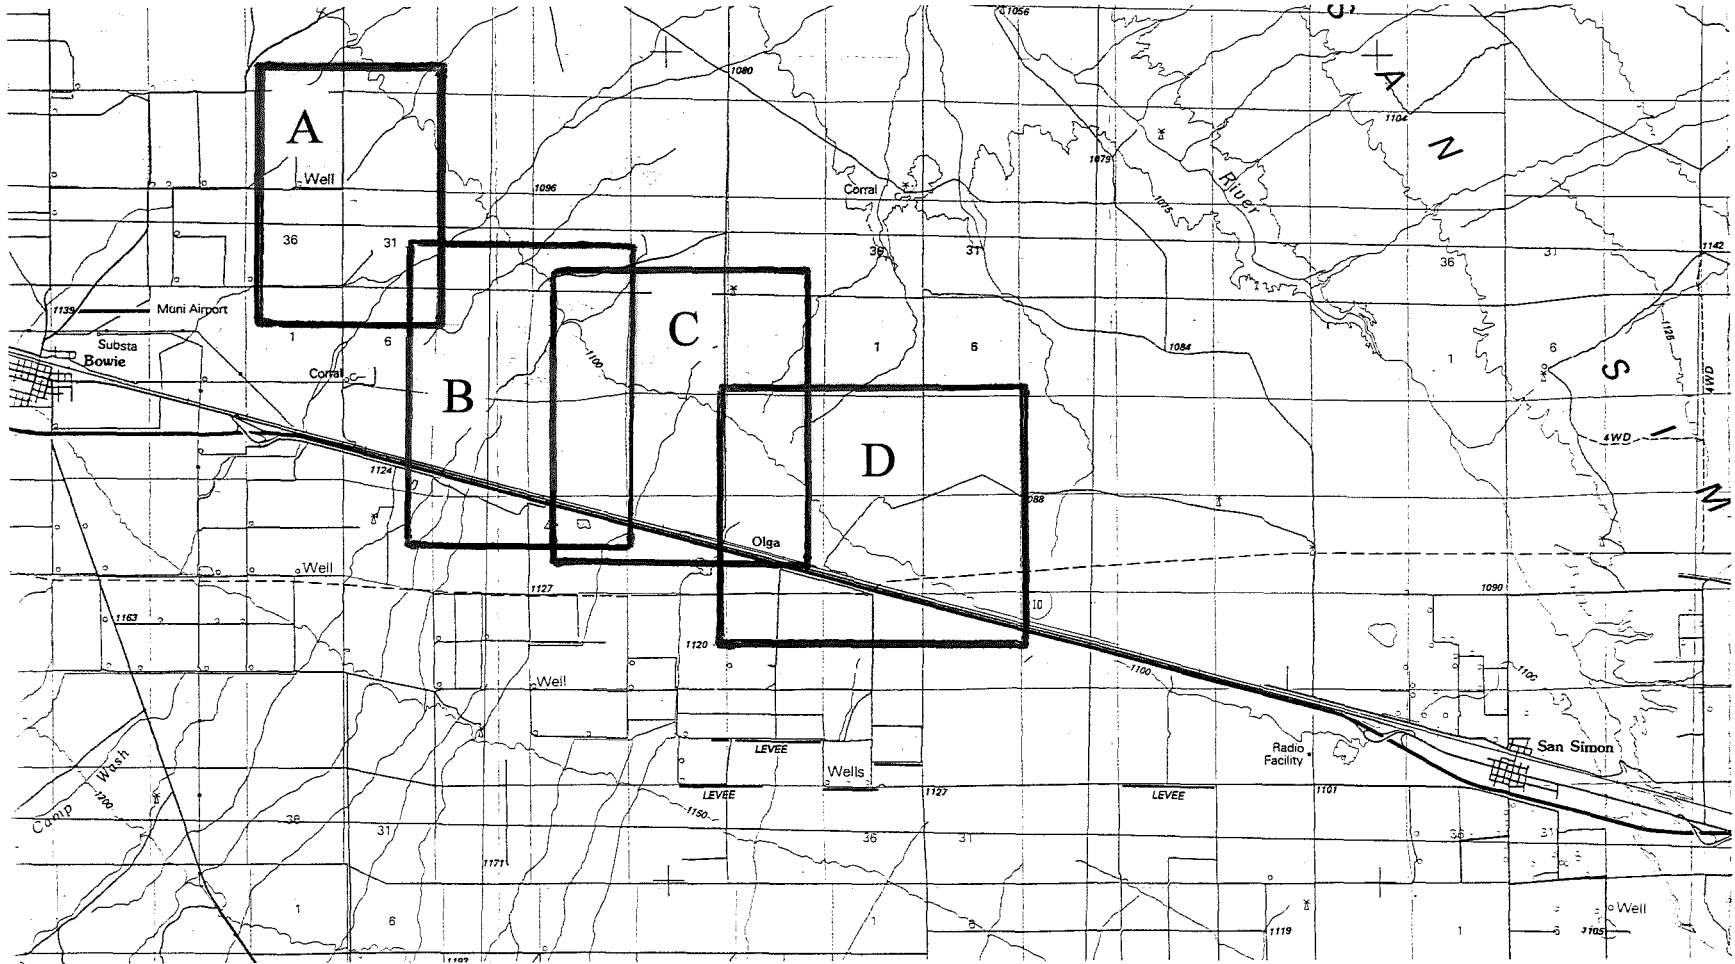
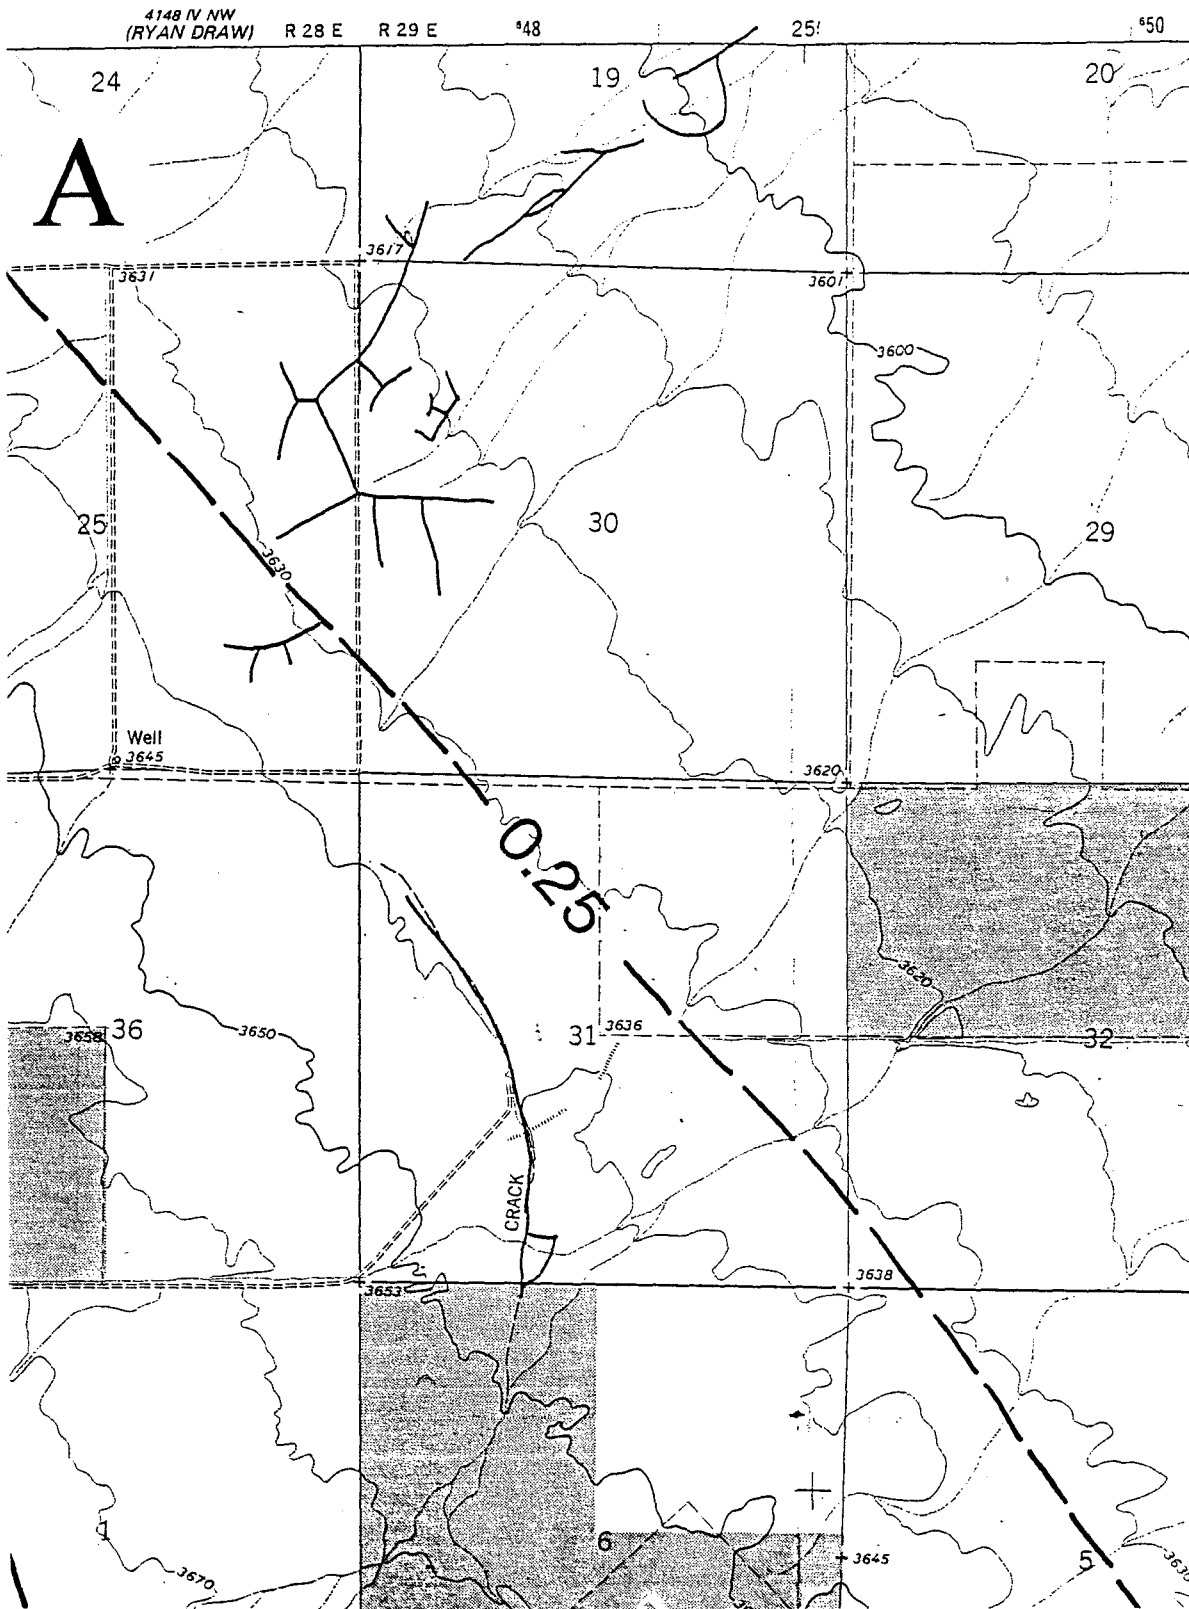
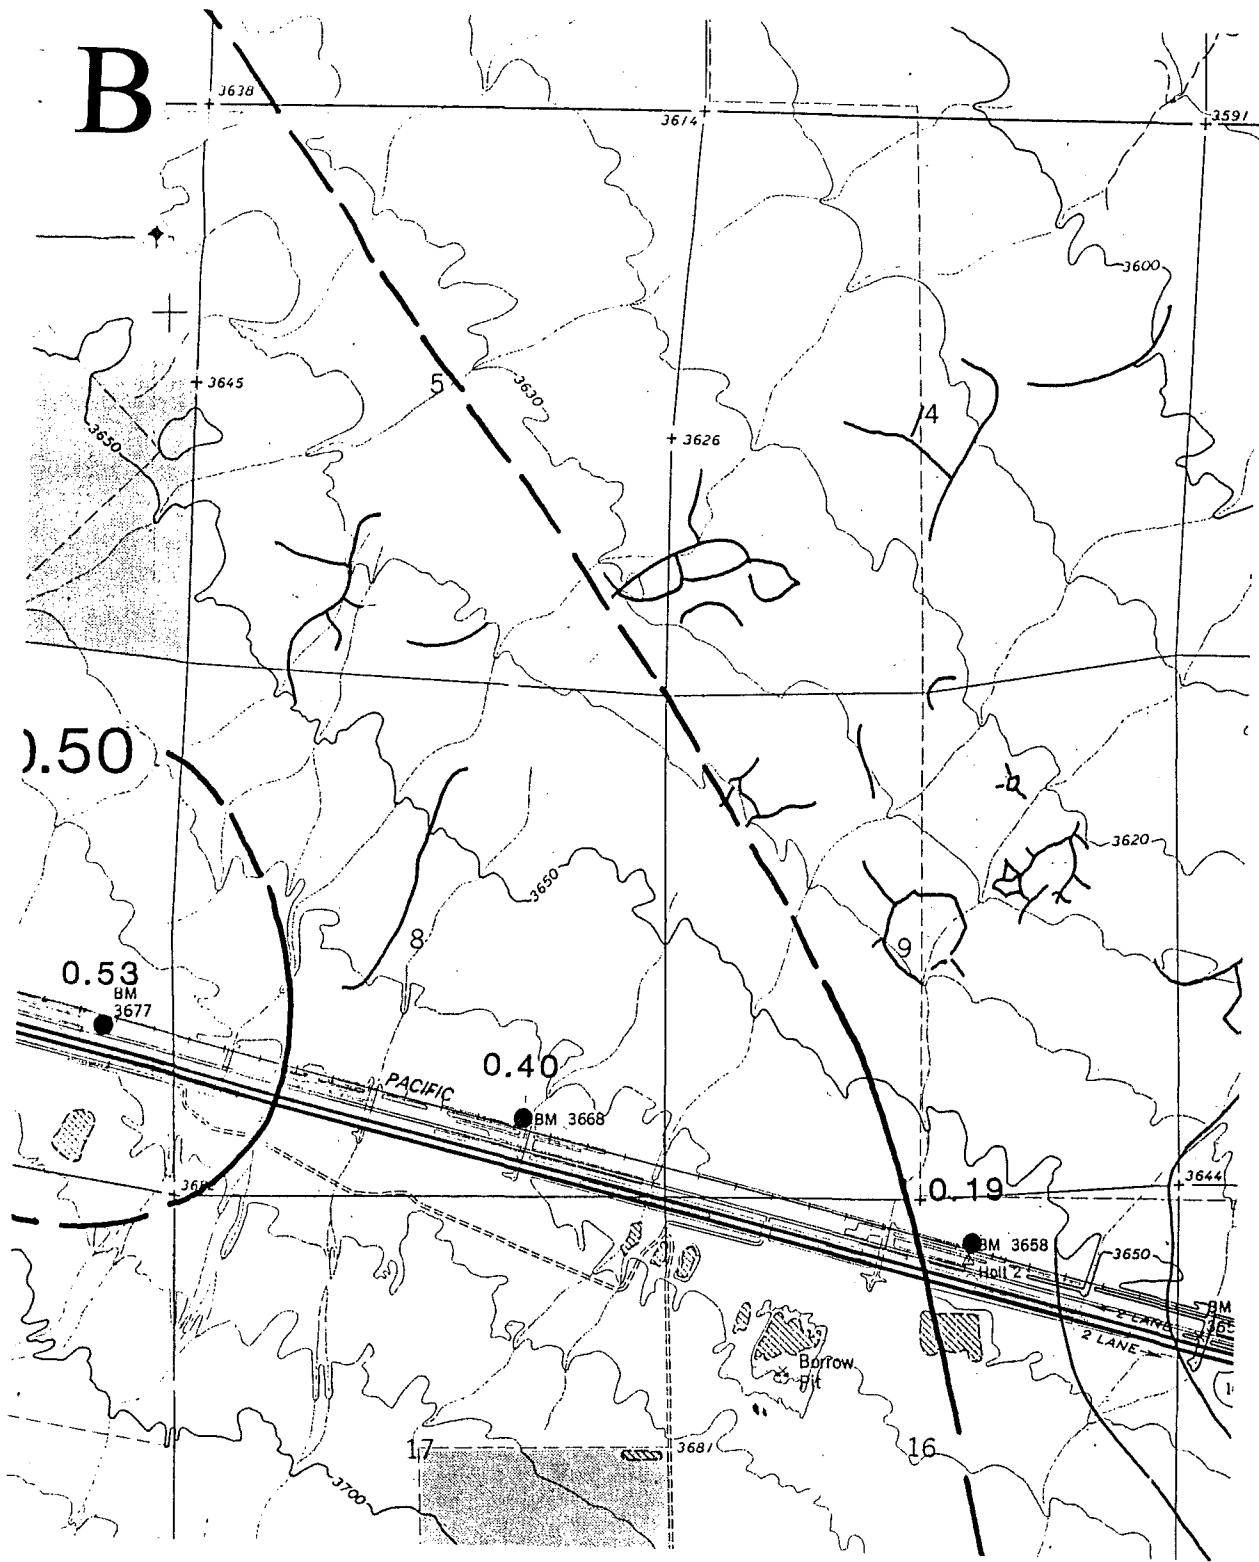
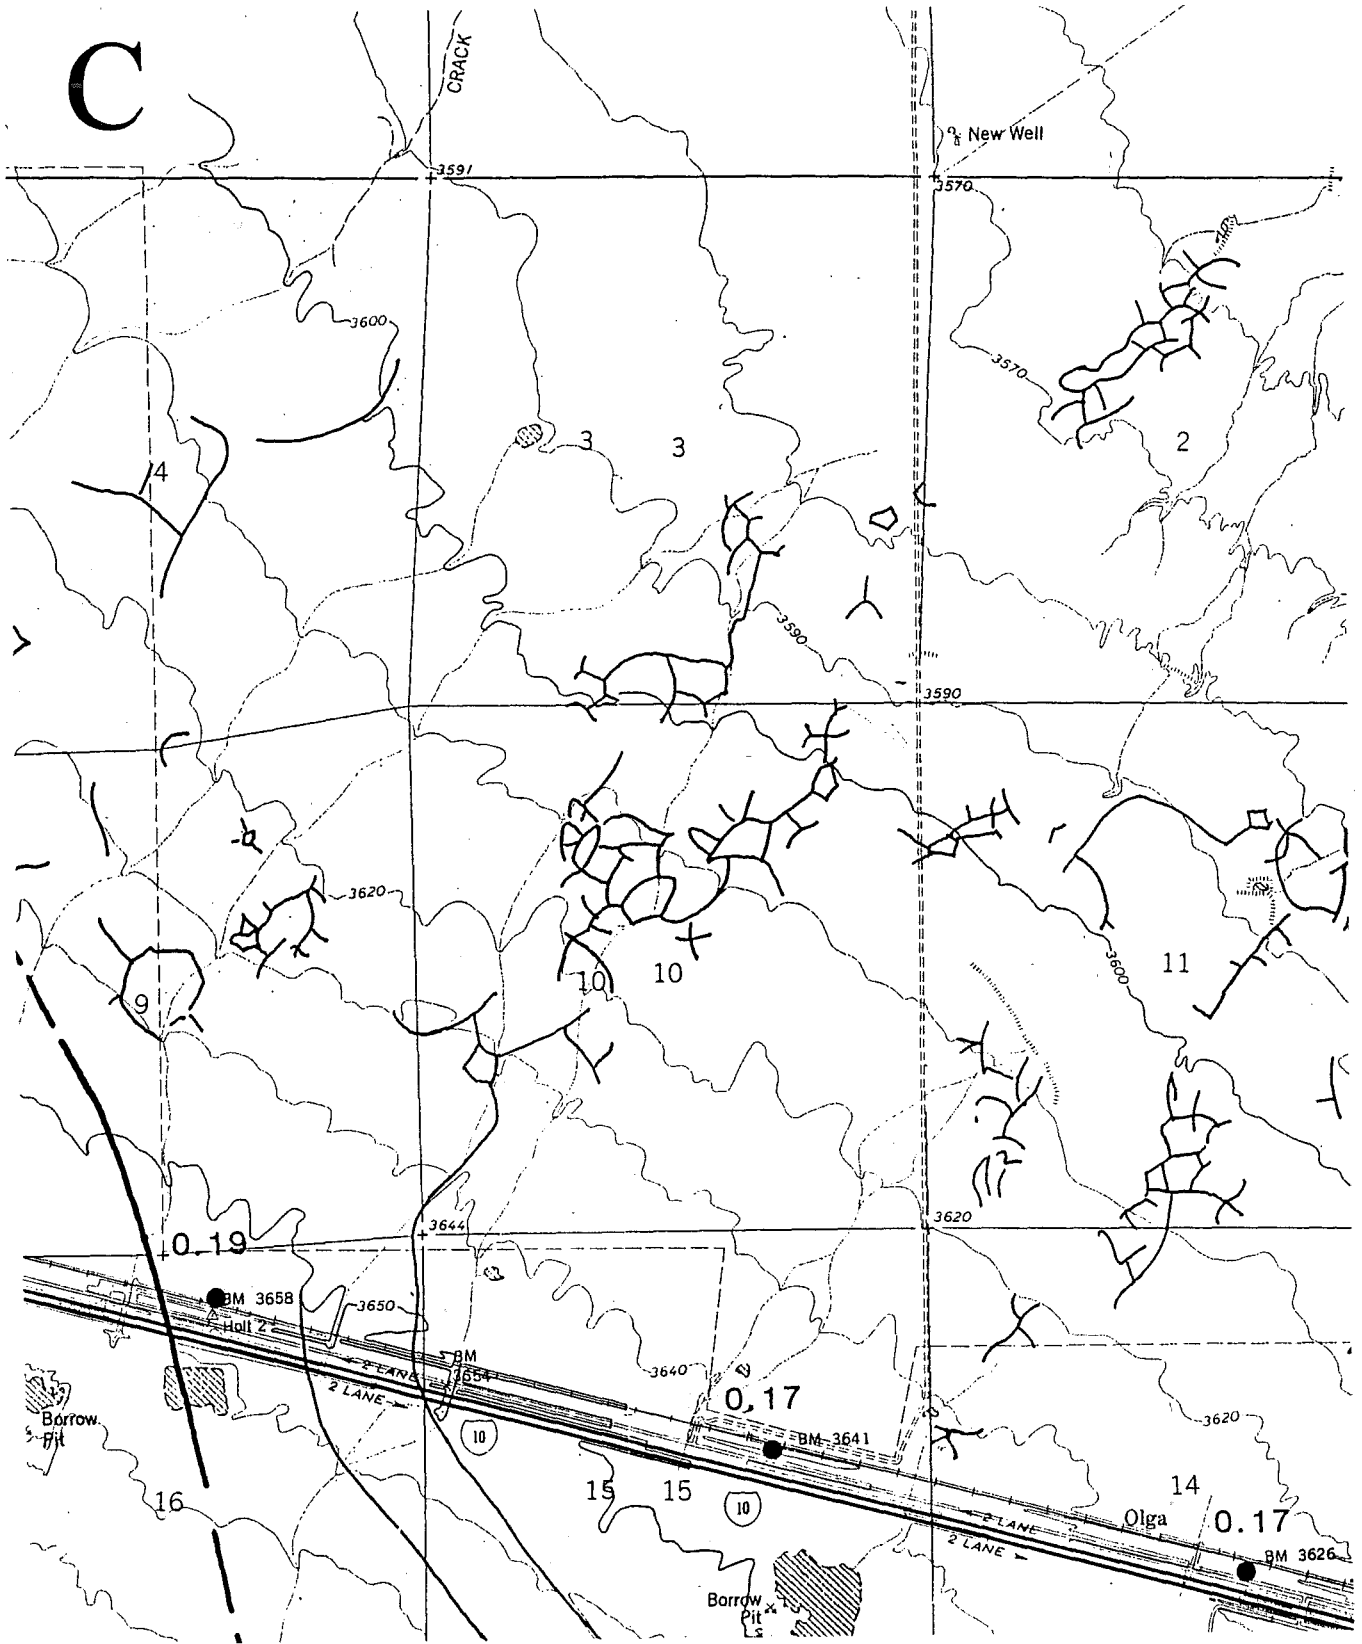
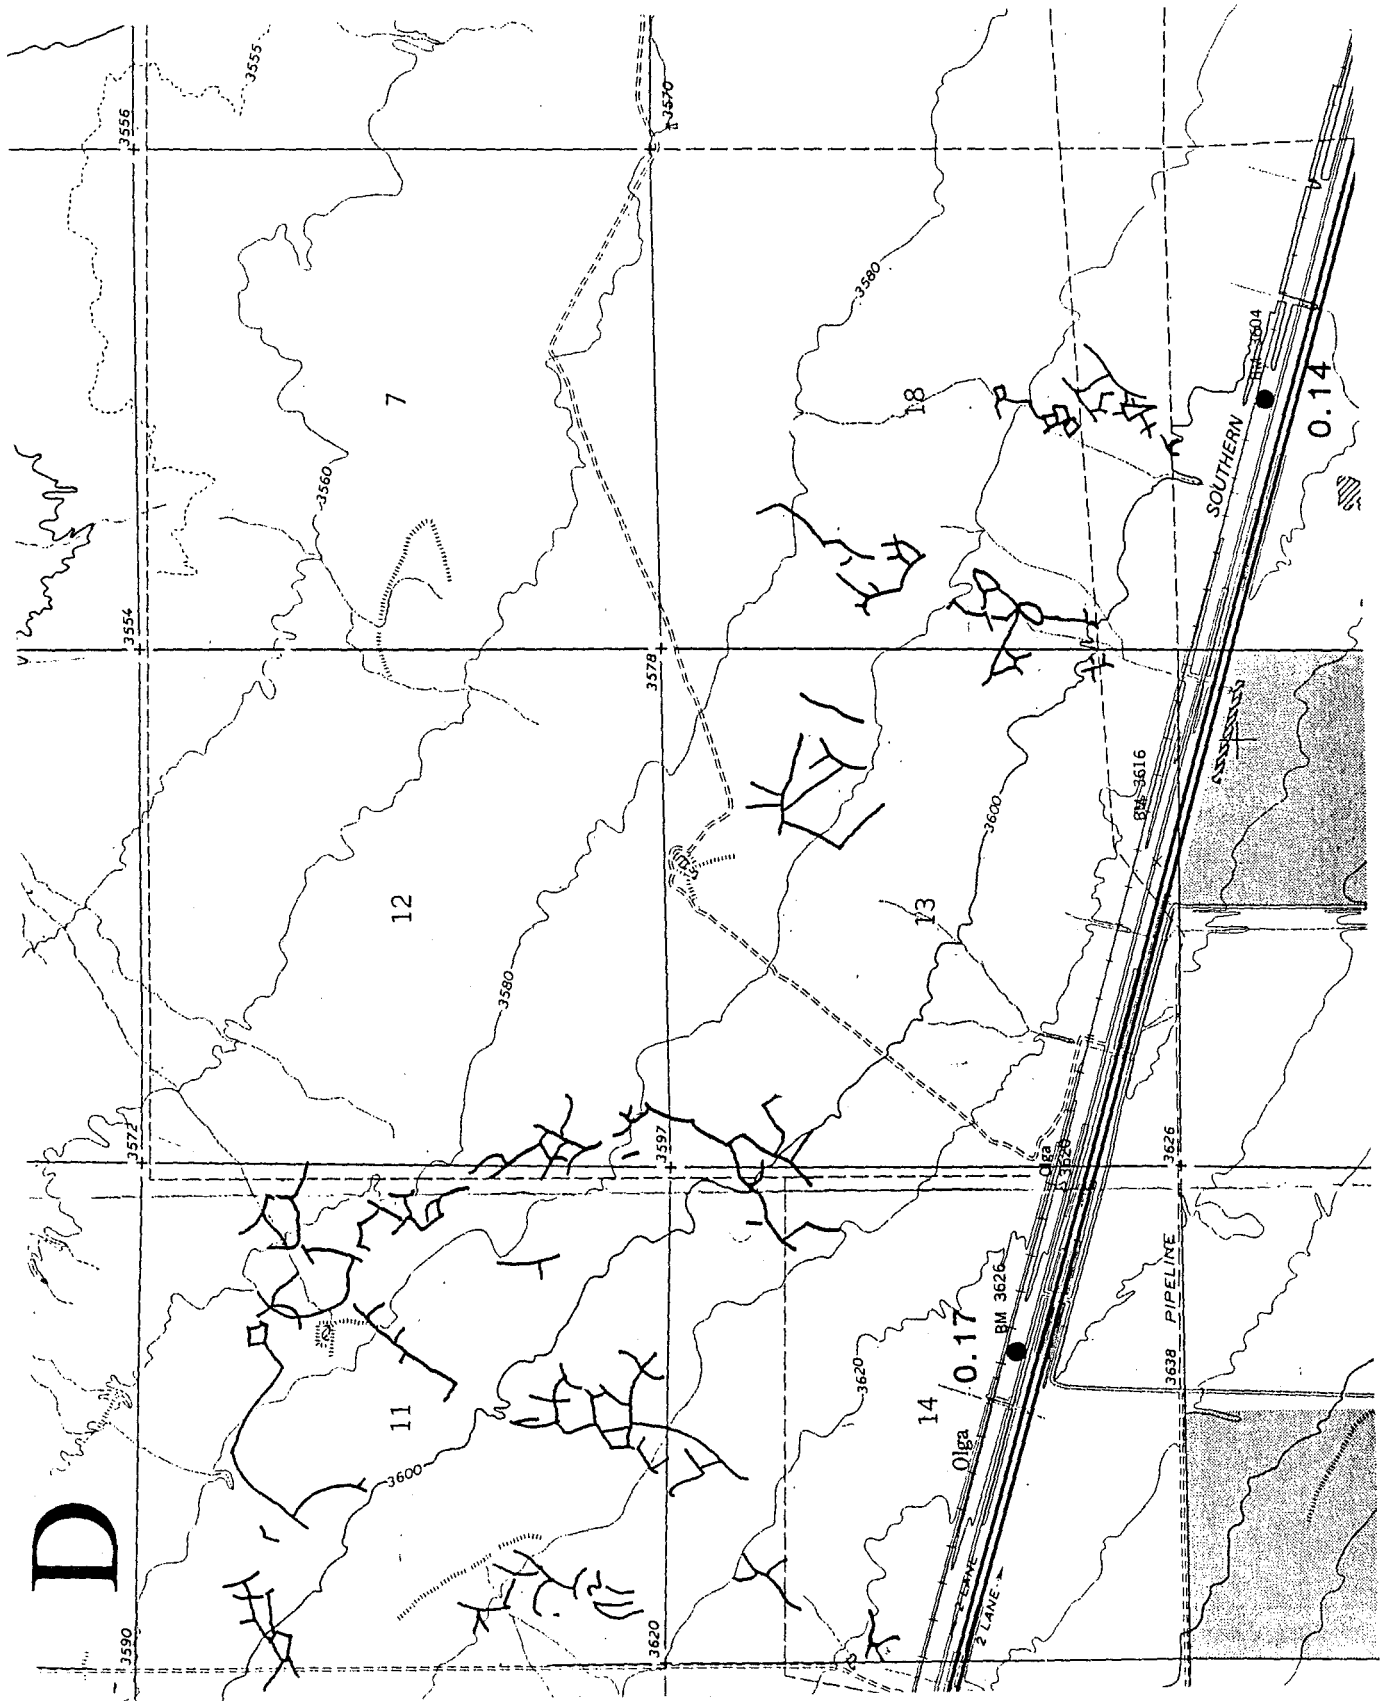
APPENDIX A

Polygonal cracks were plotted by Holzer (1980). Parts of his map are reproduced in Appendix A for convenience. A comparison of Holzer's map and 1970 ADOT photos with the 1989 photos indicates that there has not been any obvious increase in the number or size of the polygonal cracks. No attempt was made in this study to re-map all of the polygons. Several of the larger, reactivated cracks were visited and are shown on Plate 1.

Polygonal fissures in the Bowie - San Simon area.

Taken from US Geological Survey Miscellaneous Field Studies Map MF-1156, by T.L. Holzer, 1980
