FIELD GUIDE TO
EARTH FISSIONS AND OTHER
LAND SUBSIDENCE FEATURES
IN PICACHO BASIN

Arizona Geological Society
Arizona Hydrological Society
Fall 1999 Field Trip
November 13, 1999

Arizona Geological Survey
Open-File Report 99-26

Leader:
Raymond C. Harris
Arizona Geological Survey

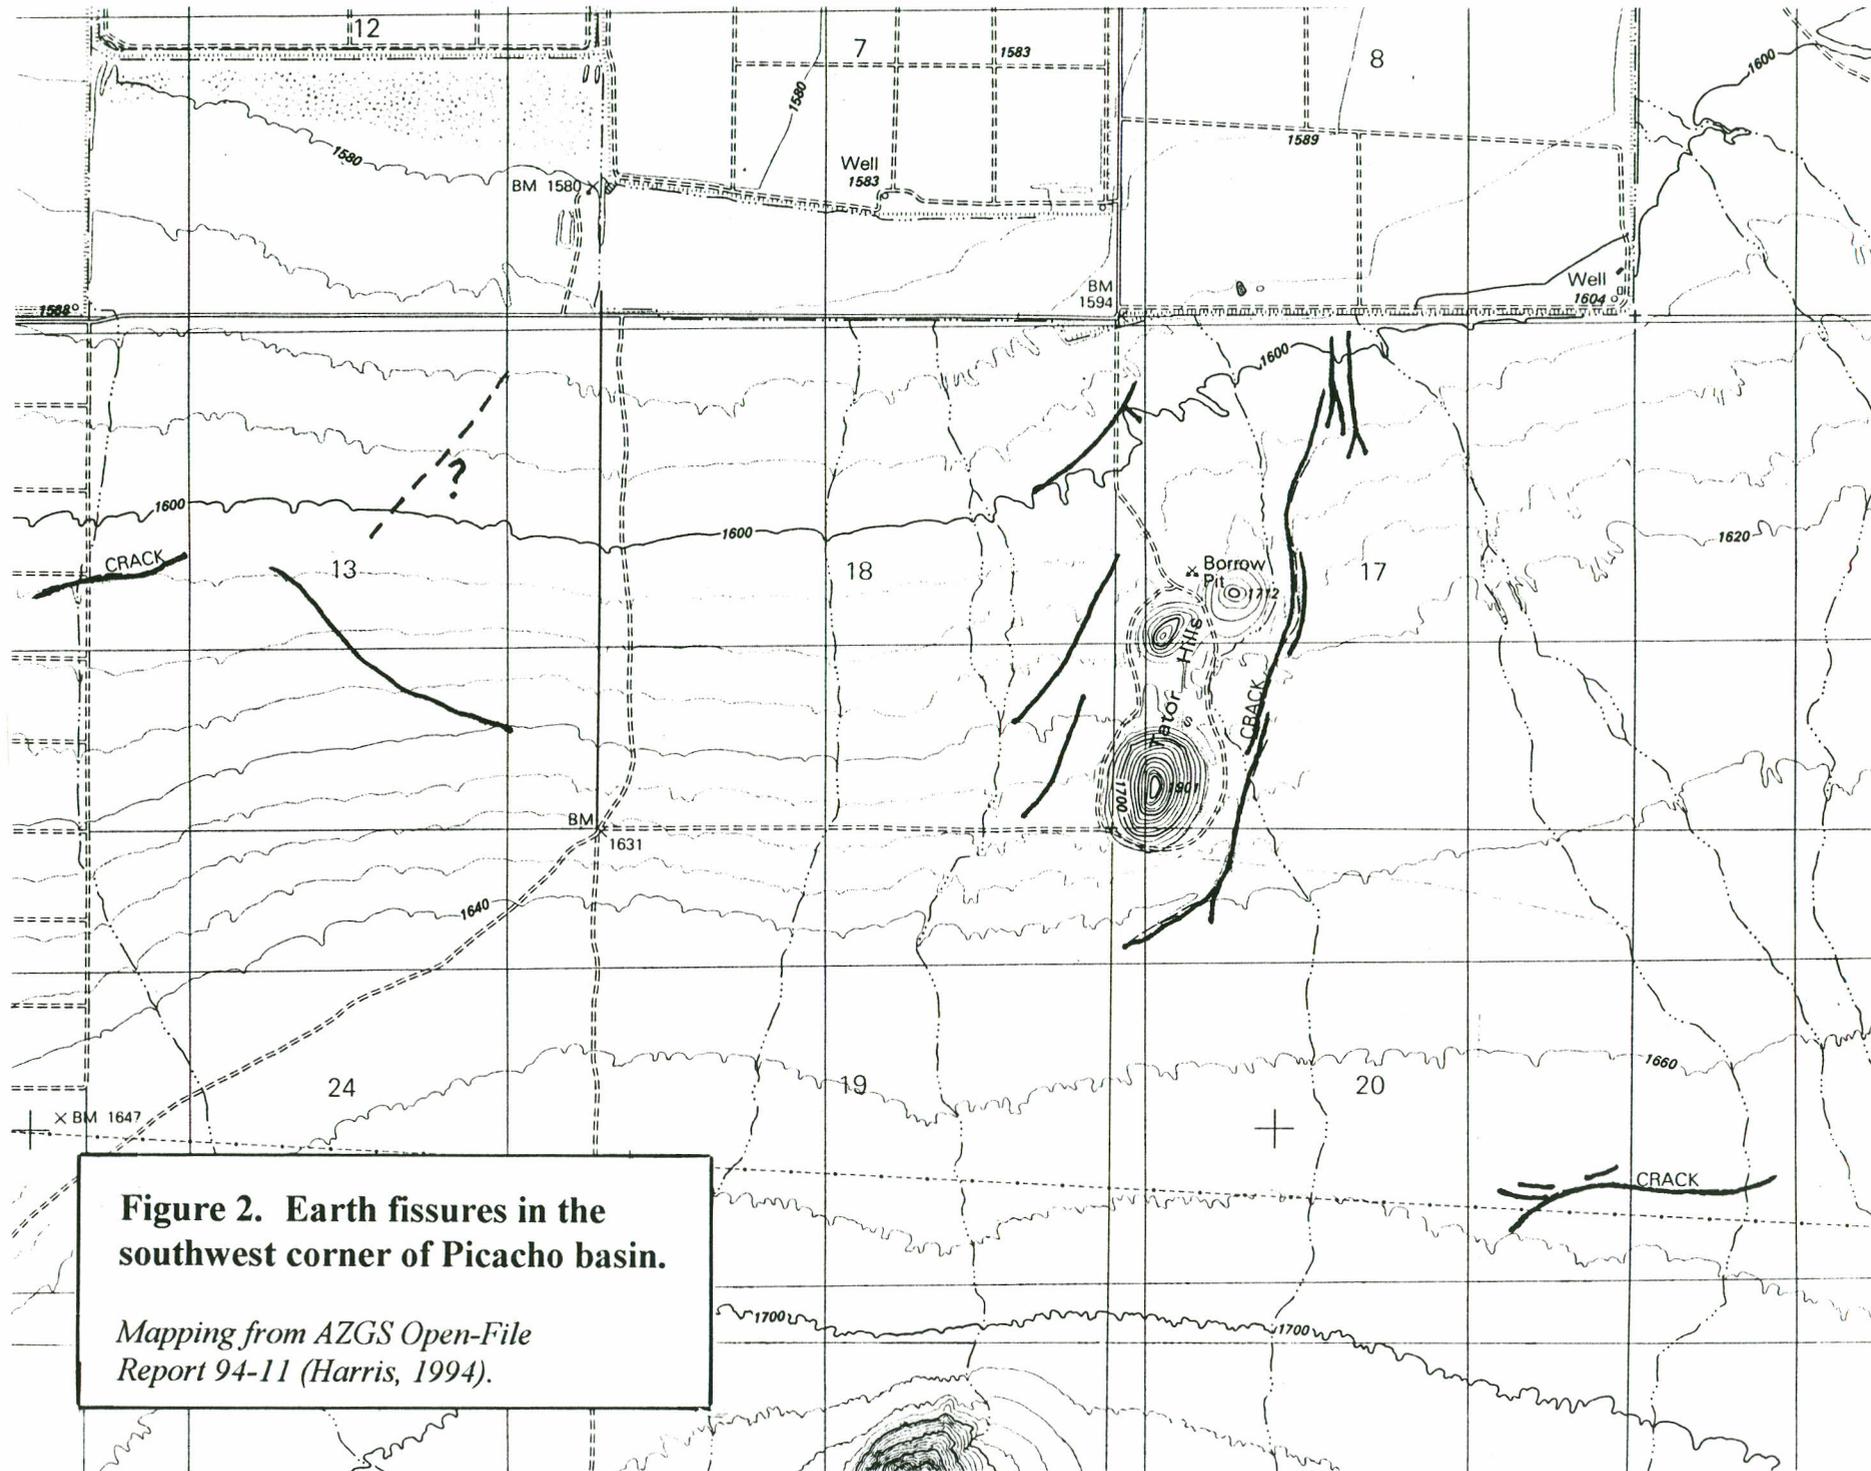
When the fissures in this part of the basin first opened up is not known, but the large fissure on the east side of the Tator Hills and several others in the region are indicated on 1981 USGS topographic maps (**Figure 2**). A comparison of the fissures present when the USGS map was field-checked in 1977 with fissures found in 1994 shows the addition of many new cracks and lengthening of older fissures (**Figure 5**). The large fissure system now typically consists of two or three parallel cracks and toward the north end begins to form multiple, offset (en echelon) cracks.

Figure 2. Earth fissures in the southwest corner of Picacho basin.

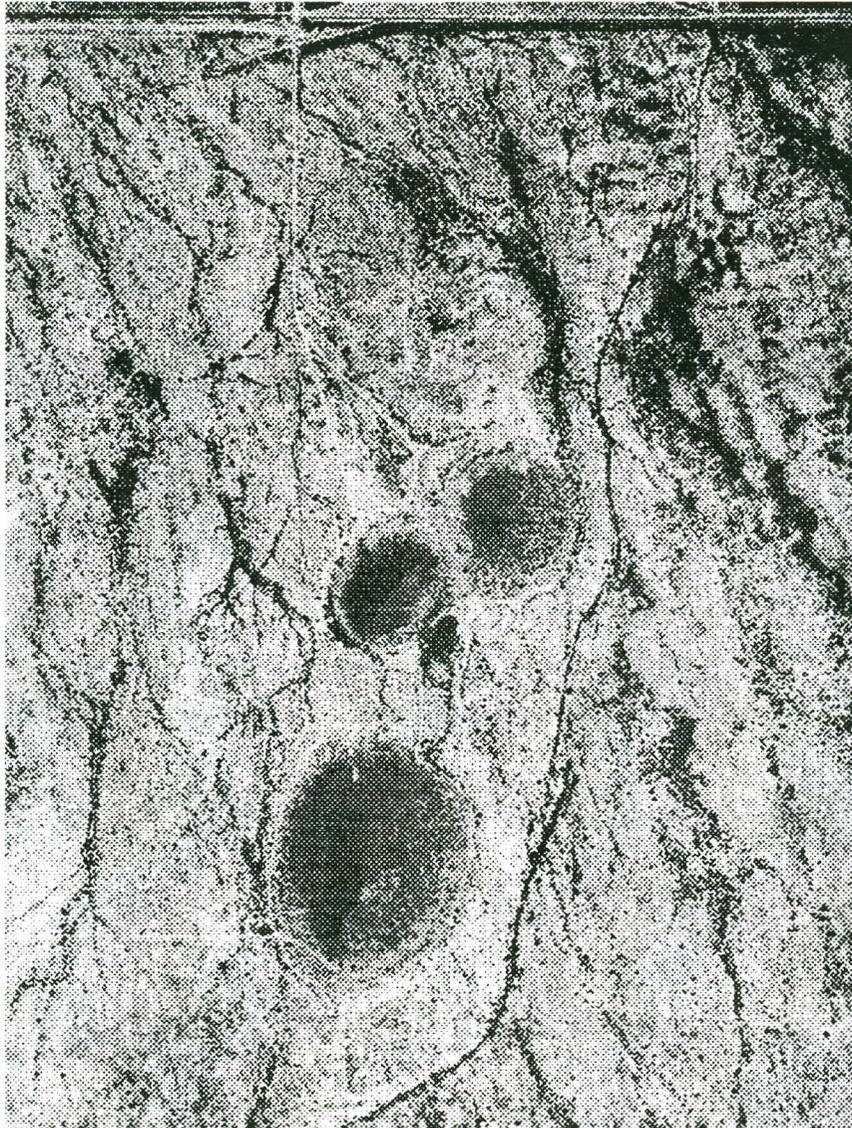
Figure 3. Aerial view of earth fissures around the Tator Hills, southwest Picacho Basin. Fissures have formed on both sides of the hills. The fissure zone to the east (right) of the hills is over a mile long. The fissure continues past the bottom of this aerial photo several hundred yards. Photo is about 1.1 miles from top to bottom. (*Aerial photo from Pinal County.*)

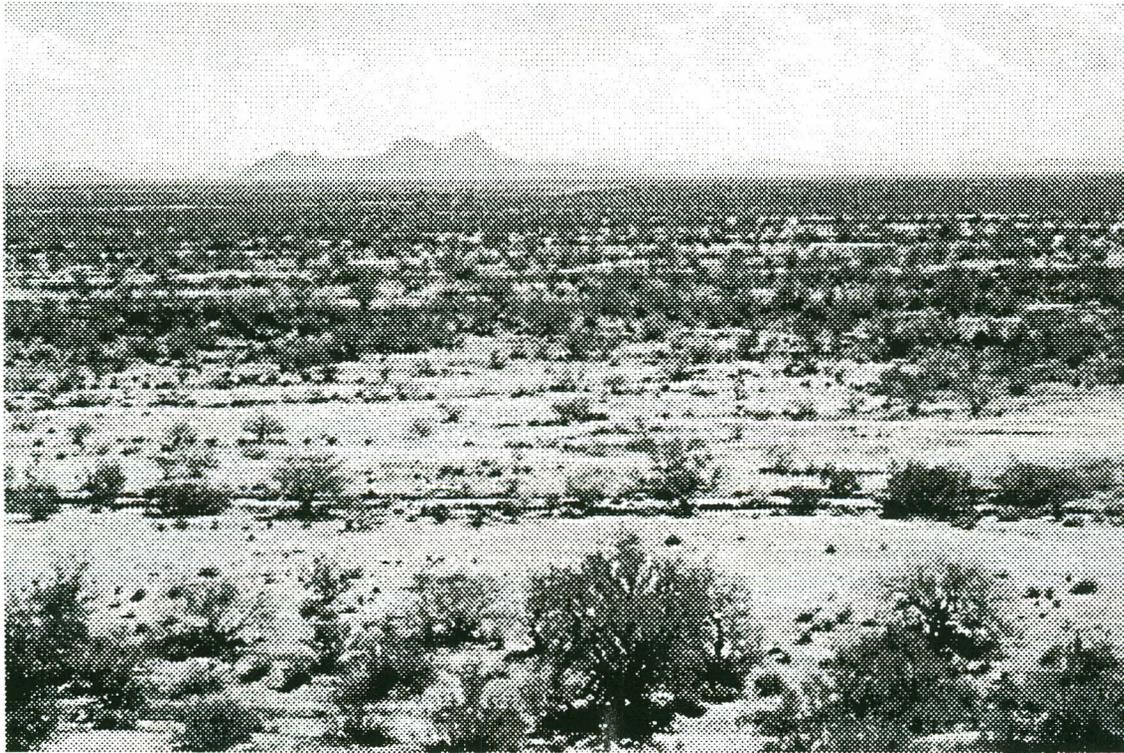
Figure 4. View of large earth fissure zone on east side of Tator Hills. Fissure zone here consists of two parallel cracks (horizontal lines about one-third up from bottom of photo). *(Photo by R.C. Harris.)*

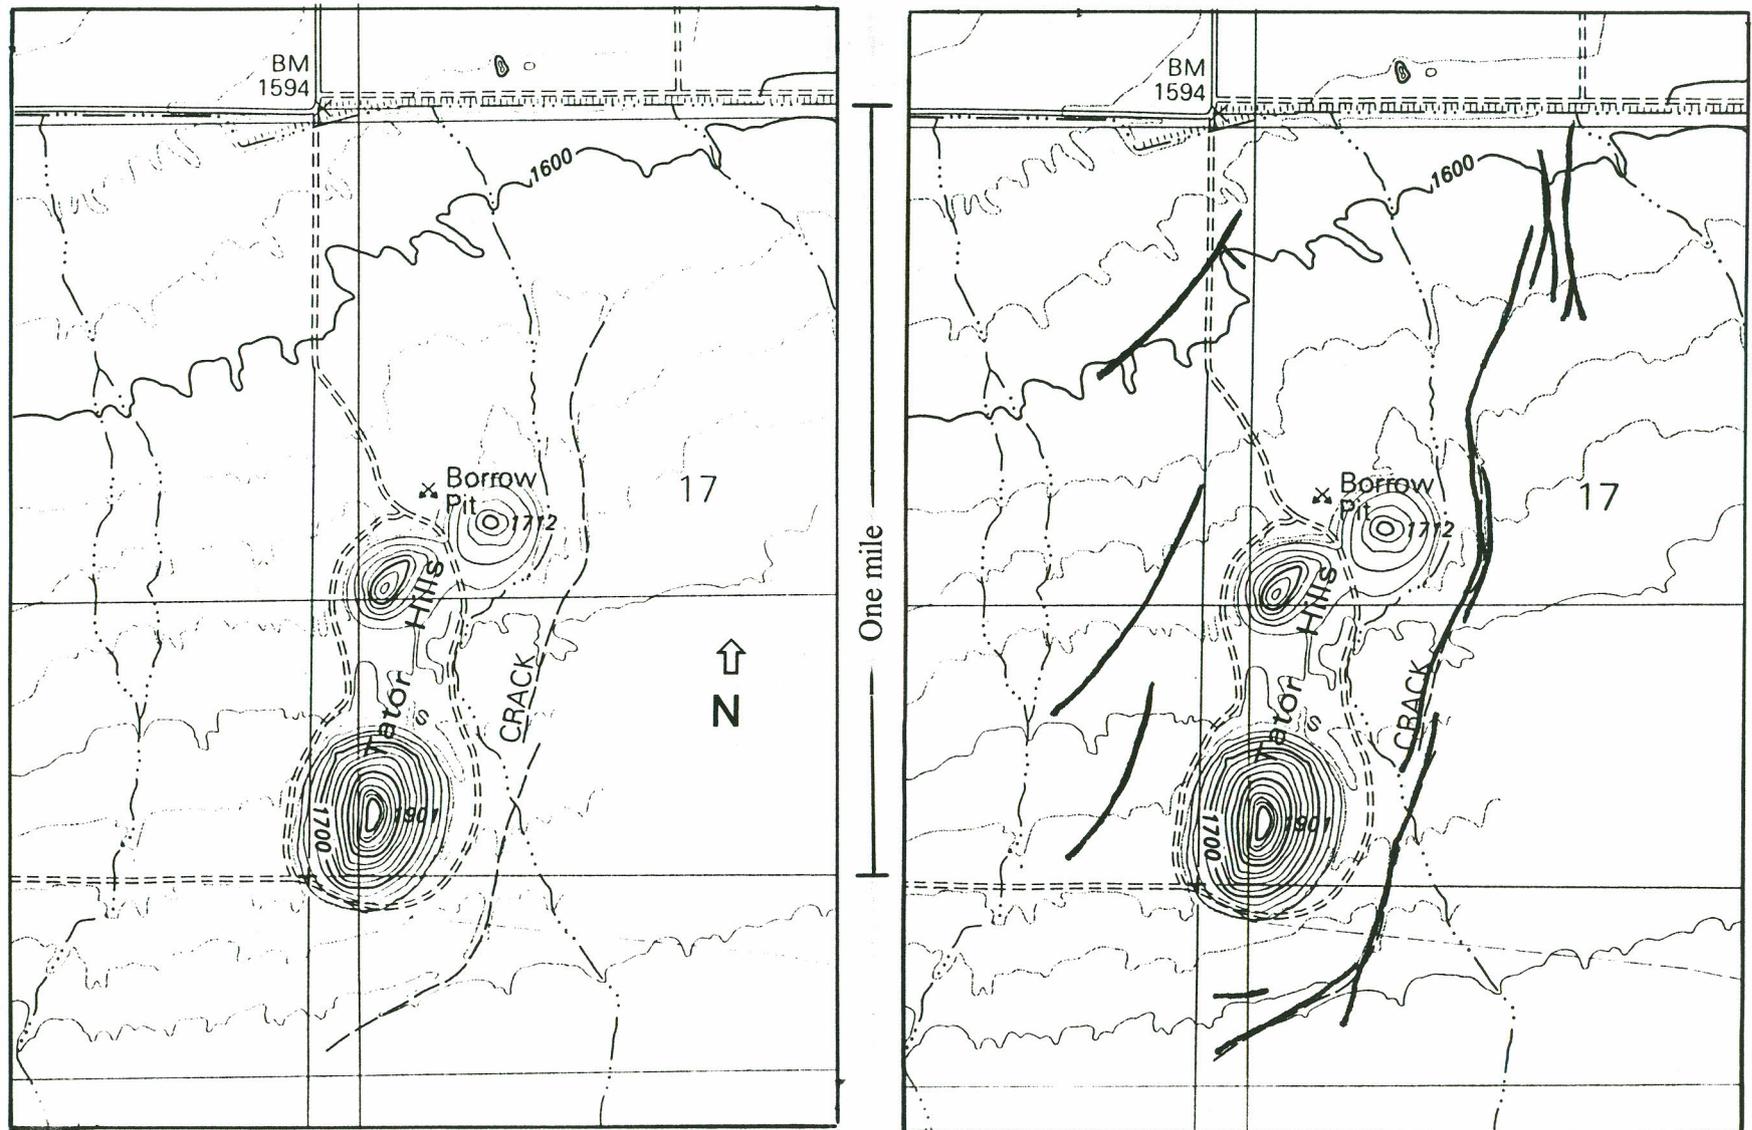
Figure 5. Development of earth fissures from 1977 to 1994. Map on left is from 1981 USGS Greene Reservoir topographic map, compiled from air photos taken in 1976 and field checked in 1977. Map on right shows fissures found in survey in 1994 (Harris, 1994). Fissures present in 1977 have increased in length and new fissures have formed.

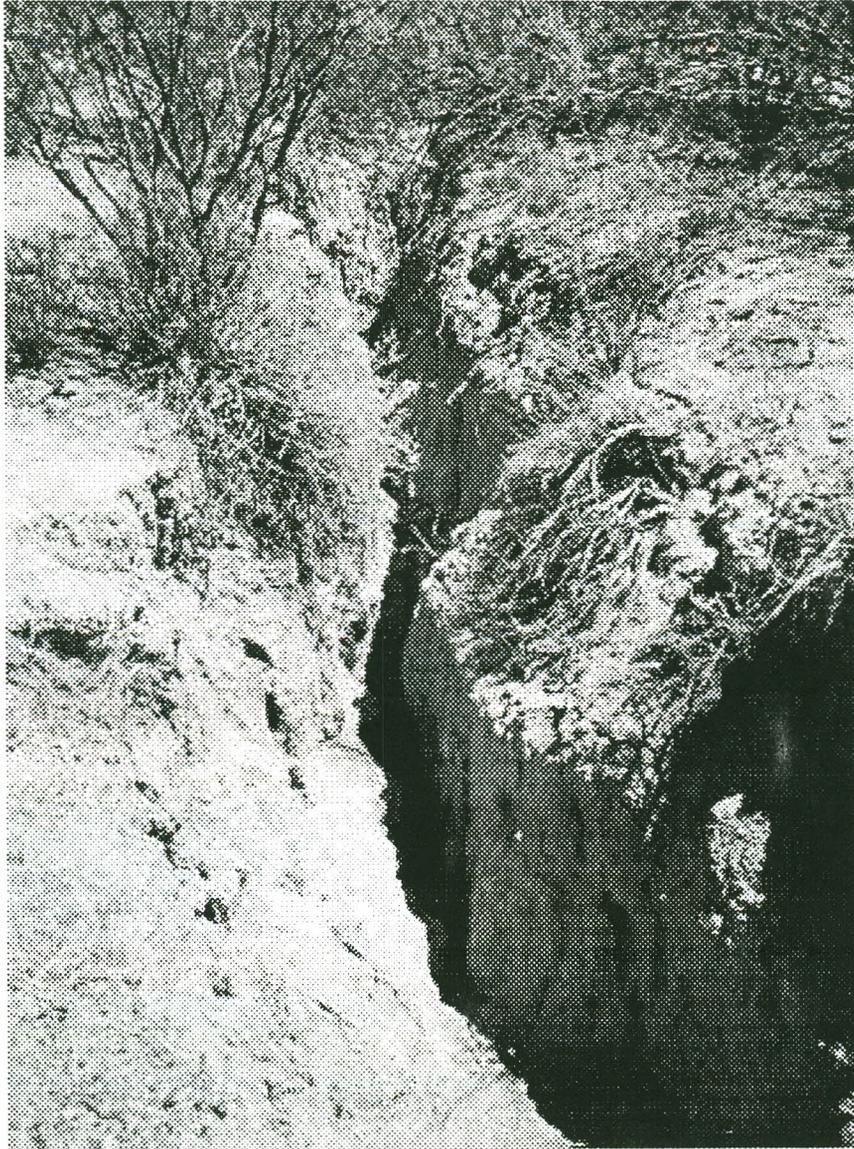
Although the older fissures formed prior to 1977, they are still active, as indicated by their steep sides and highly variable depth (**Figure 6**). In many places the fissure bottom drops out and is too deep to see. To the east of the main fissure(s) are younger cracks just beginning to open. These younger fissures are more discontinuous along their length and are not as deep. Some are not much more than alignments of small depressions or narrow cracks. Even these incipient cracks are usually marked by a line of vegetation, which is often the first sign of a developing fissure.

Figure 6. Large earth fissure. Crack here is 3-4 feet wide, up to 15 feet deep. (*Photo by R.C. Harris.*)

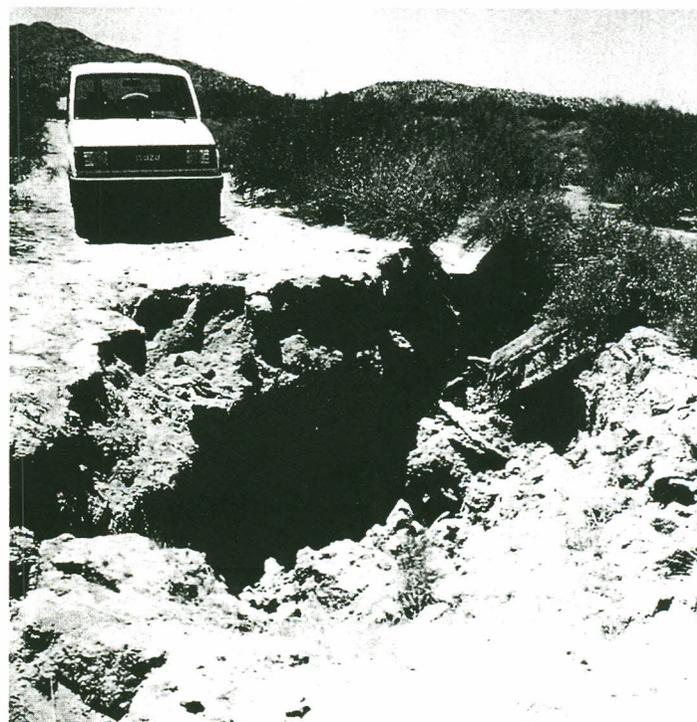
Figure 4. An earth fissure cut this road in Pinal County several miles east of Chandler Heights. Photograph by R. C. Harris.

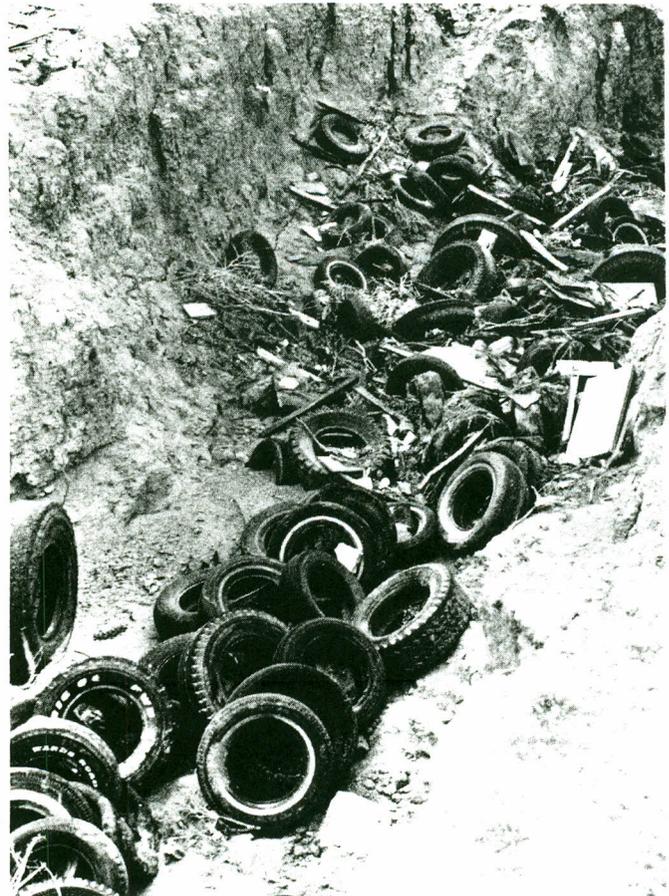
Figure 7. Earth fissures such as this one just east of the intersection of Baseline and Sossaman Road near Chandler Heights in Maricopa County are used commonly as dumps. Photograph by L. D. Fellows.

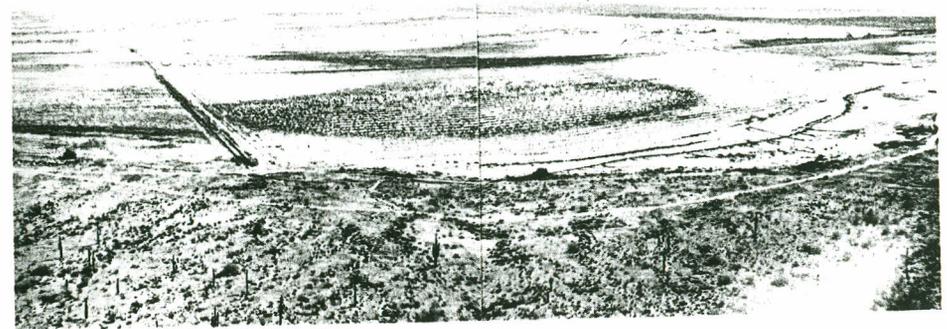
Figure 2. --View looking southeast from the Casa Grande Mountains across large pond in center of Figure 1, showing ponded rainwater in center of furrowed field and earth cracks bordering the pond.

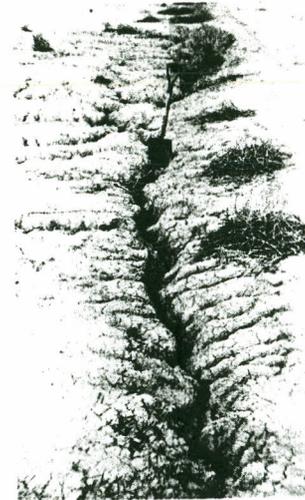
Figure 3. --Typical earth crack, showing some modification by erosion but little slumping of sides.

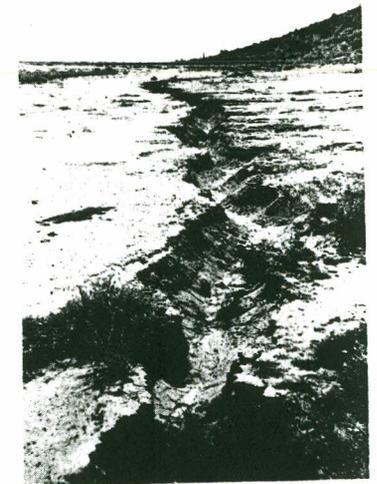
Figure 4. --Earth crack which has become wider and shallower by slumping of the sides.

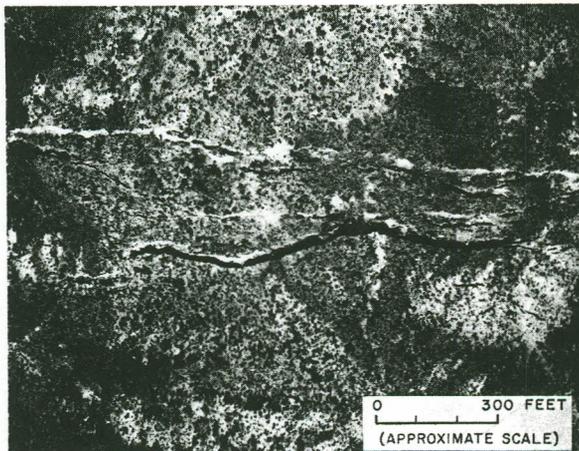
Figure 2.—Aerial photograph from altitude of 4,000 feet showing principal fissures near Black Canyon. Photographed on March 26, 1962, by H. T. Chapman.
