Specatular road washout on Ruby Road at MP 7 east of the Border Patrol Forward Operating Base (FOB). This washout was first reported on the BIRDWG05 birding list Sunday afternoon around 4PM.

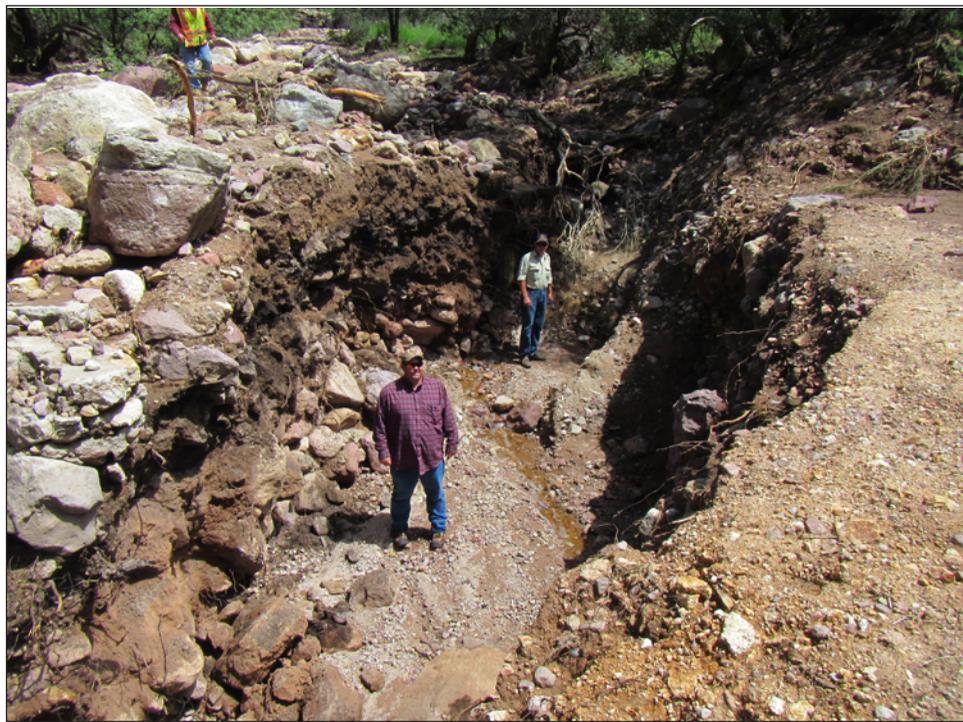
It is not clear if the washout occurred on Saturday or Sunday. Both days received significant rainfall (see graph below).

The washout is below Atacosa Peak which burned in the Murphy Complex wildfires during the summer of 2011 (see maps, upper right).

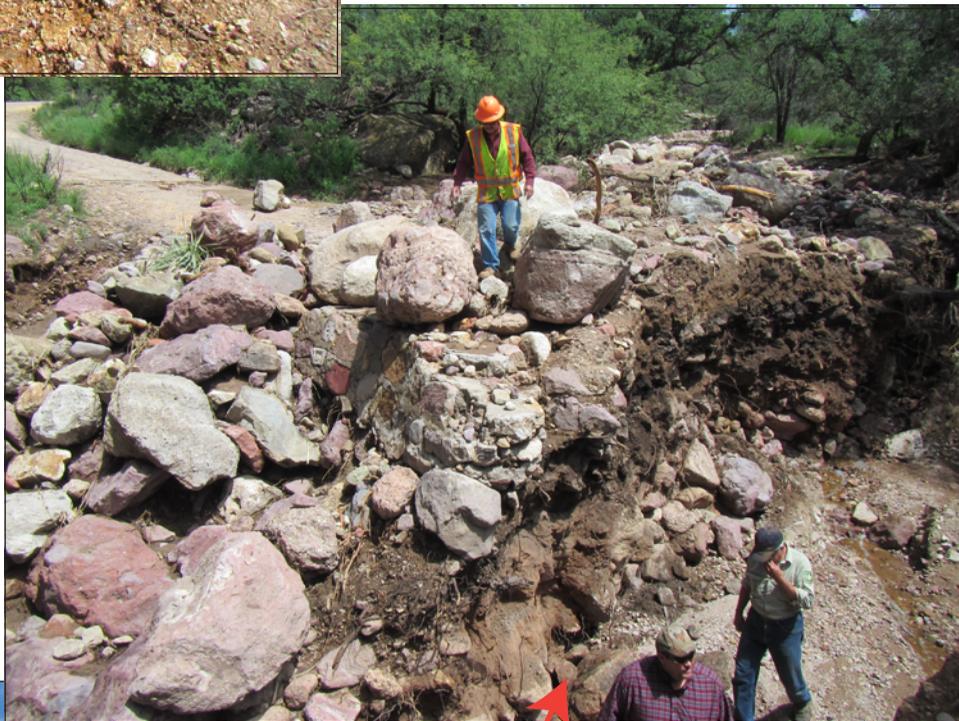
Note older bouldery deposits at the bottom of the scoured bank.

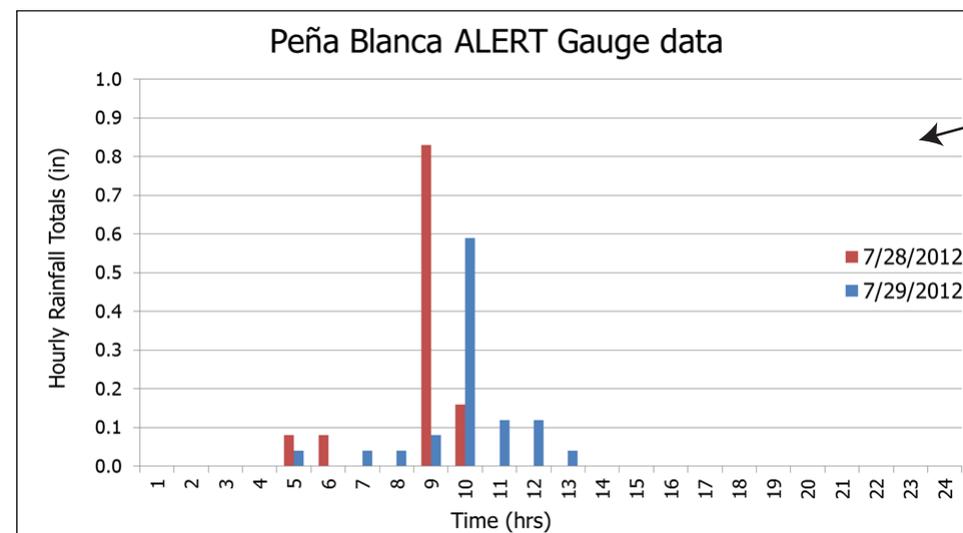
Hourly rainfall data provided by the National Weather Service from an ALERT gauge at Pena Blanca Lake. On Saturday the gage recieved a maximum of 0.83" in an hour and a total of 1.15". On Sunday the gage recieved a maximum of 0.59" in an hour and a total of 1.07".
