Site Investigation of Tributary Drainages to the San Pedro River, Arizona

OPEN-FILE REPORT OFR-15-02

Site Investigation of Tributary Drainages to the San Pedro River

Introduction

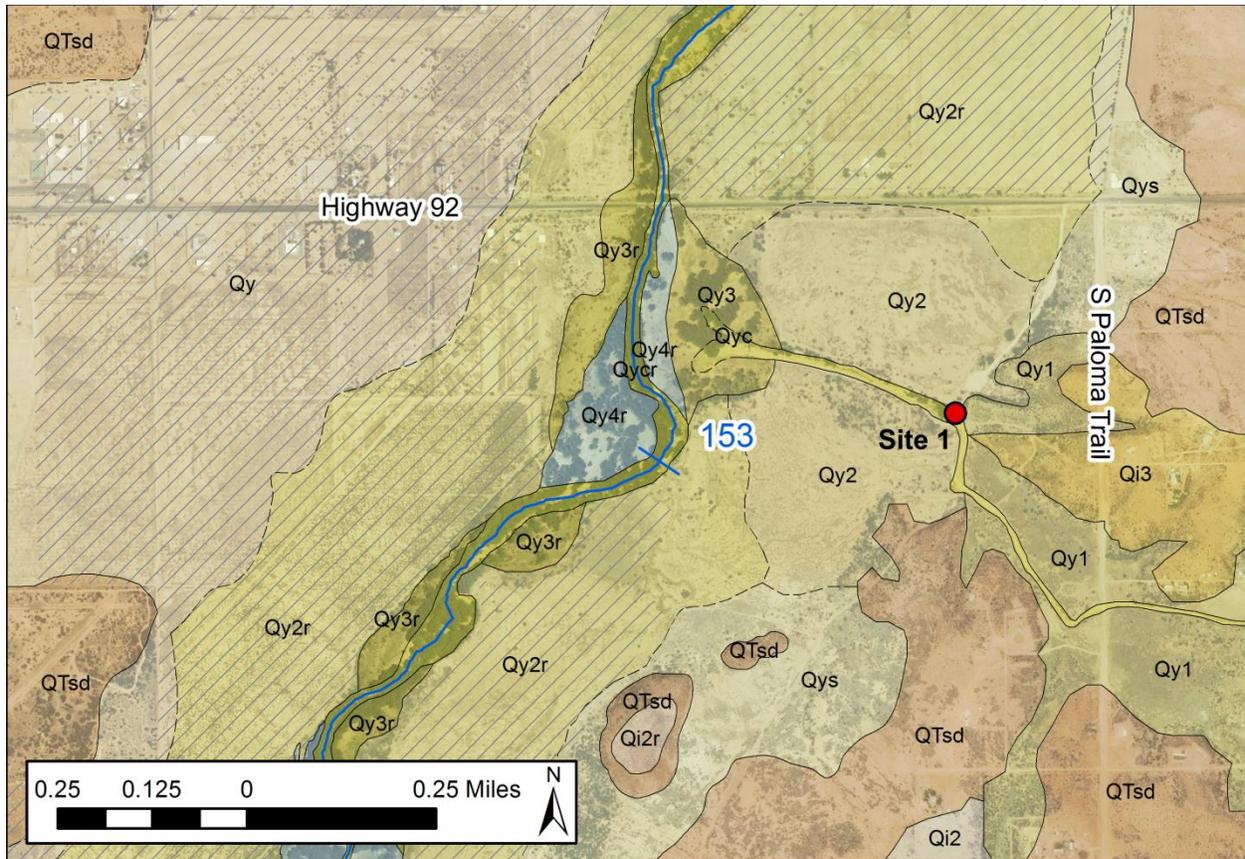
Site 1

Palominas Arroyo exits confinement from rolling basin fill (QTsd) hills to the east, flowing west toward the San Pedro River at river mile 153 south (upstream) of Highway 92. A thin, broad, nearly semicircular fan (Qy2) was deposited prior to historical incision of Palominas Arroyo driven by the downcutting of the San Pedro River. Arroyo walls exceed 15-20 ft tall in places. Recent archaeological studies in Palominas Arroyo (Ballenger, 2010) suggest all sediment exposed in arroyo walls was deposited in the Holocene. San Pedro River gravels and channel sediments are exposed at site 1 where Palominas Arroyo bends to the west.

Because this location corresponds with the topographic surface expression of nearby basin fill deposits which predate the Holocene San Pedro River it is likely this exposure offers the best known example of otherwise buried Holocene San Pedro channel deposits adjacent to basin fill bluffs outside the modern channel.

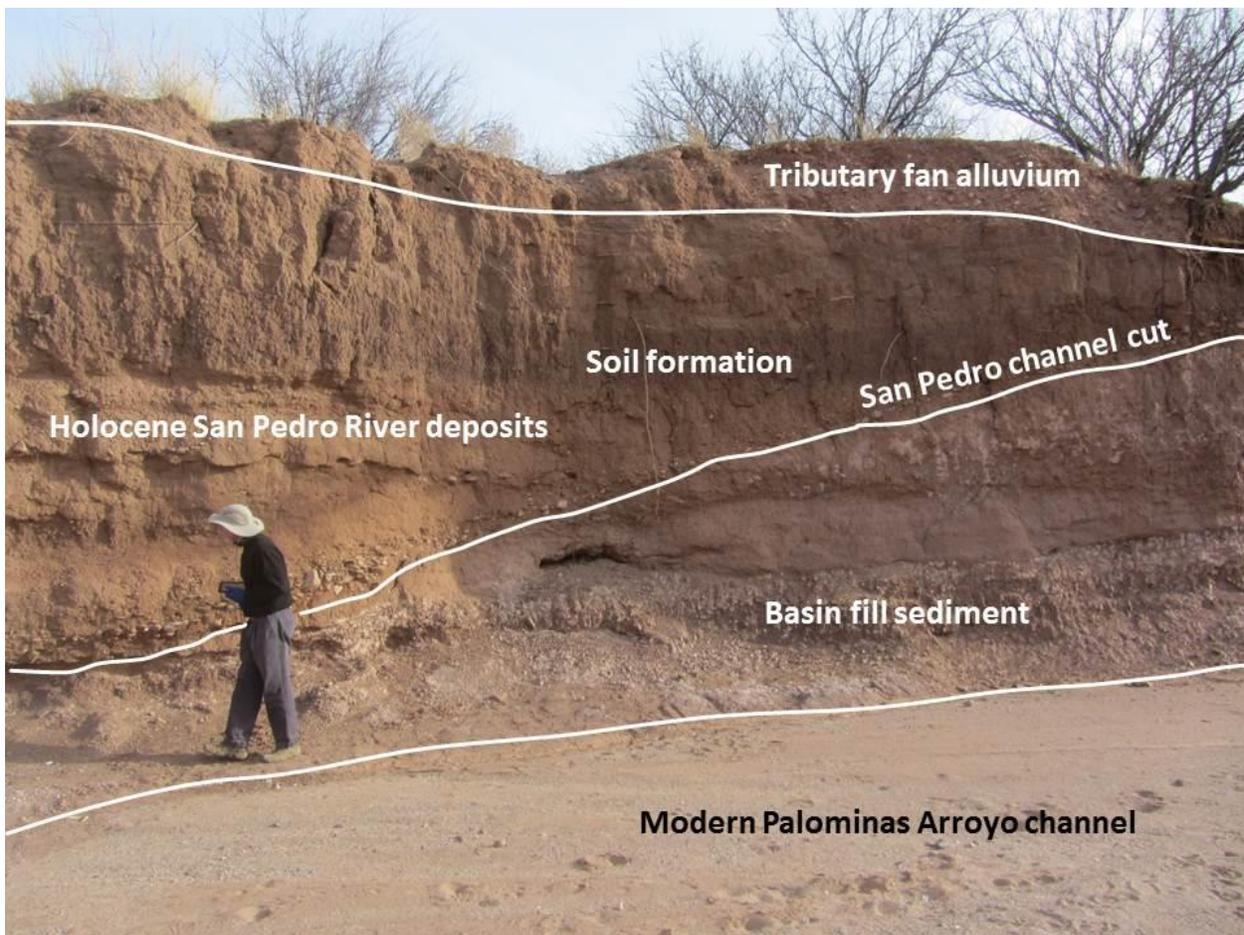
Photo SPR153E_A

Exposure within Palominas Arroyo

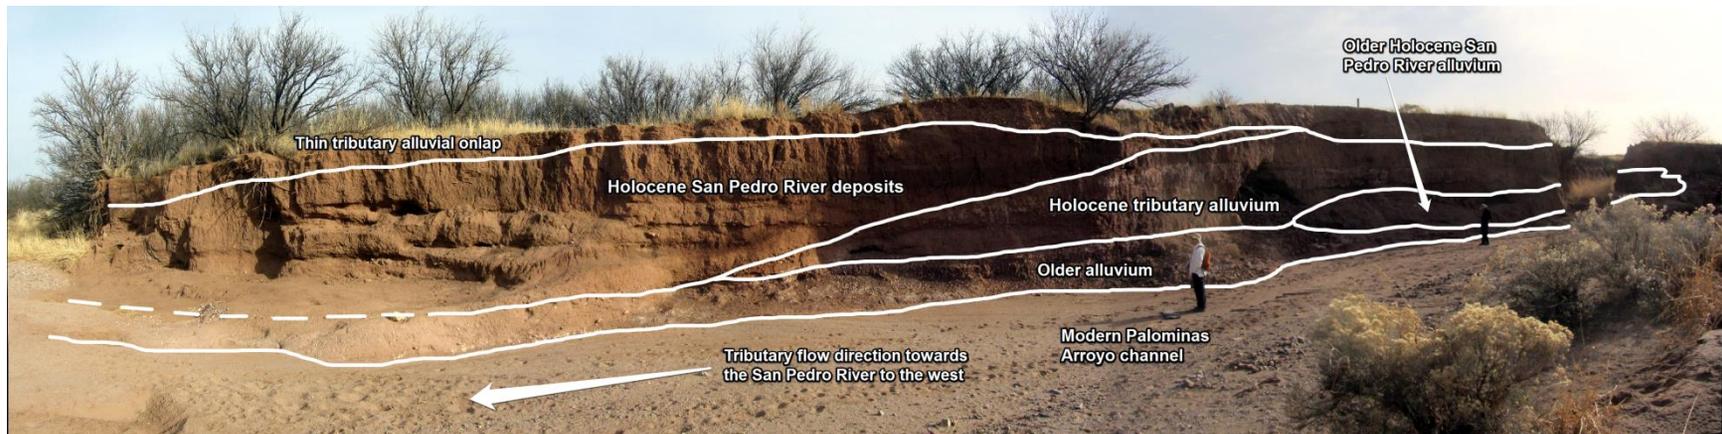
Photo SPR153E_B

A coarse, poorly sorted sand and angular to sub-angular gravel layer is present at the top of the Palominas Arroyo exposure. This base of this layer is in sharp erosional contact with underlying well-sorted, consolidated, fine to medium sand. Alternating layers of unconsolidated coarse sand with interbedded pebbles and gravel, fine reddened consolidated silts with thin clay films on blocky soil structure faces, and thin sub-rounded cobble beds are deposited above a broad erosional contact lined with rounded cobbles. The cobble-lined erosional unconformity cuts fine sandy to silty beds with abundant, well-cemented carbonate nodules up to several inches in diameter, moderately well-sorted, consolidated to poorly consolidated sandy deposits, and a second fine-grained, well-consolidated calcium carbonate nodule-rich deposit exposed at the base of the arroyo wall. The panoramic photo includes a broader view of cross cutting, erosional, and depositional sedimentary relationships exposed in the northern wall of Palominas Arroyo. Extensive beds of poorly to moderately sorted sand and gravel deposits overlie thick lenses of well-rounded and lithologically diverse pebbles and small cobbles.

Two distinct beds of carbonate nodule-rich sandy to silty alluvium are exposed in arroyo walls as far upstream as an abrupt incised tributary arroyo channel cut.

The prominent sloping, cobble-lined, erosional unconformity exposed in the arroyo wall is interpreted as the base of a large paleochannel of the San Pedro River. Deposits immediately above this contact are interpreted as San Pedro River deposits. The finer grained portion of the San Pedro deposit is characterized by well-sorted, medium to dark brown fine grained sandy beds, buried soils, and laminated fine sandy interbeds. Following deposition of river alluvium by the San Pedro, a thin cover of tributary fan alluvium was deposited on top. This deposit consists of lighter brown, poorly sorted sand and gravel including angular to sub-angular clasts. This thin fan cover extends far to the west, nearly to the modern San Pedro River channel. Well-cemented layers exhibiting multiple horizons of calcium carbonate nodule formation are cut by the San Pedro channel. These indurated layers may be a topographic high of underlying basin fill deposits or an older, possibly Pleistocene, tributary or river deposit. Isolated lenses of well-rounded pebbles and cobbles within more poorly sorted, angular clast-bearing alluvium below the upper carbonate-rich layer indicate interfingering deposition of San Pedro River and tributary alluvium occurred here in the past. Because these pebble and cobble lenses are stratigraphically below the upper carbonate nodule-rich layer which is cut by a large San Pedro paleochannel they must be older than the prominent paleochannel. San Pedro Channel deposits pinch out immediately upstream of this location; therefore these deposits appear to represent the maximum lateral extent of Holocene San Pedro River deposits exposed at the surface in Palominas Arroyo. It seems clear the Holocene San Pedro eroded into older deposits as far from the modern channel as the topographic expression of basin fill bluffs lining the east side of the modern San Pedro trough. Today the river is incised into its own Holocene floodplain deposits but earlier in the Holocene the active channel carved a path through basin fill alluvium at this location. Recent archaeological studies (Ballenger, 2010) indicate all exposed sediment in Palominas Arroyo may be Holocene in age.

Holocene San Pedro deposits exposed in Palominas Arroyo are located as much as 2,200 ft outside mapped Holocene river deposits on AZGS surficial maps.

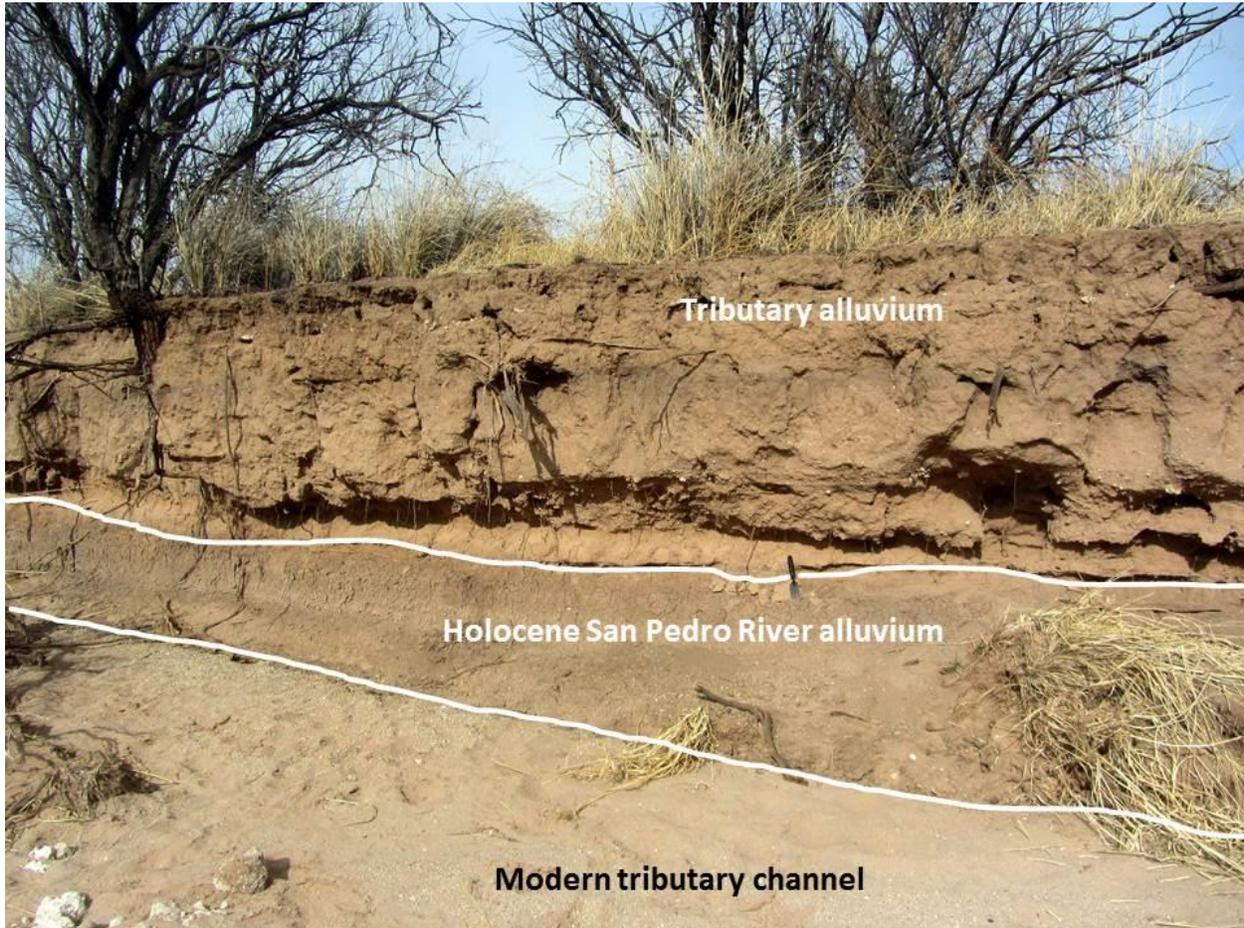
Photo SPR143W

Note trowel located right of center at contact for scale. Light brown, poorly sorted sandy to pebbly Holocene alluvium overlies well-sorted, medium brown, consolidated, fine sandy to silty deposits exhibiting a banded appearance (soil development). Upper alluvium contains abundant calcium carbonate nodules identical to those found in basin fill hills to the west. Some of these nodules are evident in the lower left corner of the photo in the modern tributary channel.

The poorly sorted alluvium containing calcium carbonate nodules is interpreted as tributary alluvium composed mainly of reworked basin fill sediment. This deposit overlies a much better sorted, fine-grained deposit consistent with floodplain deposition by the San Pedro River.

These exposures of fine grained floodplain alluvium are located up to 300 ft outside the mapped boundary of Holocene river alluvium on AZGS surficial maps. These fine-grained San Pedro deposits become buried a short distance upstream and are no longer exposed in the arroyo wall so the maximum lateral extent of these deposits is not visible.

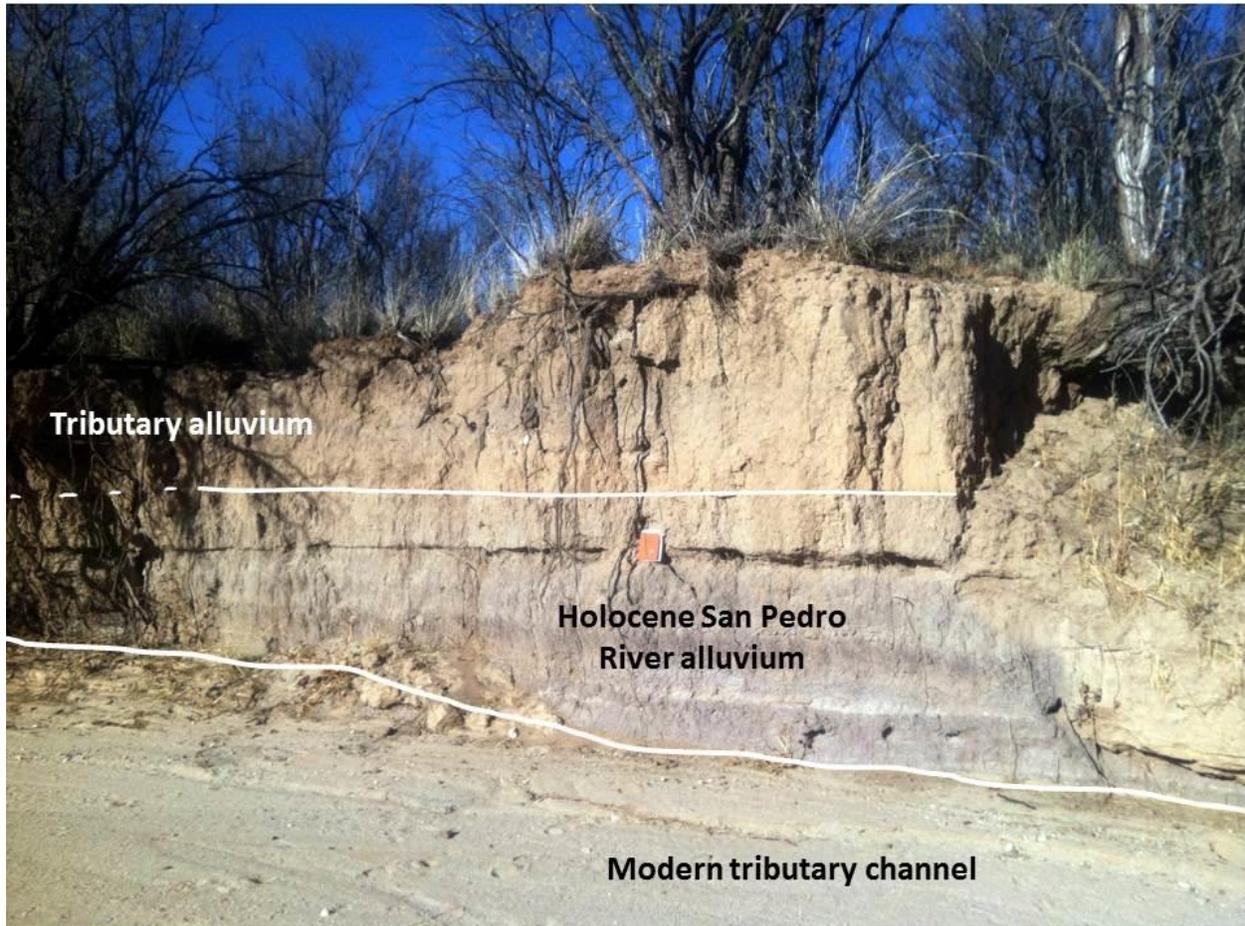
Photo SPR141.5W

Poorly sorted sandy to gravelly, latest Holocene to historical deposits overlie well-sorted, fine sand to silt dominated deposits. The upper poorly sorted alluvium exhibits angular to sub angular clasts and an abundance of calcium carbonate nodules identical to those found in well-eroded basin fill deposits to the west (upstream of this portion of the tributary channel). The underlying alluvium is much finer grained, consisting of silt to fine sand and exhibits soil development.

The poorly sorted alluvium containing angular clasts and abundant calcium carbonate nodules is interpreted to be tributary alluvium dominantly composed of reworked basin fill sediment. These tributary deposits overlie a much better sorted, fine-grained deposit consistent with floodplain deposition by the San Pedro River. The gray soil layers in the floodplain alluvium are apparent in other exposures of San Pedro floodplain and channel deposits to the south (site 6) and may reflect a period of regional landscape stability along the San Pedro River prior to burial by progradation of tributary alluvial fans.

These exposures of fine grained floodplain alluvium are located up to 175 ft outside the mapped boundary of Holocene river alluvium on AZGS surficial maps. These fine-grained San Pedro deposits become buried a short distance upstream and are no longer exposed in the arroyo wall so the maximum lateral extent of these deposits is not visible.

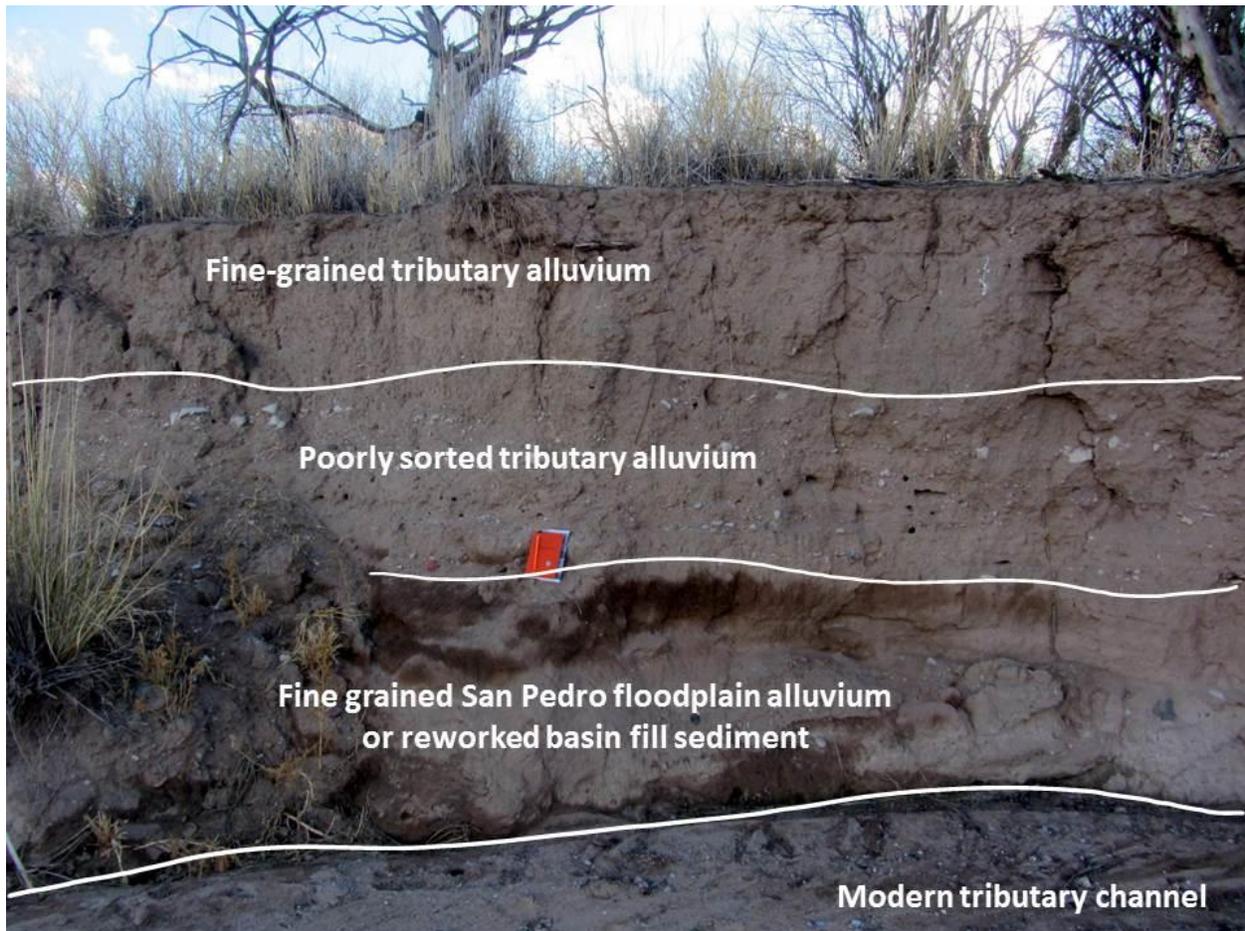
Photo SPR121.5E

Incision along lower Walnut Gulch has exposed alternating beds of poorly sorted, angular to sub angular clast-bearing alluvium and finer-grained, well-sorted, sandy to silty alluvium. Erosion of tributary channel walls at outside channel bends and recent bank collapse has provided excellent exposures of alluvial deposits at this location.

The poorly sorted beds strongly resemble modern tributary channel bedload in Walnut Gulch. For this reason these deposits are interpreted to be derived from deposition by Walnut Gulch. The well-sorted, finer-grained beds resemble deposits commonly

associated with Holocene San Pedro River floodplain deposition. It is also possible that the fine grained beds may be attributed to reworking of fine grained basin fill alluvium by Walnut Gulch.

Because either mode of deposition could result in fine-grained deposition at this location, the origin of the fine grained layers cannot be conclusively determined based on field examination of these exposures.

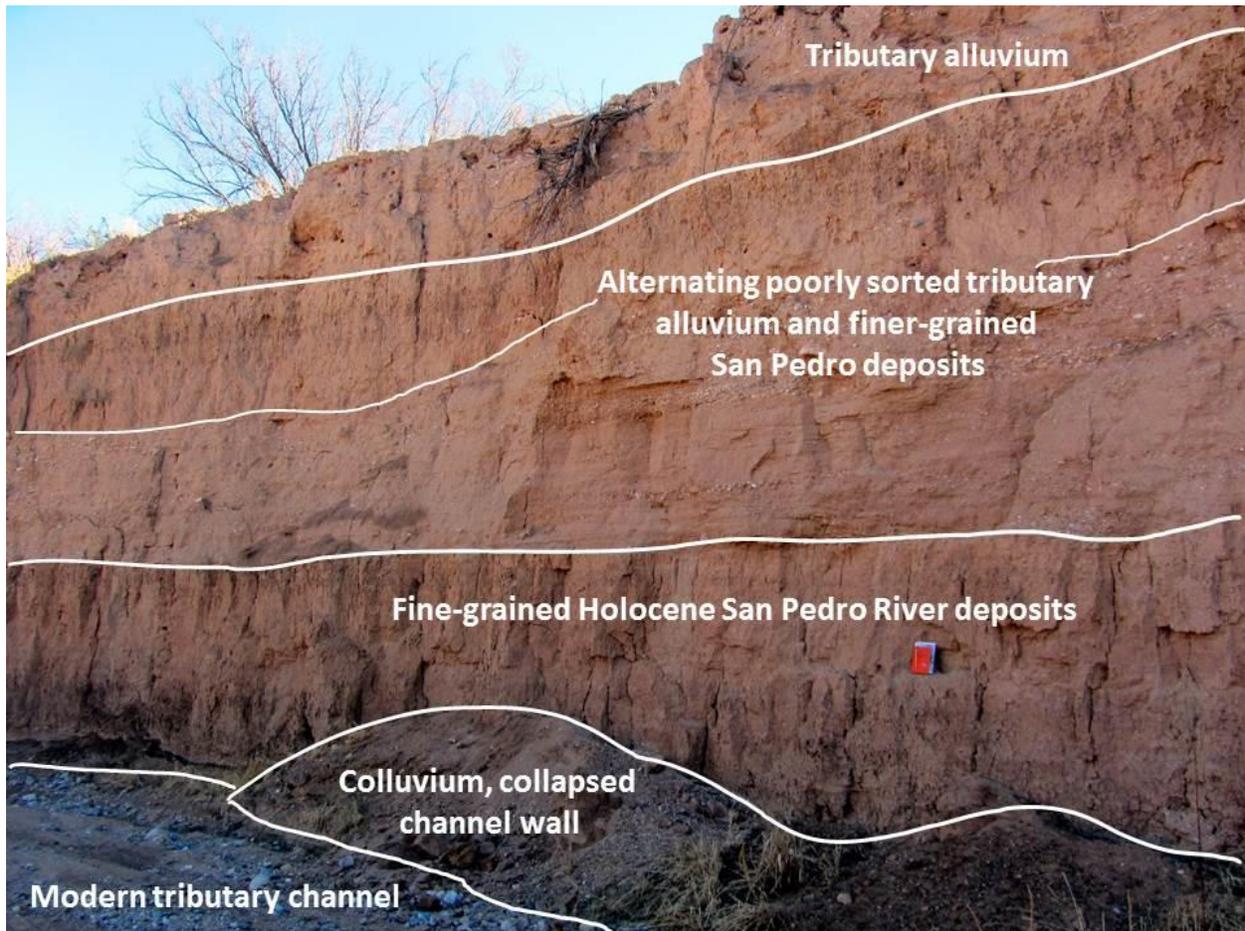
Photo SPR112W

Vertical channel walls of California Wash expose alternating beds of poorly sorted sandy to gravelly laminar and cross bedded sediment and well-sorted fine grained alluvium. The exposed sequence is aggradational but the base of some deposits exhibit erosion into underlying deposits. Mild to moderate buried soils are present in the finer grained deposits indicating a period of landscape stability. Elsewhere in California Wash possible archaeological material (a buried hearth) includes charcoal that could be used for age constraint of the deposit.

The poorly sorted beds containing angular to sub angular clasts are interpreted to be tributary alluvial deposits while the well-sorted, fine-grained alluvium strongly resembles floodplain deposits exposed in the channel walls of the San Pedro to the east. The uppermost layer at the top of the sequence exhibits little to no soil development and appears to have been deposited recently, probably in historical times prior to widespread incision along the San Pedro River. Deposits exposed along California Wash record alternating deposition of Holocene tributary and San Pedro River alluvium prior to deposition of young prograding tributary fan alluvium at the surface (uppermost unit).

These exposures of Holocene San Pedro River alluvium are located up to 275 ft outside mapped deposits of Holocene river alluvium on AZGS surficial geologic maps.

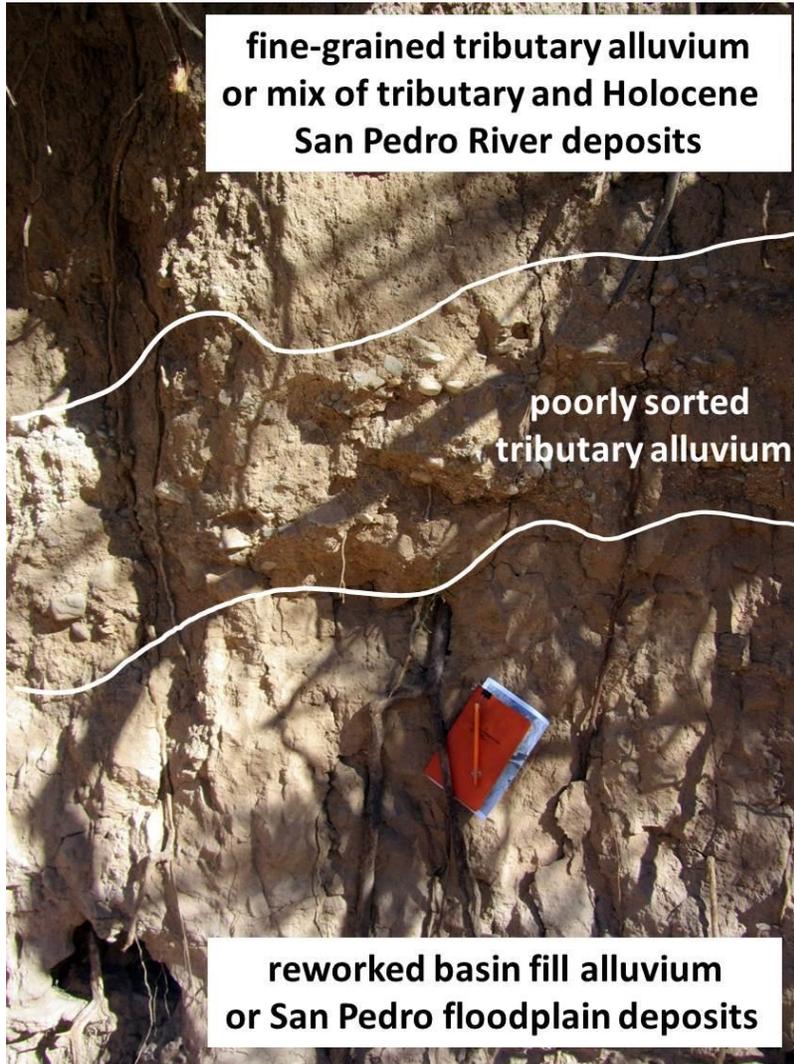
Photo SPR112E

A moderately well-sorted, fine to medium-grained, sandy to pebbly deposit overlies coarse sandy, poorly sorted deposits with abundant angular pebble and small cobble clasts. These deposits overlie a fine-grained, massive deposit of medium to fine sand exposed at the base of the channel wall. An undulating erosional contact is evident between each layer in the exposure.

The upper moderately well-sorted deposits could be a mix of tributary (poorly sorted) and low energy river floodplain (well-sorted) alluvium or they could be attributed to lower energy deposition in a large distributary fan environment such as Clifford Wash. The middle deposits are interpreted as clearly deposited by a tributary drainage based on the presence of many angular and sub angular clasts and a close resemblance to the modern bedload of Clifford Wash. The lower, well-sorted, fine-grained alluvium resembles deposits commonly associated with Holocene San Pedro River floodplain deposition. It is also possible that the fine grained beds may be attributed to reworking of fine grained basin fill alluvium by Clifford Wash. Well-eroded basin fill hills are located upstream along Clifford Wash to the east.

Because either mode of deposition could result in fine-grained deposition at this location, the origin of the fine grained layers cannot be conclusively determined based on field examination of these exposures.

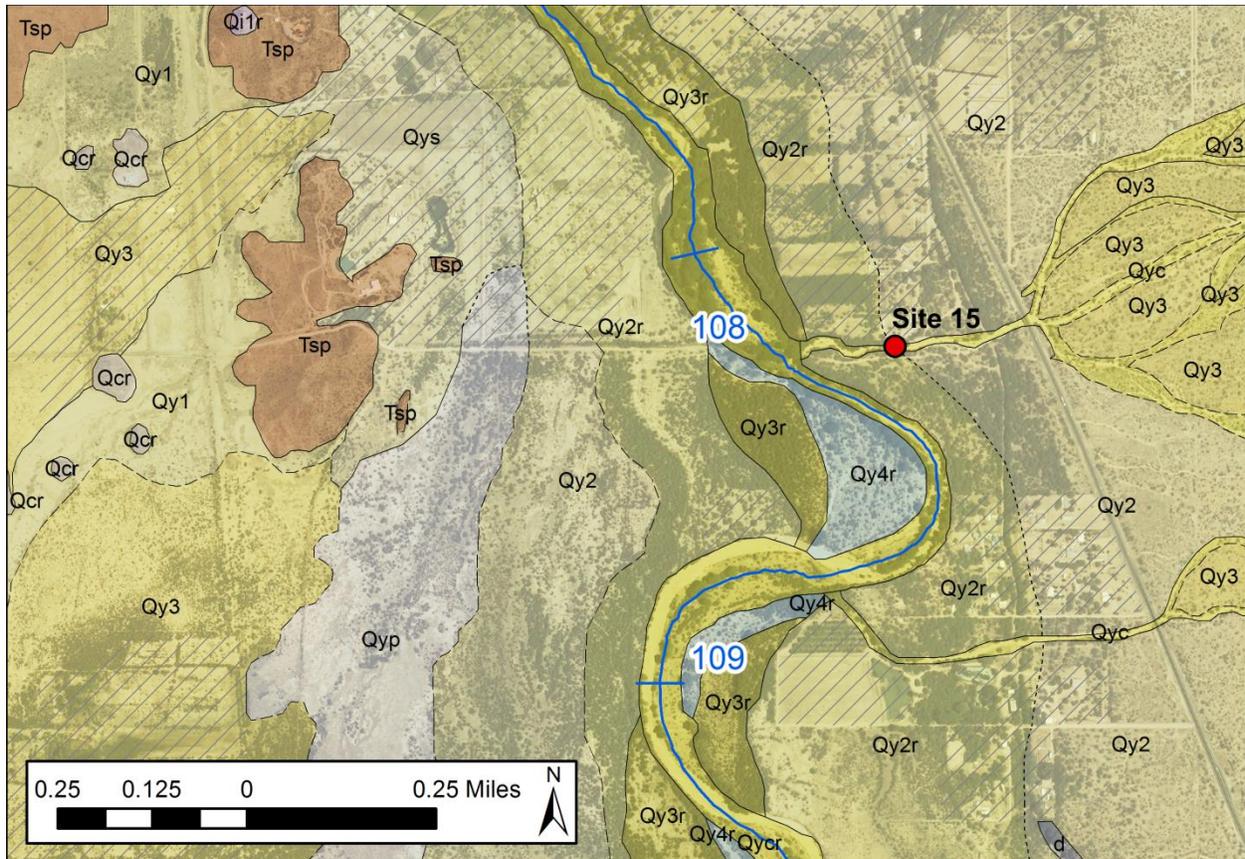
Site 15

A narrow arroyo joins the San Pedro from the east near river mile 108 south of St David, AZ. The arroyo incises through broad, low-relief tributary alluvial (Qy2) fans and Holocene (Qy2r) San Pedro deposits. Historically, agricultural fields straddled the boundary between tributary and river alluvium, obscuring the contact at the surface. Some of these fields are still cultivated today. Exposures of sedimentary relationships are present in the northern wall of the arroyo at site 15 in the figure above.

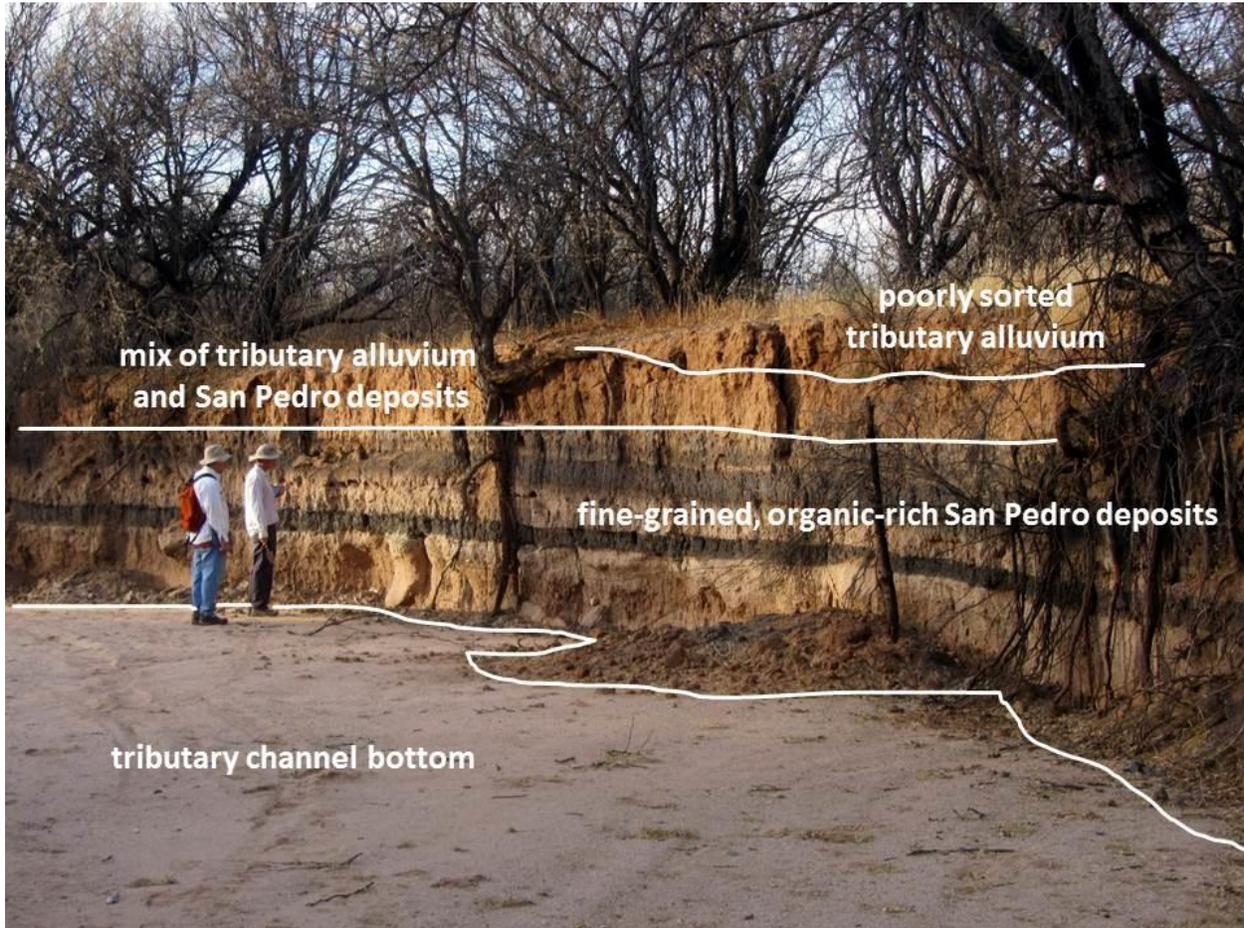
Photo SPR108E

Exposures along the north channel wall at site 15 consist of fine-grained, moderately well-sorted alluvium with dark gray to black, organic-rich interbeds overlain by predominantly fine sandy alluvium with coarse sandy to pebbly interbeds. These deposits, in turn, are overlain by a thinning deposit of poorly sorted sandy to pebbly alluvium with angular to sub angular clasts. A wavy erosional contact into underlying sands is present at the base of the poorly sorted uppermost layer. A near vertical channel wall with fresh bank collapse provides excellent exposures of these alluvial units.

The dark, organic-rich, banded fine-grained deposits are interpreted as low energy cienega-like San Pedro River alluvium. Springs were known to sustain wetlands in this area in the past. These dark layers could represent slow aggradation of organic-rich, swampy sediment prior to historical incision along this portion of the San Pedro River. Some of the dark banded layers appear to include angular sand and pebbles which may indicate mixing of tributary and San Pedro alluvium at the time of deposition. This location is very near the incised modern San Pedro channel yet the banded appearance is stratigraphically above the exposed channel walls so deposition of the organic-rich beds occurred prior to historical downcutting along the San Pedro. These deposits are overlain by more recent medium brown river alluvium and a mix of tributary deposits which becomes more apparent upstream along the incised tributary. The uppermost deposit that pinches out as it nears the San Pedro is interpreted as a thinning tributary fan deposit emplaced prior to historical incision of the San Pedro and headcutting of the tributary arroyo. This exposure is located at the mapped tributary fan/Holocene San Pedro alluvial boundary on the surface.

Exposures of San Pedro deposits extend upstream in the arroyo for approximately 20-30 ft where they become buried. Upstream of this point the exposed deposits consist entirely of tributary alluvium.

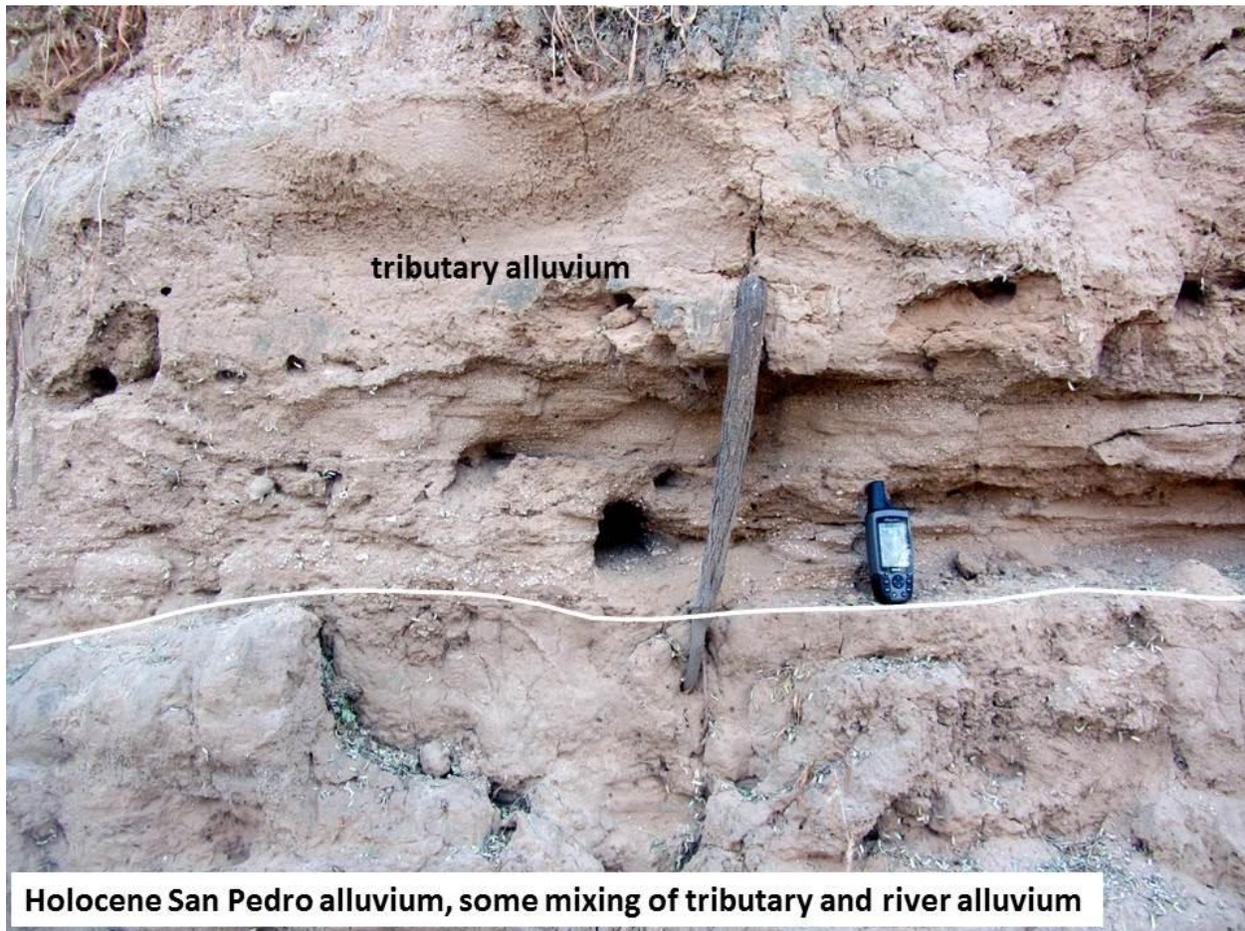
Photo SPR107E

Poorly sorted sandy to pebbly alluvium is interbedded with well-sorted, fine-grained alluvium. Deposits are noticeably less well sorted above the marked contact in the image above (GPS for scale). This exposure is very close to the mapped surficial boundary of tributary alluvial fans on AZGS surficial geologic maps although an interfingering relationship between tributary and river alluvium appears to exist in the subsurface.

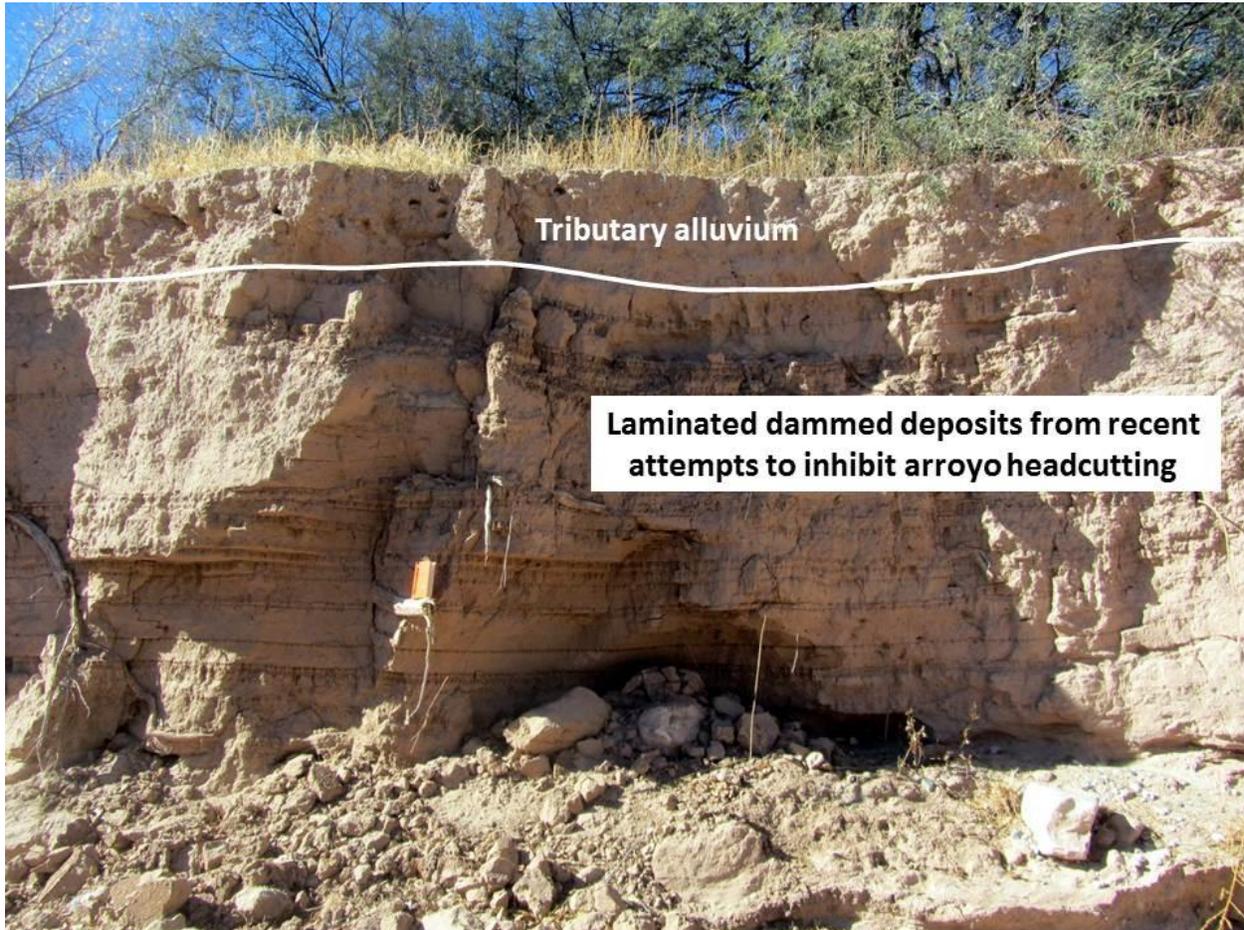
Photo SPR105E_A

The northern arroyo wall just west of Miller Lane exposes thick deposits (field notebook for scale) of well-sorted, laminar, fine to medium sandy alluvium beneath poorly sorted sandy to gravelly deposits at the top of the arroyo wall. Thick piles of large chunks of rebar-reinforced concrete lie immediately upstream in an attempt to inhibit further erosion and property loss along the headcutting arroyo. Further headcutting of the arroyo would cut access to nearby homes and erode property very near existing homes. Conversations with residents indicate extensive effort aimed at halting further incision along this arroyo has been attempted since the 1980s including a concrete and earthen dam downstream of this exposure which has since been eroded away by the arroyo.

The laminated beds apparent in this exposure are interpreted as a result of deposition of fine sands into standing water ponded upstream of a dam formerly spanning the arroyo downstream of this exposure. Poorly sorted sands and gravels overlying the laminar deposits are interpreted as prograding tributary alluvium atop the sand and sediment that gradually filled the area behind the dam. Once channel flow overtopped the dam it failed and was subsequently eroded away again allowing headcutting along the arroyo.

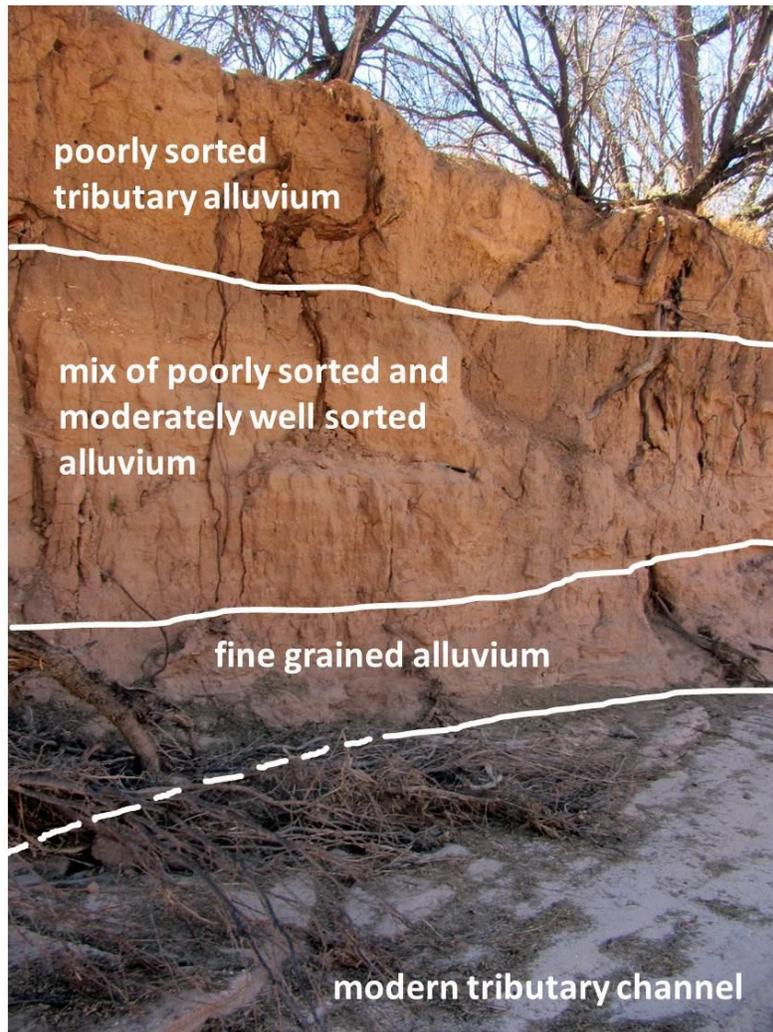
Predominantly fine grained, well-sorted alluvium is exposed at the base of the southern arroyo wall downstream from the historically disturbed portion of the arroyo. These deposits are overlain by interbedded well-sorted, fine sandy and poorly sorted sandy to angular pebbly alluvium. Atop these sediments lies very poorly sorted, medium brown, sandy to gravelly alluvium. The finer interbeds in this exposure exhibit some consolidation and blocky soil structure. Every layer tested reacts strongly to acid indicating calcium carbonate development is present throughout the exposure.

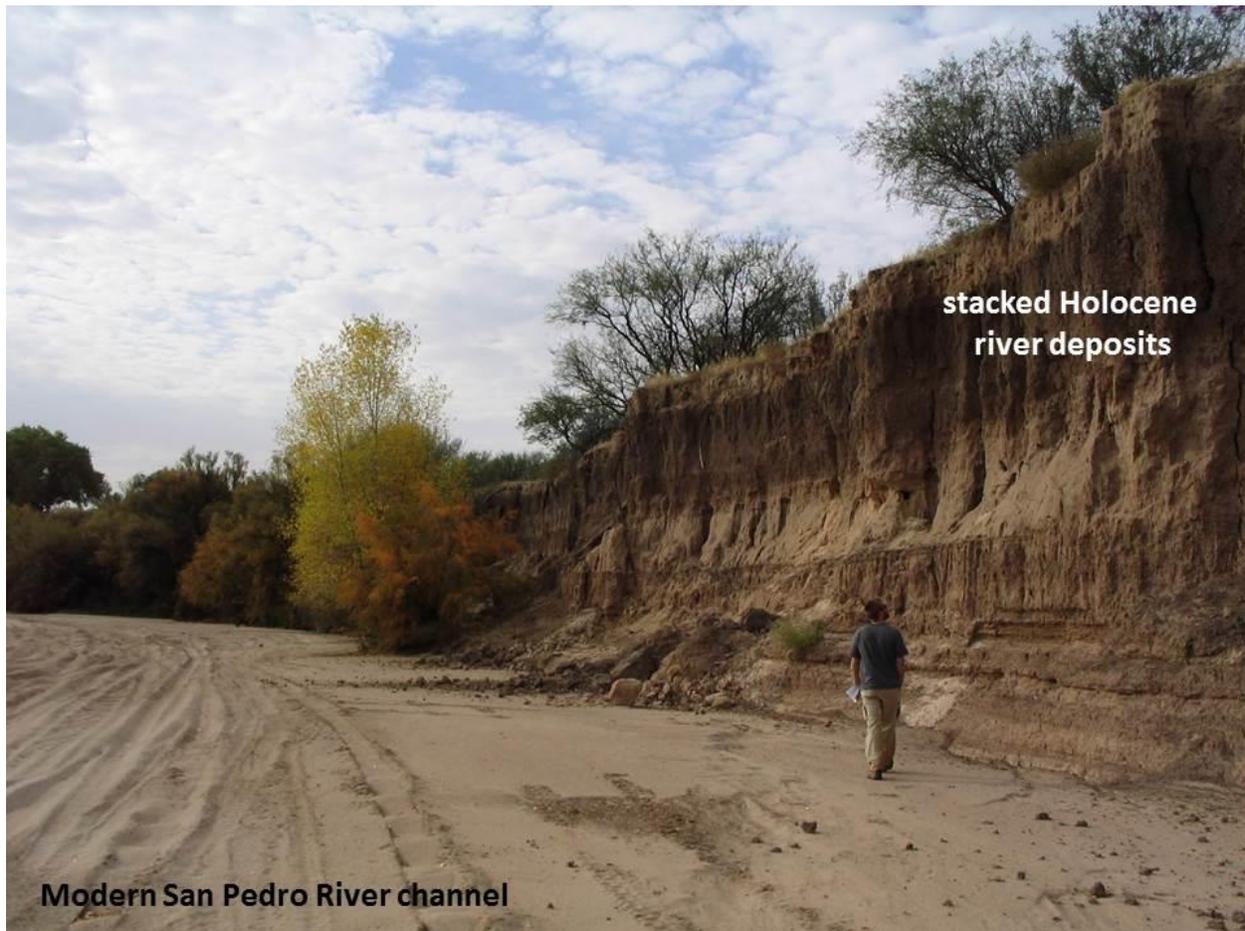
Alternating beds of fine grained, well-sorted San Pedro floodplain and channel deposits are visible in the west wall of the San Pedro near Benson, AZ. The youngest deposit (excluding the modern incised channel bottom) is the medium brown sandy to pebbly layer located at the top of the exposure. Below the uppermost layer lies a darker brown fine sandy layer exhibiting mild to moderate soil development. Alternating channel sands without soil development and other fine grained San Pedro alluvium compose the lower levels of this exposure. 15-20 ft of Holocene river alluvium is exposed at this location. All of these units appear to be Holocene in age and may be used to compare similar fine

Few erosional contacts are noted between alluvial layers exposed in the San Pedro channel wall at this location. Some coarse sandy to pebbly channel deposits appear to have been erosionally emplaced atop underlying fine grained river floodplain deposits but the erosion is minimal and the exposed stratigraphic sequence was deposited in an aggradational meandering river system. Alternating beds of fine sandy to silty and sandy to pebbly alluvium are interpreted to represent river floodplain and channel deposits, respectively. Layers exhibiting soil development are indicative of periods of depositional inactivity. Sedimentary layers with soil development must have been exposed at the surface for extended periods of time in order for soil horizons to form. Rapid, continuous aggradation of river sediment would not allow multiple soils to form in the profile. Gradual deposition of these deposits punctuated by periods of stability in the Holocene was followed by rapid incision of the San Pedro and tributary drainages in the late 1800s and early 1900s resulting in the steep channel walls still present along this portion of the San Pedro today.

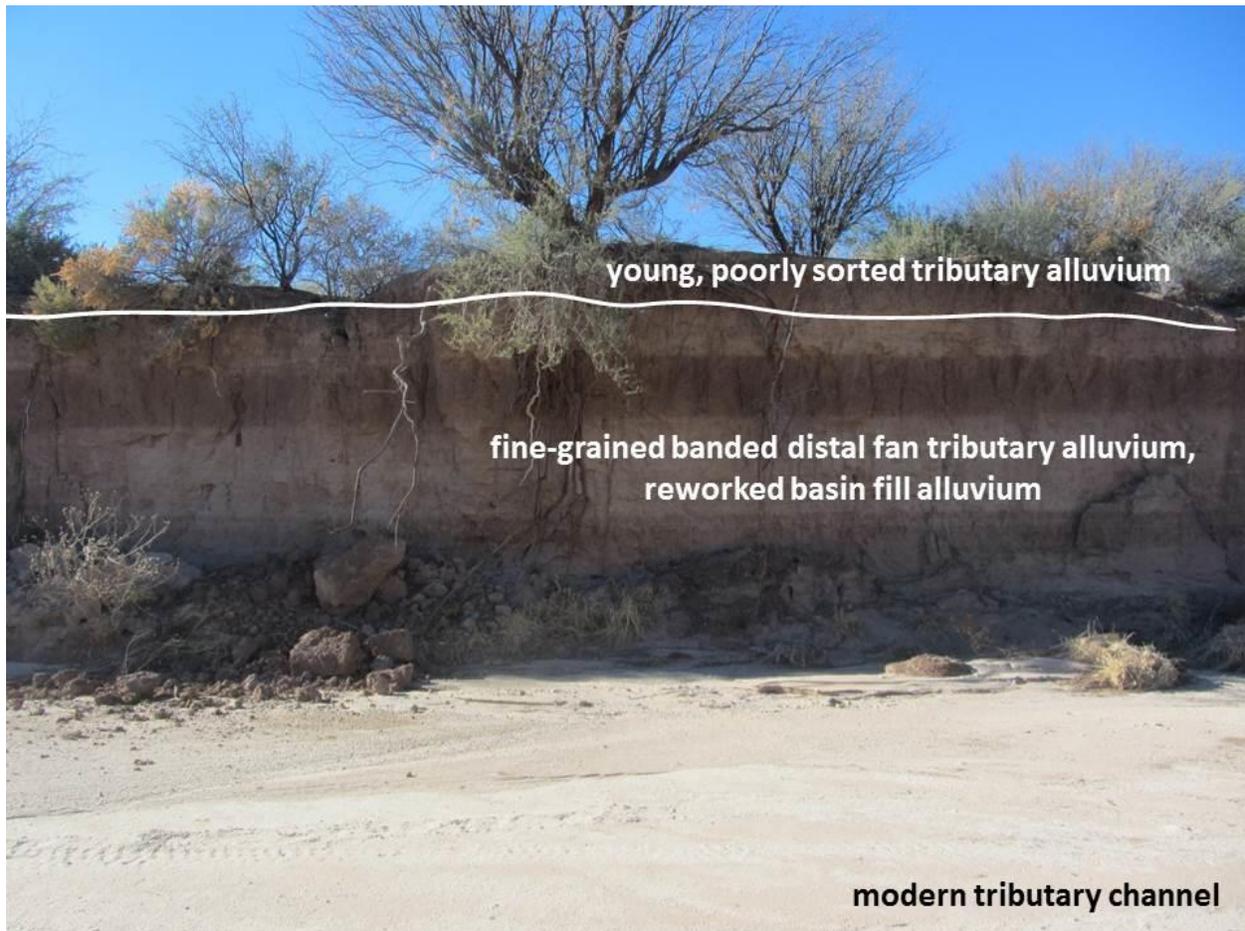
Poorly sorted coarse sandy to gravelly deposits with angular to sub angular clasts are evident at the top of the exposed arroyo wall. These deposits erosionally overlie thicker deposits of finer grained, banded, moderately well-sorted alluvium. Modern tributary channel alluvium is dominantly sandy with pebble to cobble bars throughout the channel. Fresh bank collapse provides good exposures of sedimentary relationships at this location.

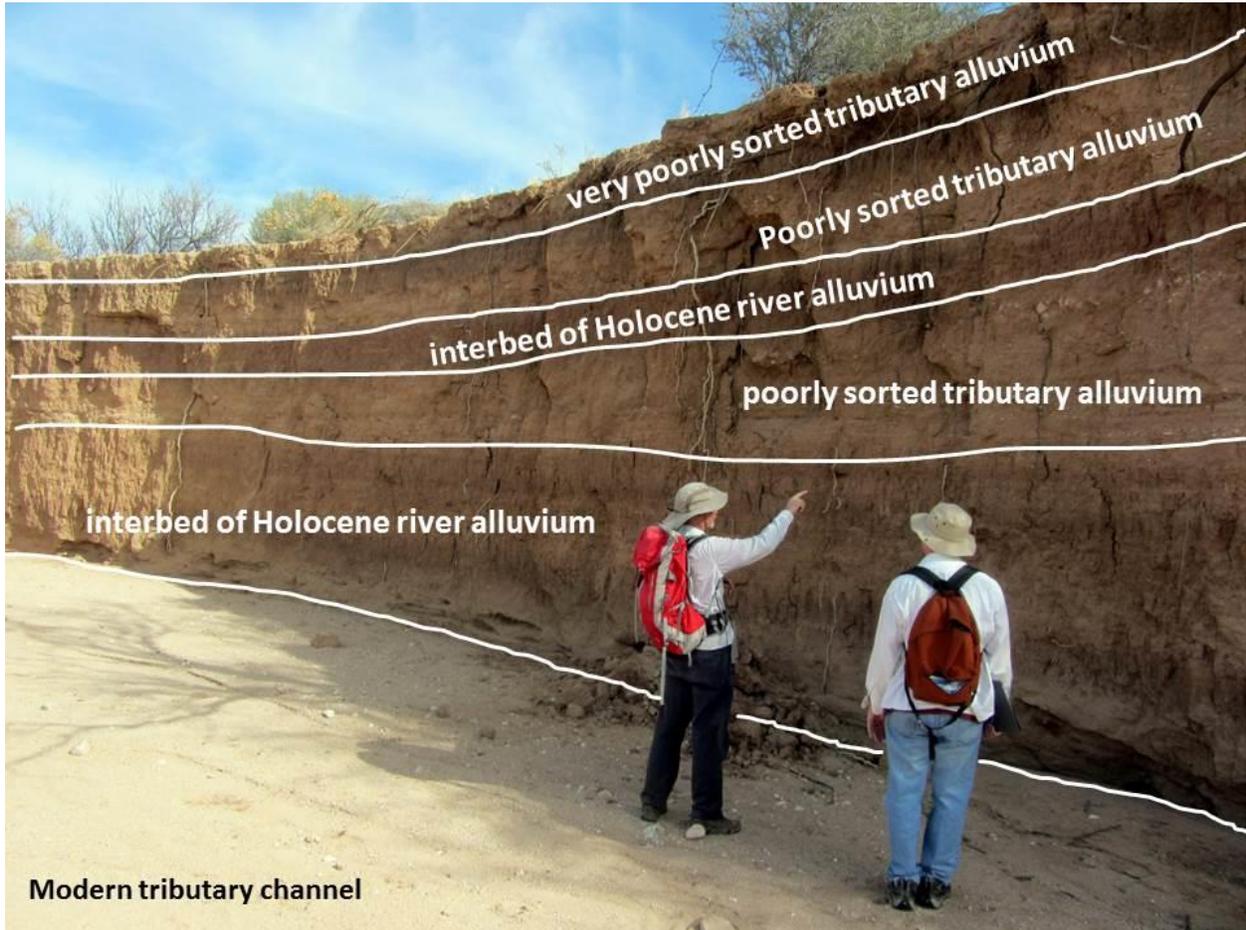
Very poorly sorted light brown sandy to gravelly beds with angular to sub angular clasts interfinger with finer-grained, well-sorted, darker brown interbeds. The coarser beds strongly resemble tributary fan alluvium observed throughout the arroyo and in the modern tributary channel while the finer grained interbeds resemble San Pedro River floodplain deposits exposed in a similar relationship in nearby arroyos (site 24) and in modern channel walls of the San Pedro River.
