Site Investigation of Tributary Drainages to the San Pedro River, Arizona

OPEN-FILE REPORT OFR-15-02

Site Investigation of Tributary Drainages to the San Pedro River

Introduction

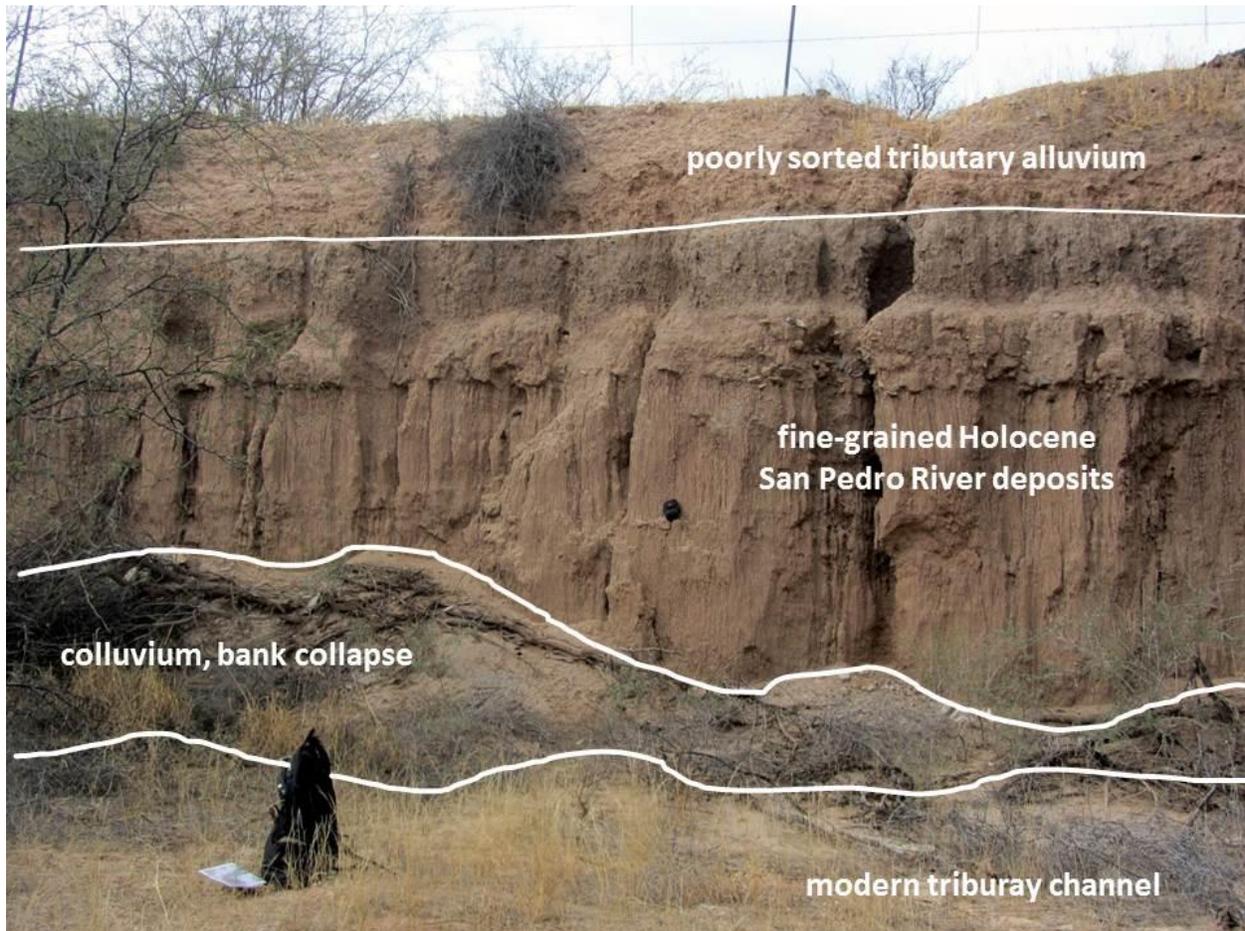
Light brown, poorly sorted, sandy alluvium with angular to sub-angular pebble and gravel-dominated interbeds overlies more uniformly sorted, medium brown, fine sandy beds with darker brown fine sandy to silty buried soils (just below upper drawn contact in the image above) in the north arroyo wall at this location. Isolated lenses of lithologically diverse, well-rounded pebbles and cobbles are present within the fine-grained layer. A darker brown buried soil is present in the finer layer just below the overlying poorly sorted coarser sediment. The angular clasts present in the upper deposit strongly resemble those found in the modern tributary channel bottom. Discontinuous interbeds of poorly sorted alluvium interfingering with the finer-grained deposits are apparent in arroyo walls here but become

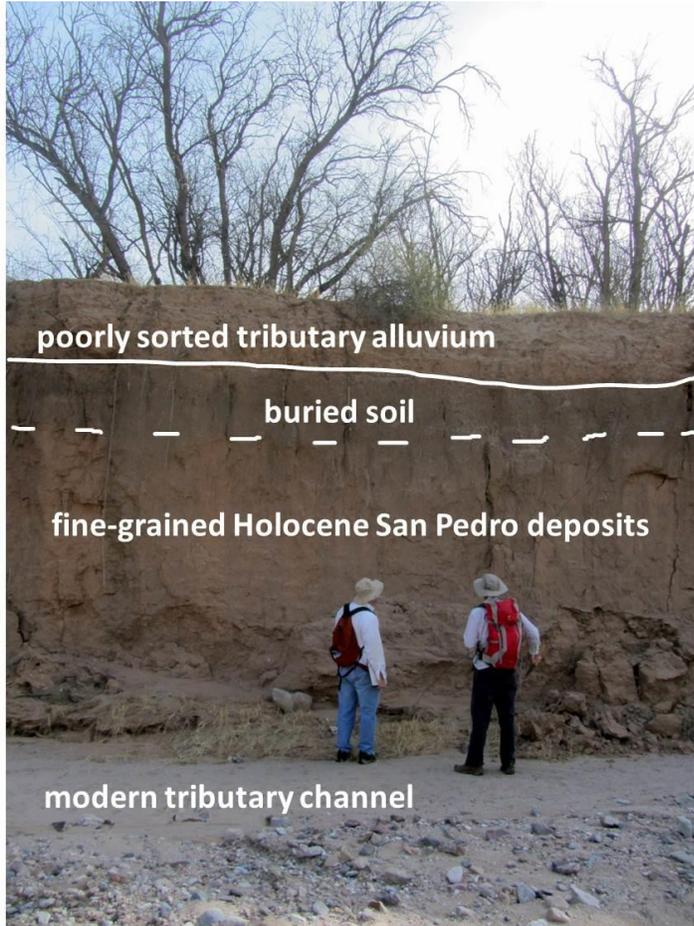
Site 26 offers another view of predominantly well-sorted, fine grained, Holocene alluvium with buried soil layers beneath a thin veneer of poorly sorted alluvium. This exposure is located several hundred feet farther downstream from site 25 in the southern arroyo wall closer to the modern San Pedro River channel.

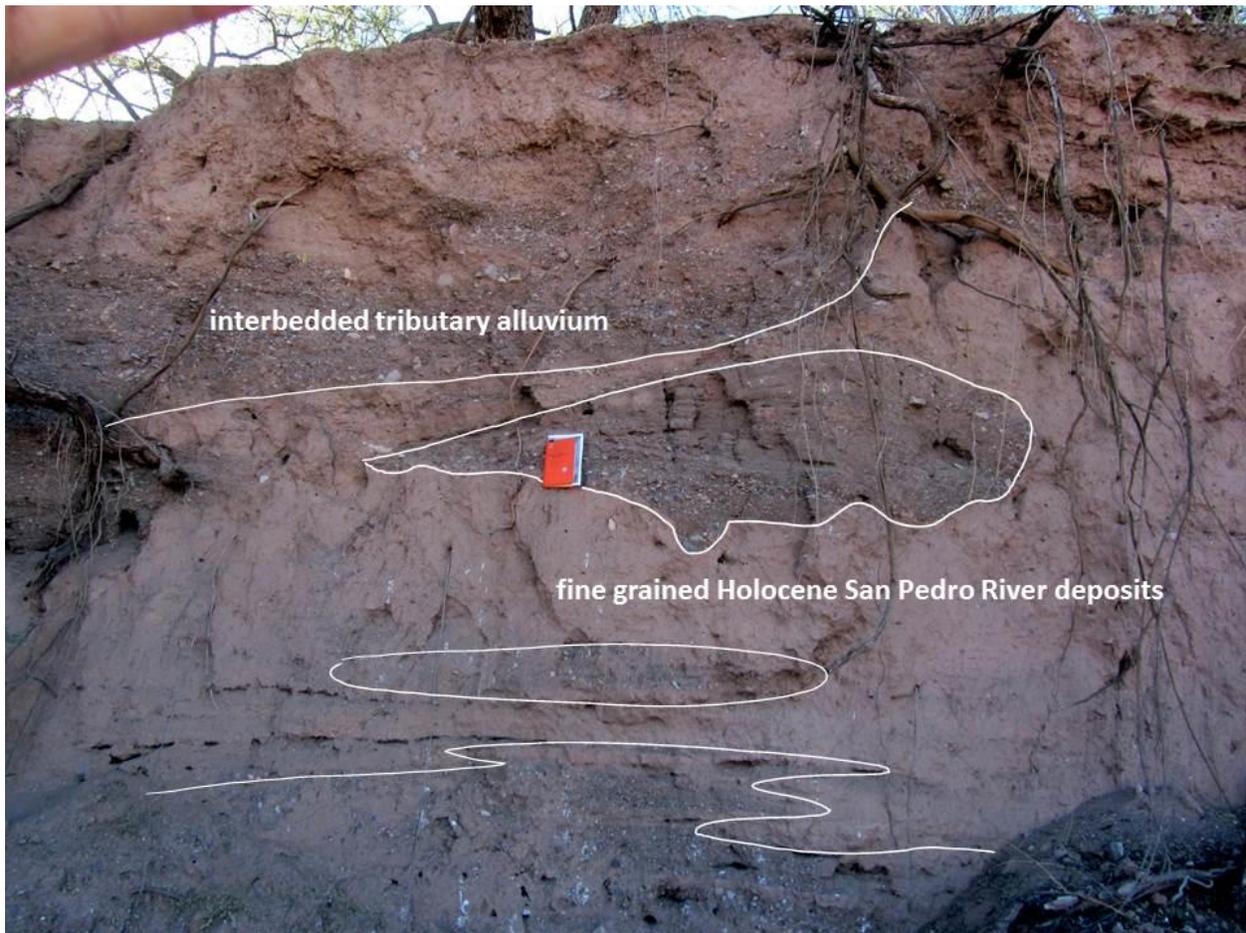
Erosional interbeds and channel deposits of cross bedded, poorly sorted, sandy to pebbly angular alluvium are exposed within well-sorted fine sandy to silty deposits in a channel wall in an outside bend of Teran Wash north of its confluence with the San Pedro River. The poorly sorted interbeds strongly resemble modern Teran Wash bedload and the finer grained, well-sorted beds are evident in Holocene San Pedro River deposits exposed along the river throughout the area.

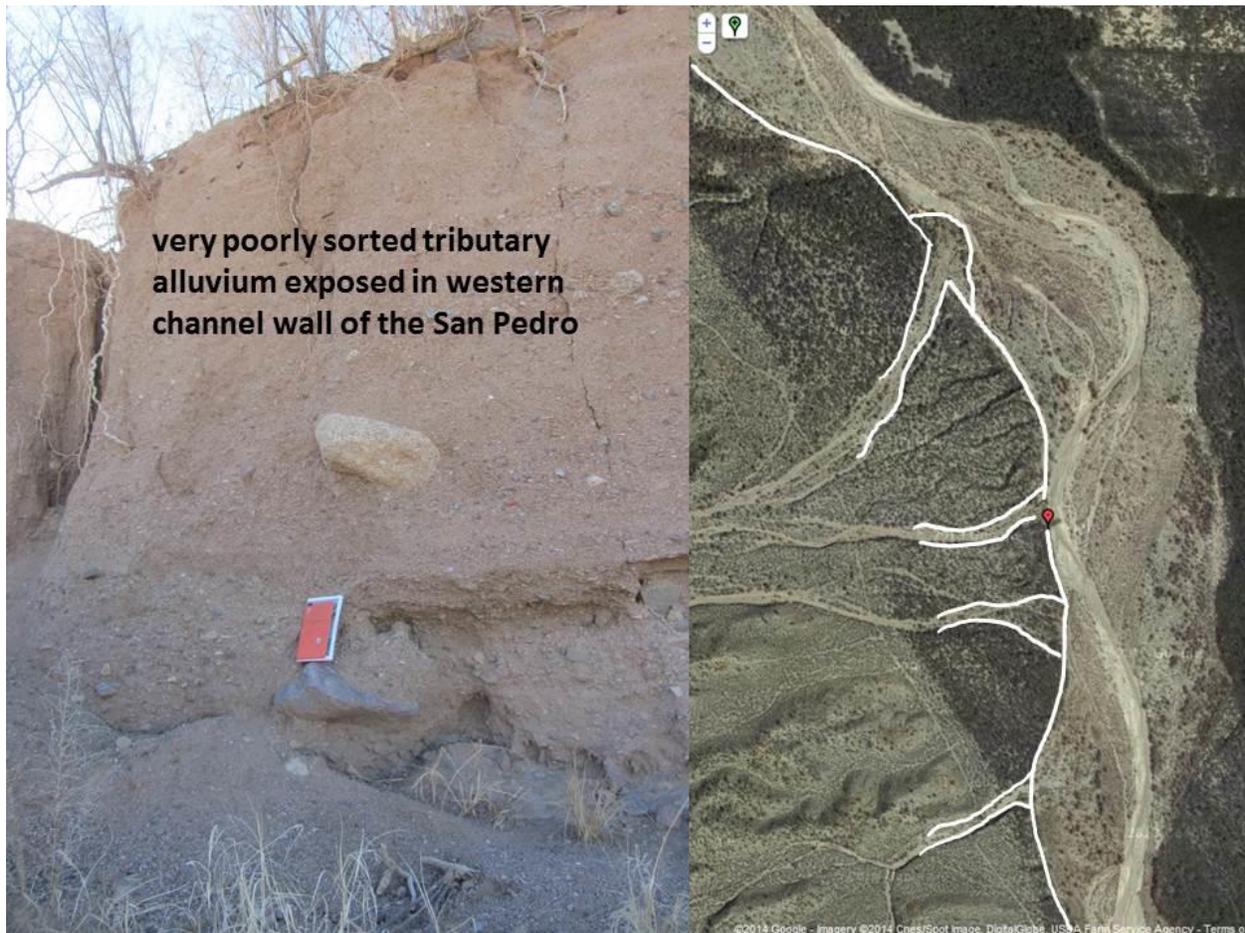
Here we observe Mammoth Wash deposits to overlie former San Pedro River deposits but no exposures of the sedimentary relationship were found farther from the San Pedro River channel bottom. This is likely due, in part, to the unincised character of Mammoth Wash fan channels nearby.
