# Earth Fissure Map of the Chandler Heights Study Area: Pinal and Maricopa County, Arizona

June 2019  
Arizona Geological Survey

Digital Map Series - Earth Fissure Map 1 (DM-EF-1)  
version 5.0

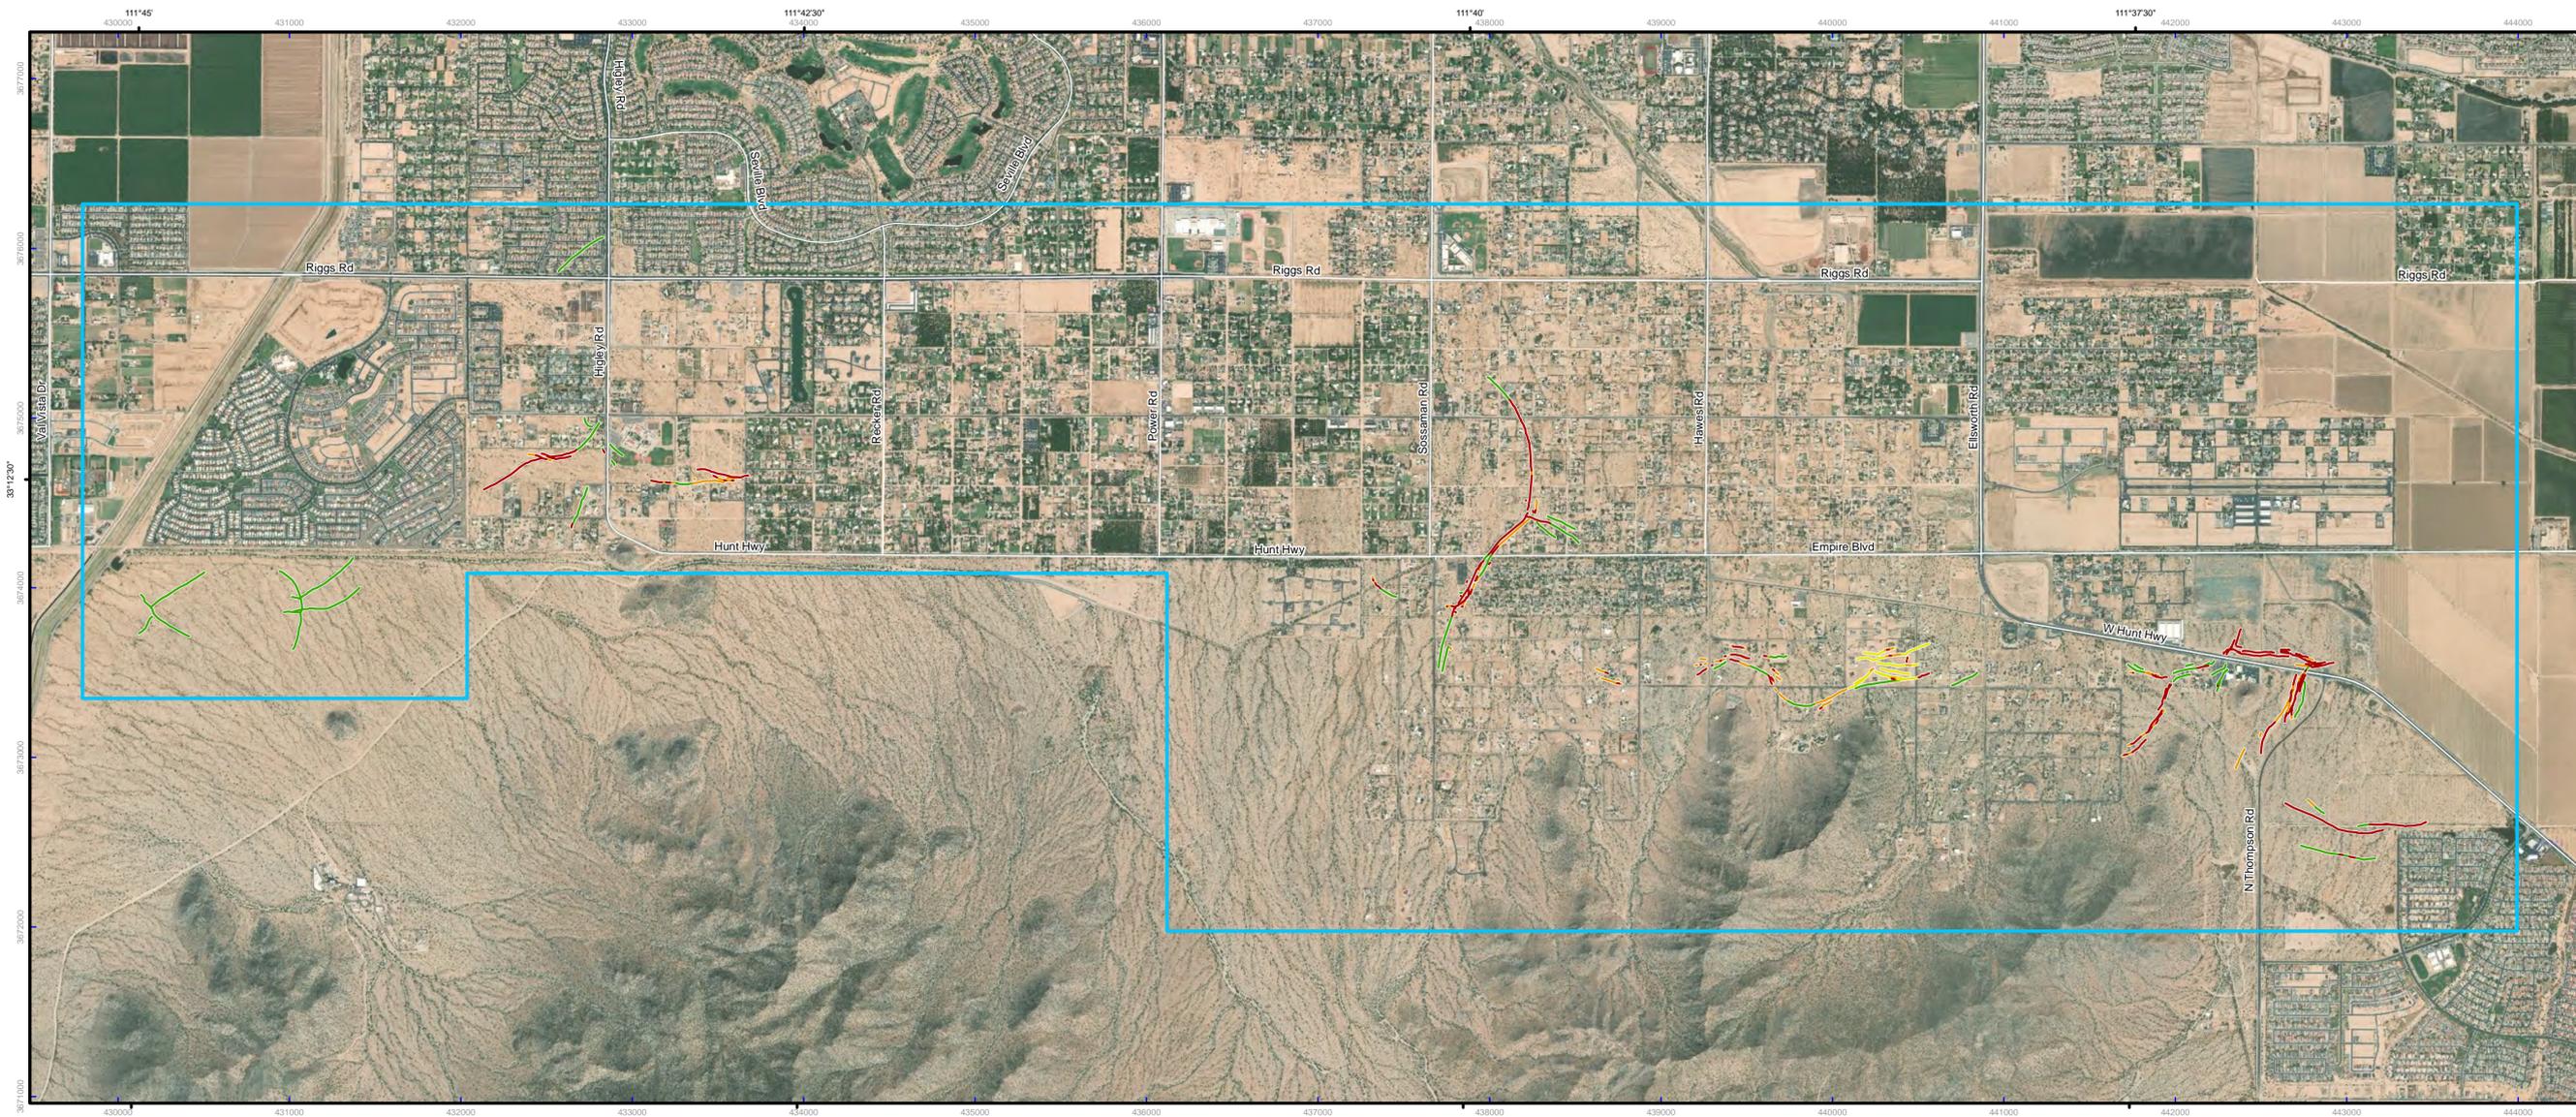
Arizona Geological Survey  
DM-EF-1 (Chandler Heights), v. 5.0

- Red lines represent the location of continuous earth fissures manifested as open cracks or gullies.
- Orange lines represent the location of discontinuous earth fissures manifested as elongated to circular depressions or as abbreviated or irregular linear depressions. These discontinuous surface features frequently represent an incipient surface expression of an earth fissure.

- Yellow lines represent the location of fissures confirmed by non-AZGS personnel or clear evidence of earth fissures on aerial imagery. Traditional field investigation of these features by AZGS was hindered by agricultural or urban modification of the land surface.

- Green lines represent the approximate locations of unconfirmed earth fissures, defined as fissures which could not be confirmed by surface investigations by AZGS geologists, but which have been previously reported by Professional Geologists in published documents or maps.

- The outline of the Study Area is shown in blue. The limits of the study area are based on interpretation of modern and recent ground subsidence data provided by the Arizona Department of Water Resources. Historical and modern aerial photos taken within this area were searched for anomalous lineaments. These lineaments were then investigated in the field to determine if there was any evidence of earth fissures.
