**White Tank Mountains
Flood Hazard Map - SE Section**

by
John J. Field and Philip A. Pearthree
1991

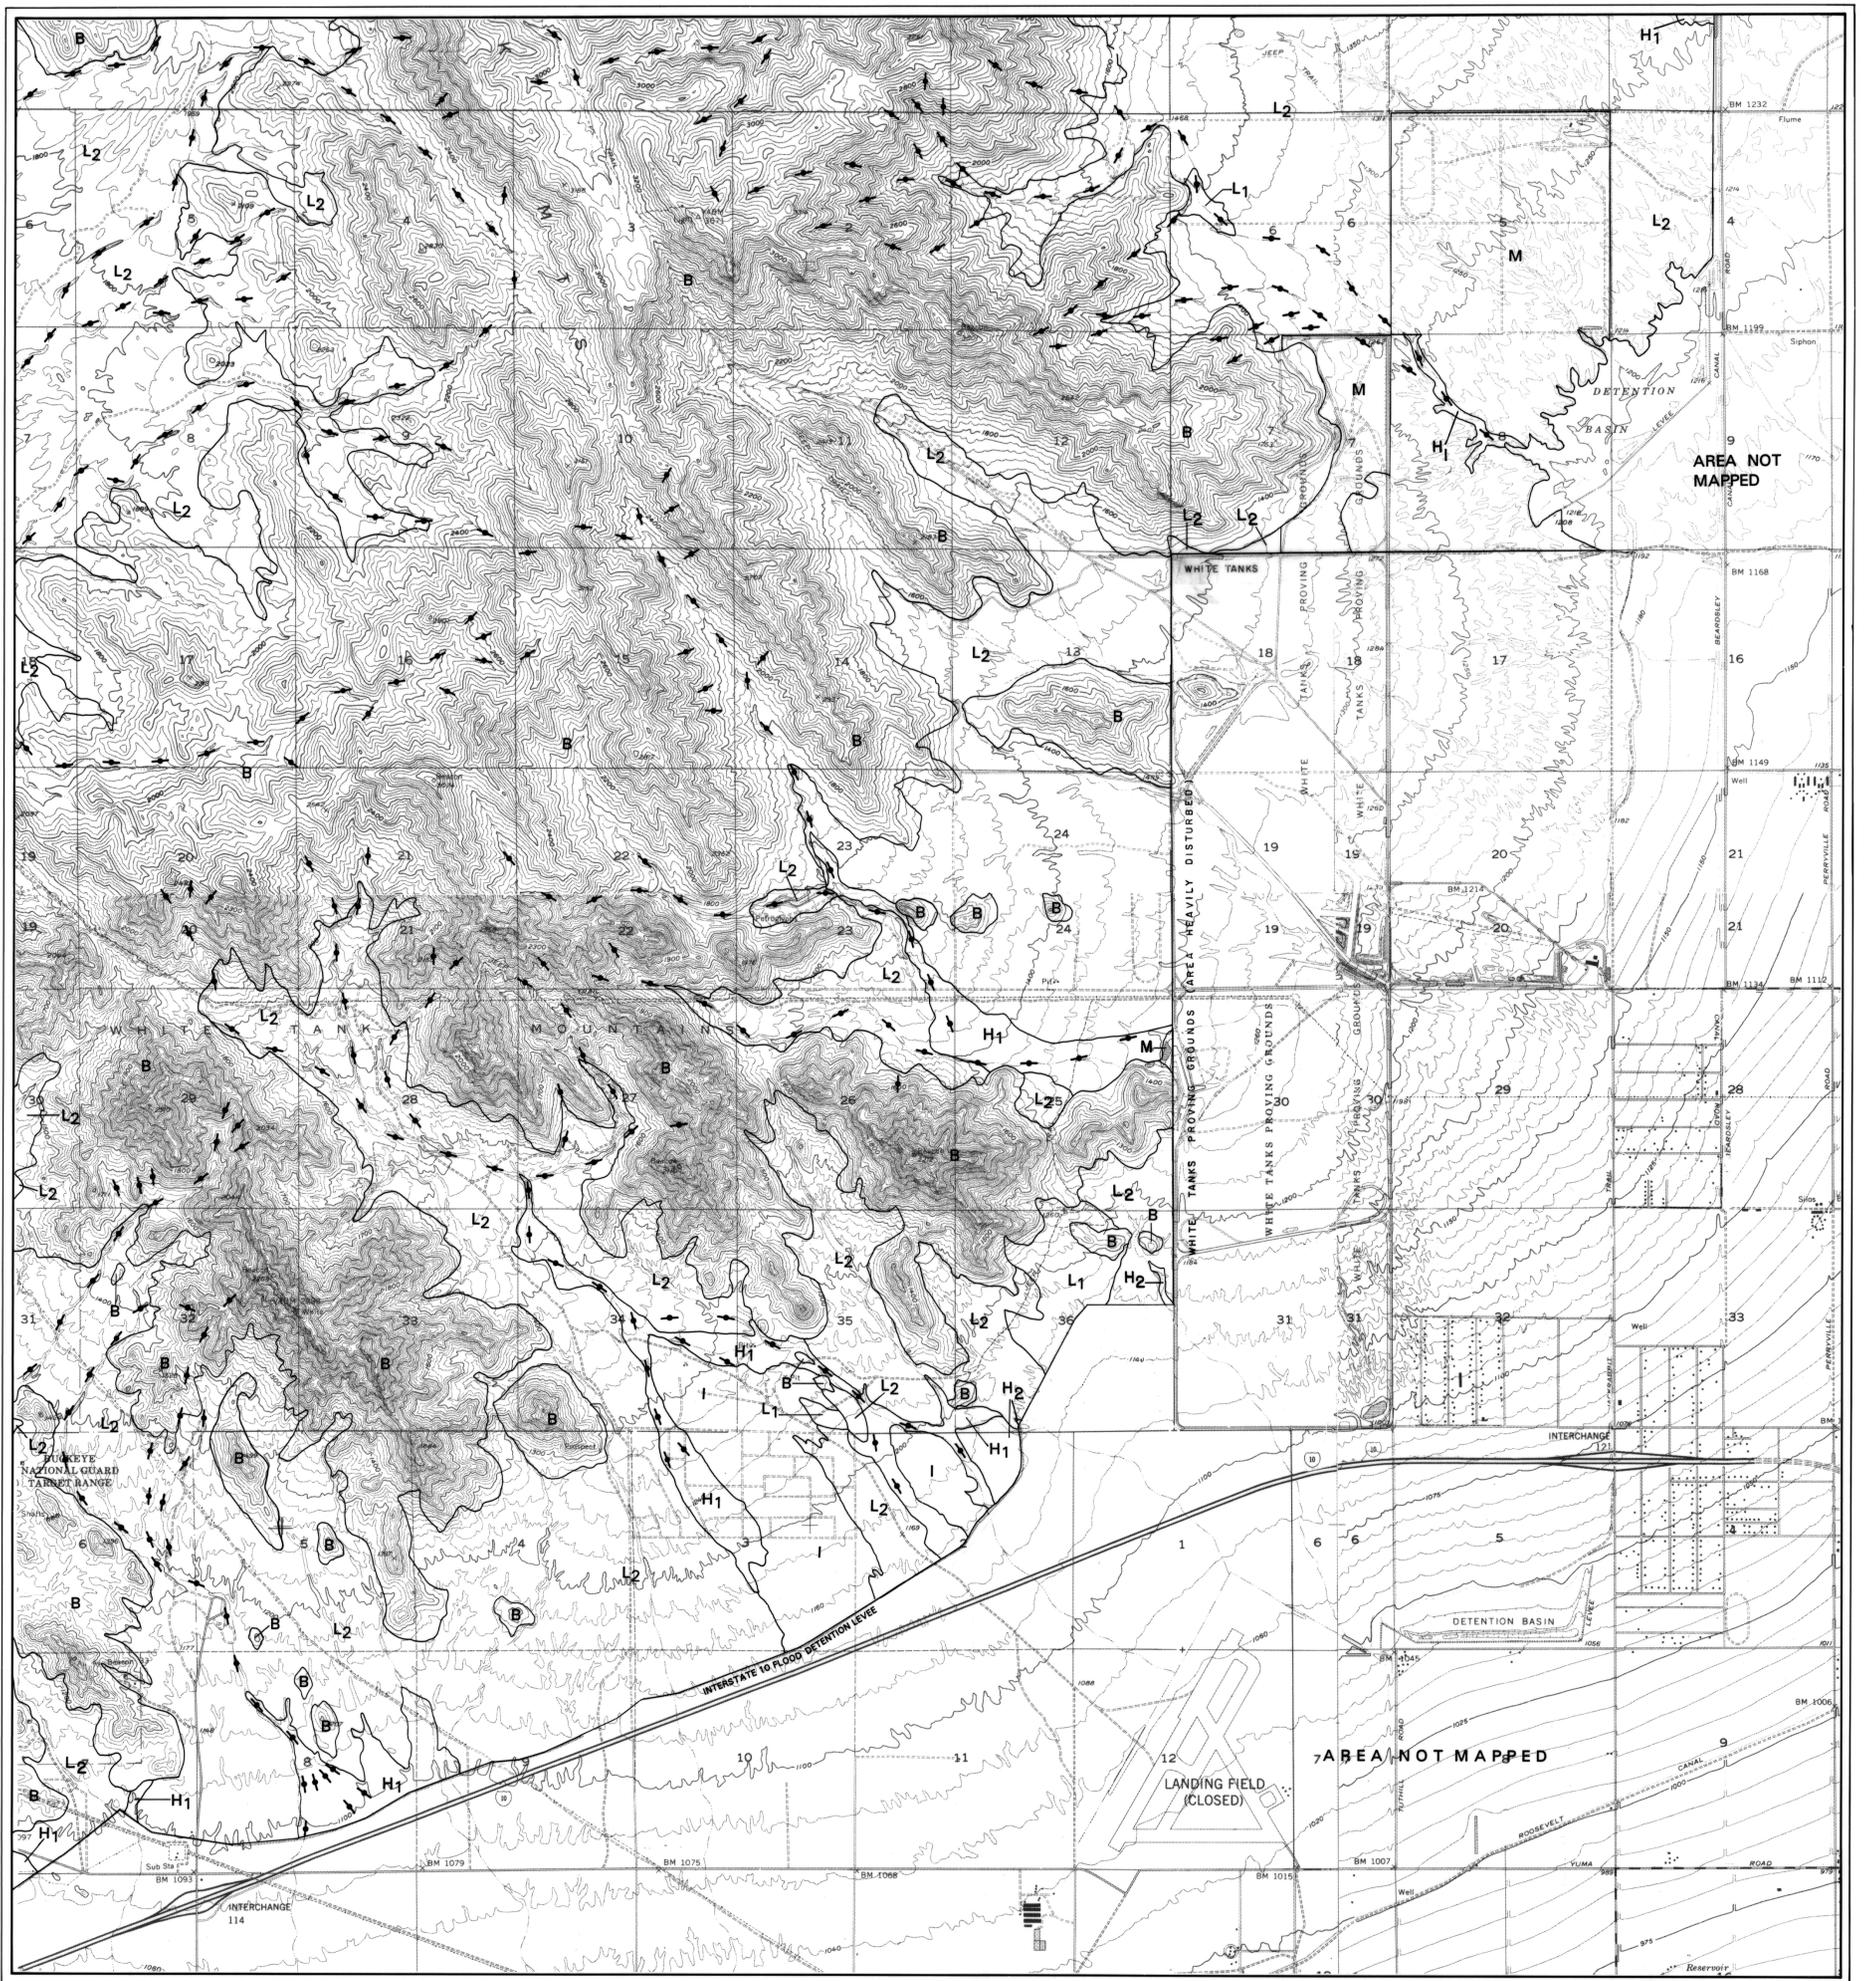
- H1 Flood Hazard:** Highest; high-velocity channelized flow and sheetflow
Distribution: Entrenched reaches of major drainages and distributary flow areas on middle and upper piedmont
Soil Group*: Torrifluvents
Channel Pattern: Braided (anastomosing) or distributary
Surface Relief: Less than 2 ft; bar and swale topography
Surface Texture: Silt to very gravelly sand
Surface Color: Dull yellow-orange (10YR 6/4)
Desert Varnish: Unvarnished gravel
Vegetation:** Brittle bush, rabbit bush, bunch grass, creosote
Estimated Surface Age: Historical to late Holocene (0 to 2,000 yrs old)
- H2 Flood Hazard:** Moderately high; dominantly sheetflow with minor channel flows
Distribution: Restricted to lower piedmont and small drainages heading on the piedmont
Soil Group: Torrifluvents
Channel Pattern: Distributary; incipient dendritic drainage in less active areas

- I Flood Hazard:** Intermediate; has not been subject to significant flooding for more than 1,000 yrs, but lack of topographic relief between these surfaces and active surfaces (H1 and H2) suggests that they could become flood prone with channel filling, avulsion, or human disturbance
Distribution: Adjacent to H1 and H2 in distributary flow areas and on lower piedmont
Soil Groups: Torrifluvents and Camborthids
Channel Pattern: Widely spaced, dendritic tributary drainages
Surface Relief: Less than 4 ft in distributary flow areas and less than 3 ft on lower piedmont; bar and swale topography well preserved in distributary flow areas
Surface Texture: Open desert pavement consisting of granules and small cobbles
Surface Color: Dull yellow-orange (10YR 6/4)
Desert Varnish: Unvarnished to weakly developed over 10% of the surface - brownish black (7.5YR 3/1) on top and orange (7.5YR 7/6) on undersides

- L1 Flood Hazard:** Low; localized sheetflooding possible; flooding might occur if channels are altered by human disturbance because of low relief downslope from major distributary flow areas
Distribution: Downslope from and adjacent to distributary flow areas on middle and lower piedmont
Soil Groups: Camborthids and Haplargids
Channel Pattern: Moderately spaced, dendritic tributary drainages
Surface Relief: 1 to 10 ft; fairly smooth subdued bar and swale topography
Surface Texture: Open to closed desert pavement consisting of granules and cobbles
Surface Color: Bright brown (7.5YR 5/6) to orange (7.5YR 6/6)
Desert Varnish: Weakly to moderately developed over 50% of surface - brownish black (7.5YR 2/2) to grayish brown (7.5YR 4/2) on top and dull orange (5YR 6/4) to reddish brown (2.5YR 4/6) on undersides
Vegetation: Brittle bush, creosote, cane cholla
Estimated Surface Age: Latest Pleistocene to middle Pleistocene (15,000 to 250,000 yrs old)

- L2 Flood Hazard:** Lowest; restricted to small channels and localized sheetflooding
Distribution: Upper and middle piedmont and adjacent to Hassayampa River
Soil Groups: Haplargids and Durorthids
Channel Pattern: Closely to widely spaced, dendritic tributary drainages; rounded interfluvies in areas of highest relief
Surface Relief: 5 to 40 ft; fairly smooth surface; uncommon bar and swale topography
Surface Texture: Closed desert pavement consisting of cobbles and pebbles; uncommon salt-shattered cobbles; in places, surface is denuded and covered by petrocalcic fragments
