**DRASTIC Analysis of Pinal County**

by  
**Steven Slaff**  
 Arizona Geological Survey  
 for  
 Arizona Department of Environmental Quality

September 1992

Plate 6 of 9: Earth Fissures

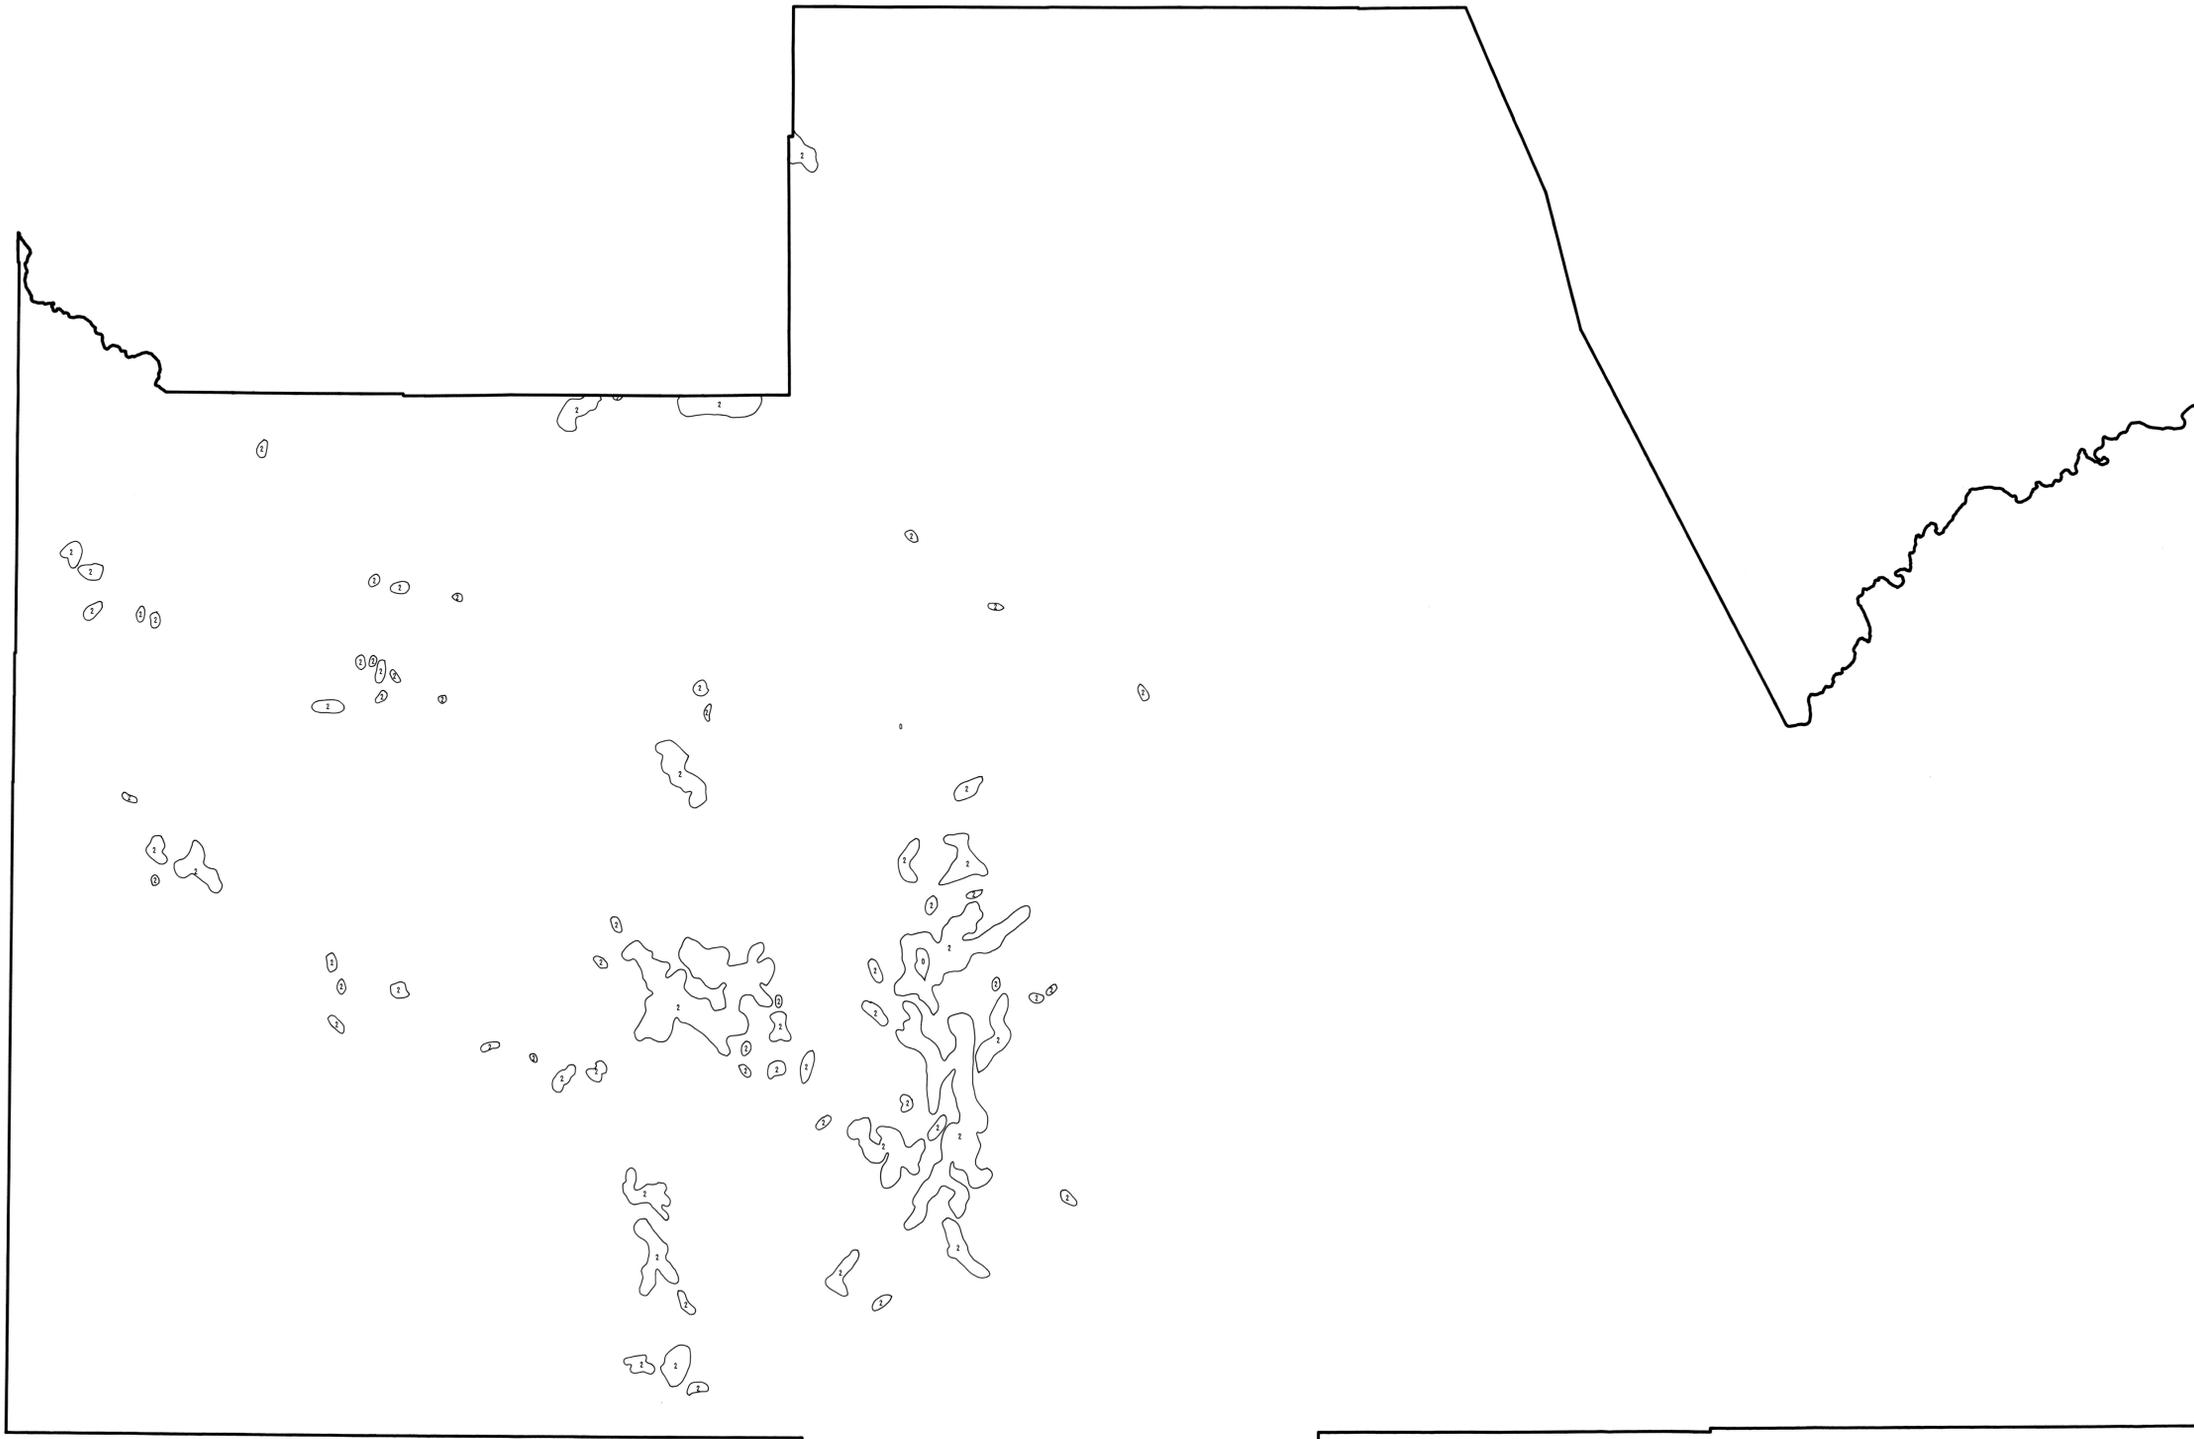
This map was compiled in 1991. The mapping was accomplished by interpretation of aerial photographs, aerial visual reconnaissance, and field checking. The investigators worked at different times, mapped at different scales, and did not necessarily include all portions of the county. Fissures are shown as polygons rather than discrete lines because this map is for general planning, not site-specific assessment. The map may be incomplete because: 1) farmers quickly fill in fissures that form in their fields; 2) some fissures (especially those in remote locations) may not have been discovered; 3) more may have formed since the data used in the compilation were published; 4) some fissures are virtually invisible; and, 5) some fissures extend farther laterally beneath the ground surface than shows at the surface. A blank area on the map does not necessarily lack fissures.
