Earth Fissure Map of the Santa Rosa Wash Study Area: Pinal County, Arizona

June 2019
Arizona Geological Survey

Digital Map Series - Earth Fissure Map 19 (DM-EF-19) version 3.0

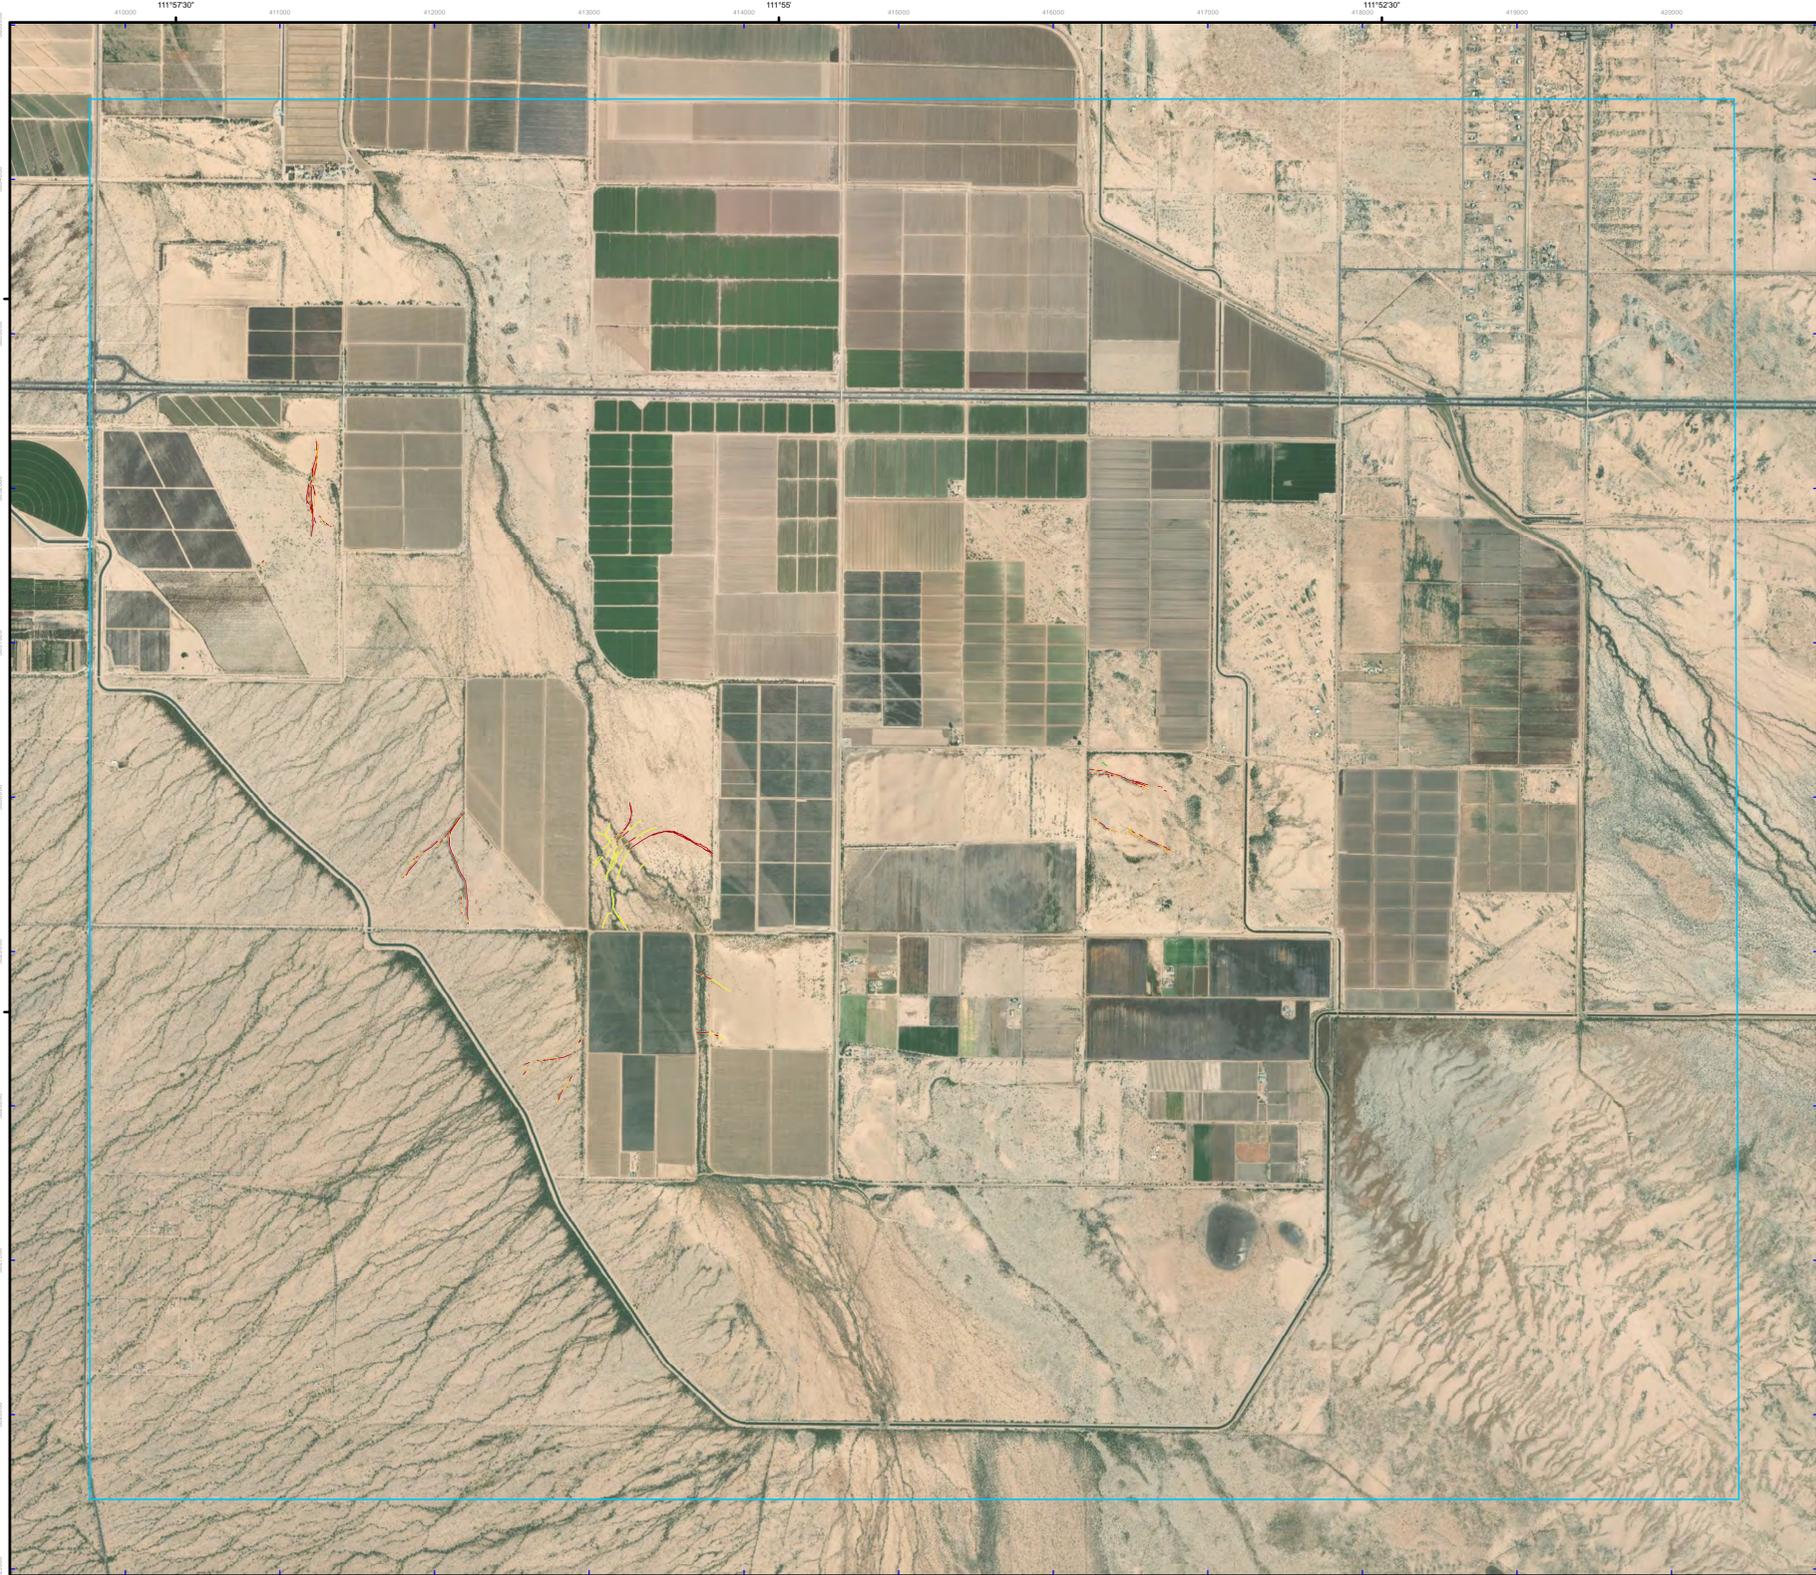
- Red lines represent the location of continuous earth fissures manifested as open cracks or gullies.
- Orange lines represent the location of discontinuous earth fissures manifested as elongated to circular depressions or as abbreviated or irregular linear depressions. These discontinuous surface features frequently represent an incipient surface expression of an earth fissure.

- Yellow lines represent the location of fissures confirmed by non-AZGS personnel or clear evidence of earth fissures on aerial imagery. Traditional field investigation of these features by AZGS was hindered by agricultural or urban modification of the land surface.

- Green lines represent the approximate locations of unconfirmed earth fissures, defined as fissures which could not be confirmed by surface investigations by AZGS geologists, but which have been previously reported by Professional Geologists in published documents or maps.

- The outline of the Study Area is shown in blue. The limits of the study area are based on interpretation of modern and recent ground subsidence data provided by the Arizona Department of Water Resources. Historical and modern aerial photos taken within this area were searched for anomalous lineaments. These lineaments were then investigated in the field to determine if there was any evidence of earth fissures.

- 4) Some earth fissures mapped in this study area fit the description of "combination earth fissure-desiccation cracks" of Harris, 2004. Based on similar appearance, morphology, and depth of surface crack to nearby known earth fissures, these features are depicted here as earth fissures. Other shallow polygonal surface crack networks within the study area were interpreted to be giant desiccation cracks and are not individually depicted on this map. However, zones of desiccation cracks are outlined.
