A NEW EARTH FISSURE
NEAR WINTERSBURG,
MARICOPA COUNTY, ARIZONA

Arizona Geological Survey
Open-File Report 01-10

Raymond C. Harris
Arizona Geological Survey

November 2001

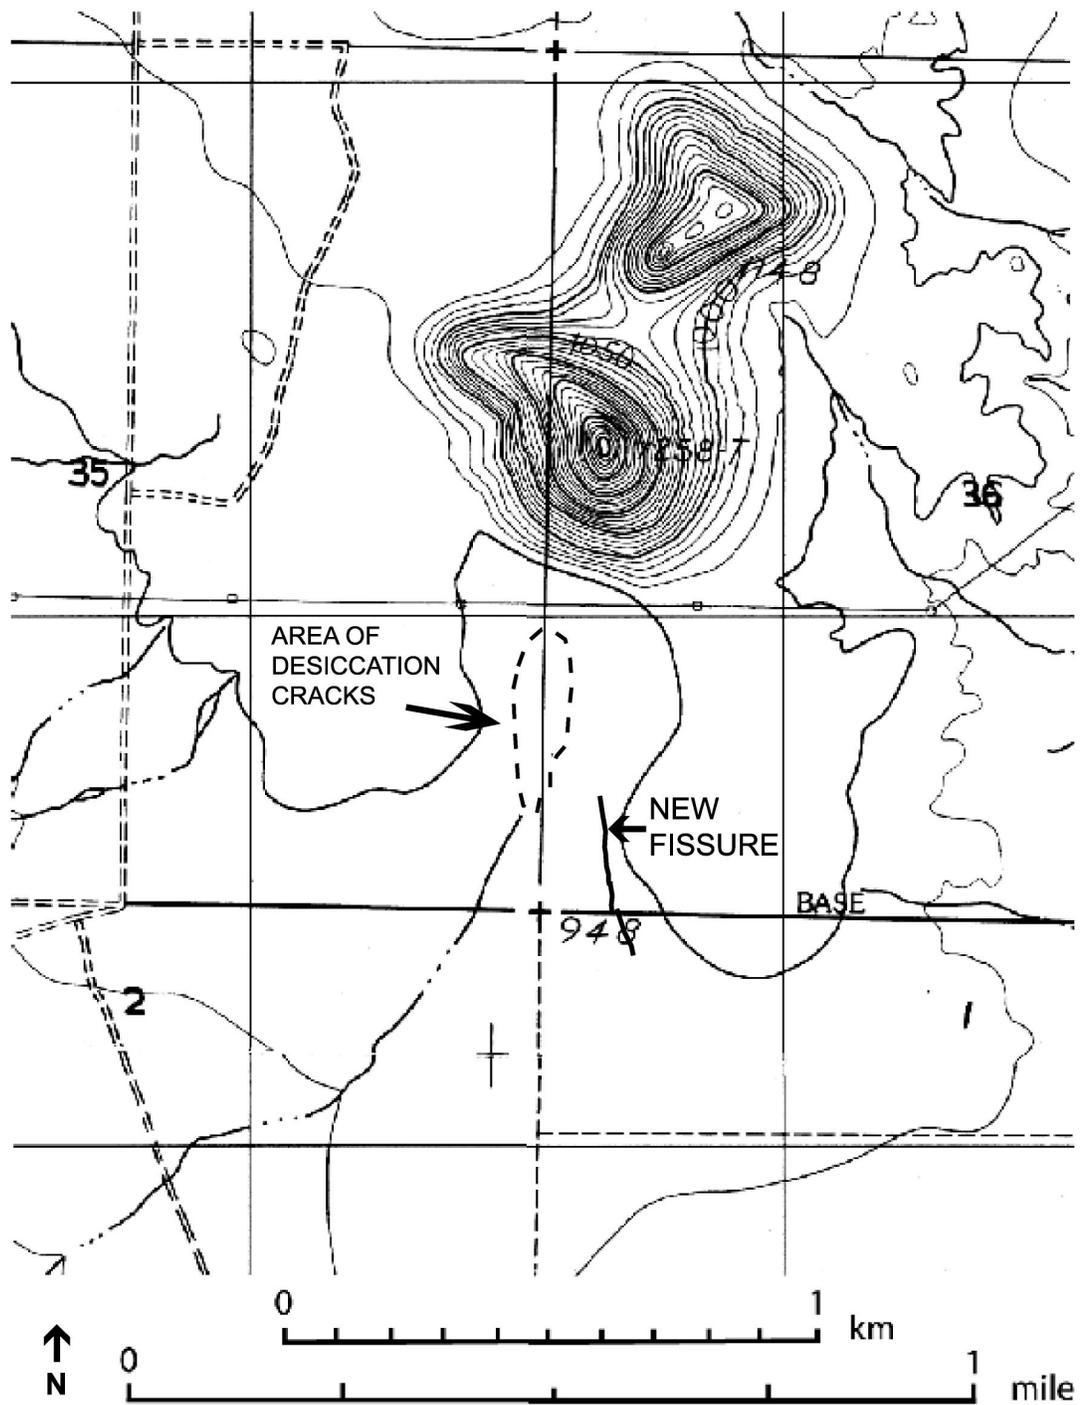
Figure 2. Topographic map showing location of new earth fissure and area of Desiccation cracks. Hill at top of map is 3 miles southeast of Wintersburg. (Base from Wintersburg and Arlington 7.5-minute quadrangles)

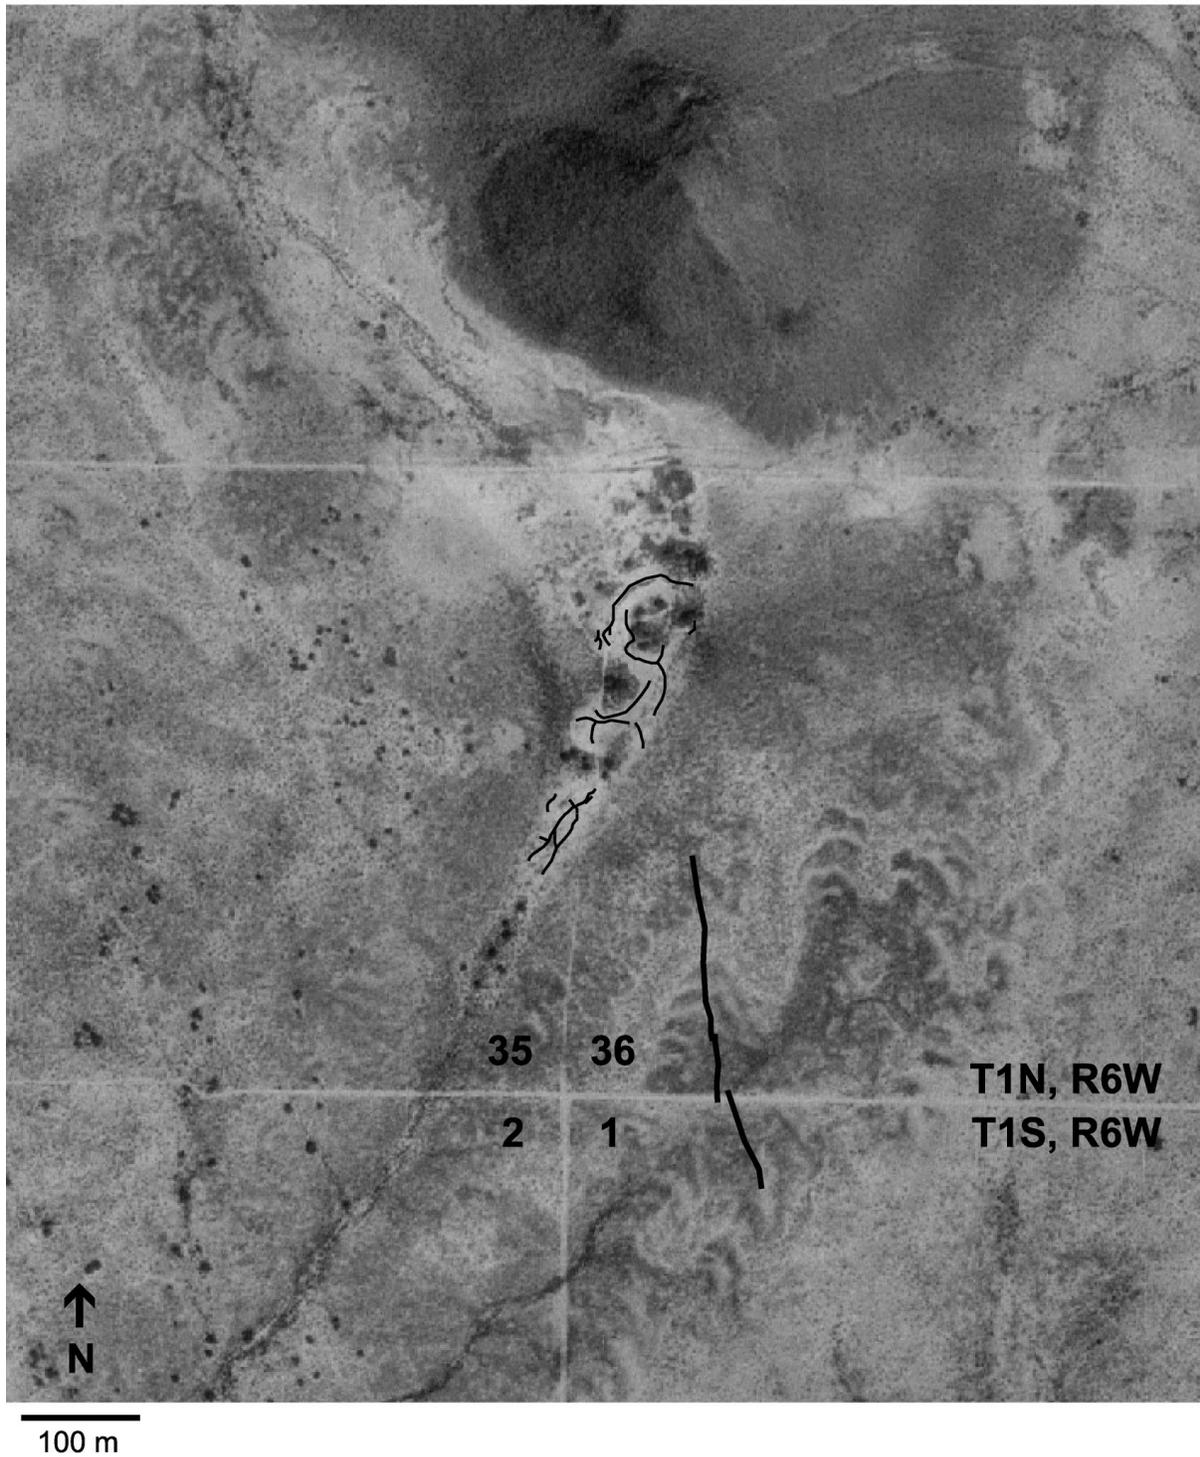
Figure 3. Aerial photo showing location of earth fissure and desiccation cracks.

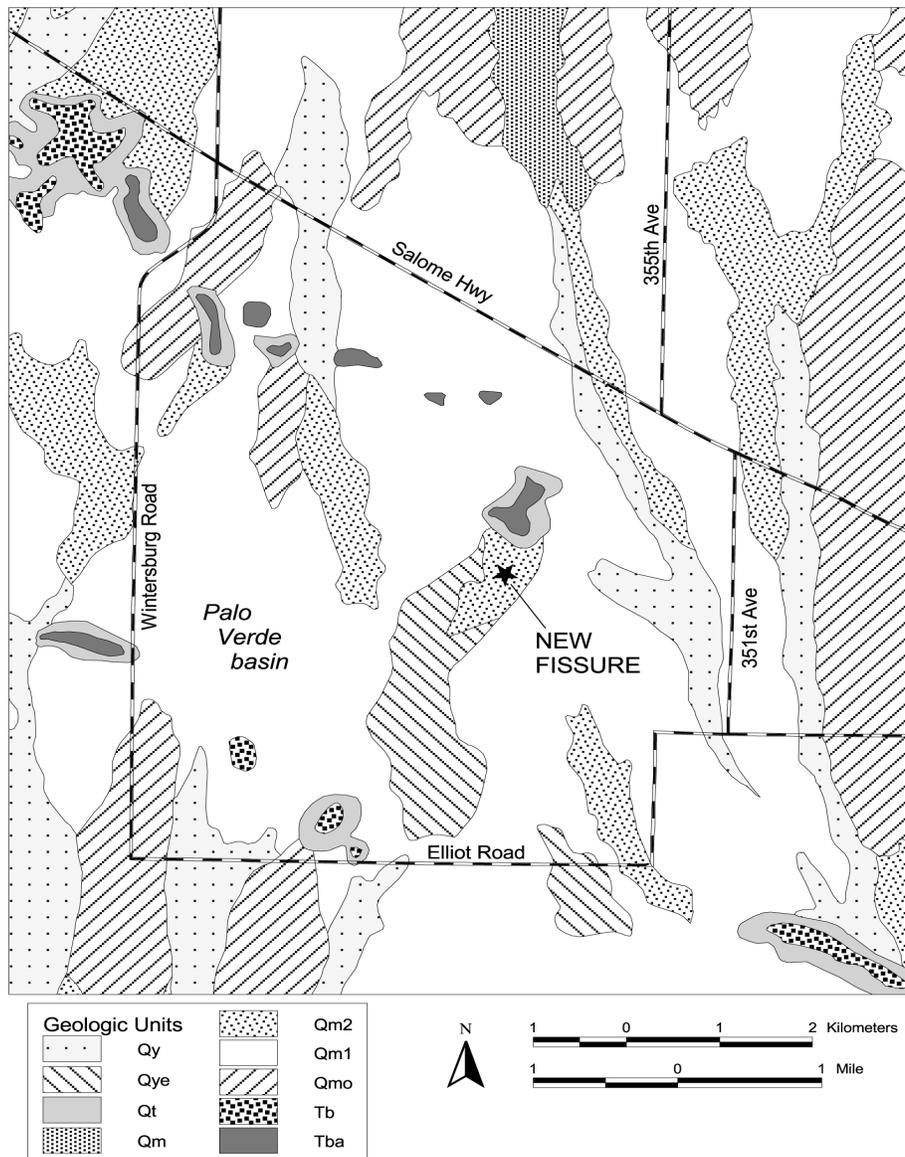
The site of the new fissure is immediately south of a small hill three miles southeast of Wintersburg. A ring of similar small hills defines the tiny Palo Verde basin, with the new fissure near its eastern margin. Figure 17 is a generalized geologic map of the Wintersburg area, based on the mapping of Demsey (1989) and Reynolds and Skotnicki (1993). Geologic units are described in Tables 1 and 2.

The oldest rocks in the area shown in Figure 2 are middle Tertiary basalts and basaltic andesites of the Palo Verde Hills. Age dates on these volcanic rocks range from 16.9 to 20.7 million years (Reynolds and others, 1986). Beginning 12-13 million years ago, Basin and Range faulting broke the crust into blocks that were tilted 15-23 degrees to the southwest in the region that became the Palo Verde Hills.

Figure 17. Geologic map of the Wintersburg area. Units described in Tables 1 and 2.

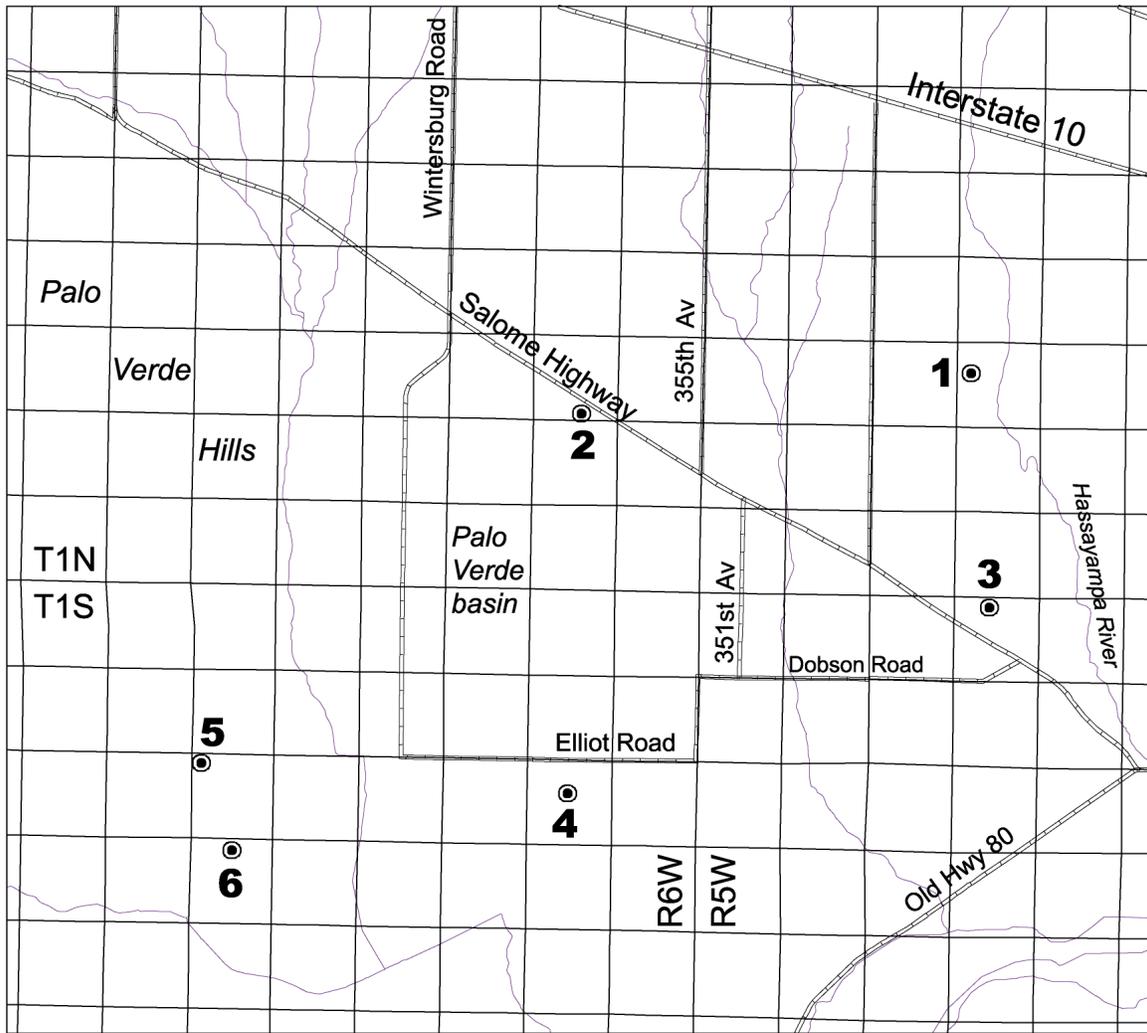
Groundwater levels in the vicinity of the fissure have been measured for many years. Long-term records for six wells in the region were obtained from the Arizona Department of Water Resources. Well locations are plotted in Figure 18. Water levels seem to be fairly steady in the area immediately surrounding the fissure. Plots of water levels over several decades in three wells (Figure 19, a-c) north and east of the fissure show little sign of groundwater decline. Three wells (Figure 19, d-e) southwest of the Palo Verde Hills do record groundwater decline trends on the order of 100 feet (neglecting the lowest “outlier” points on the plots) from the 1950s to about 1980. Groundwater declines of similar magnitude have been responsible for subsidence and earth fissures in other Arizona basins. Since 1980, however, groundwater levels in these three wells have recovered to almost the 1950s levels.

Figure 18. Location of wells with long-term water level measurements.

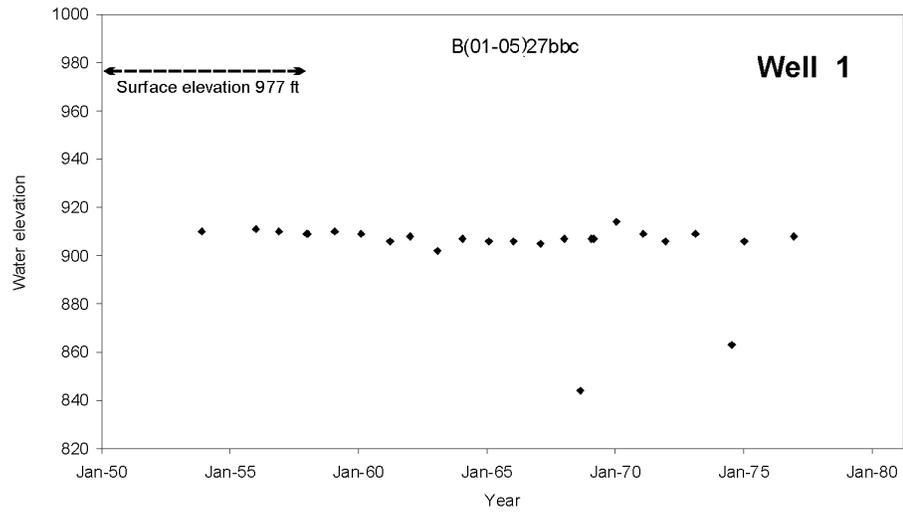
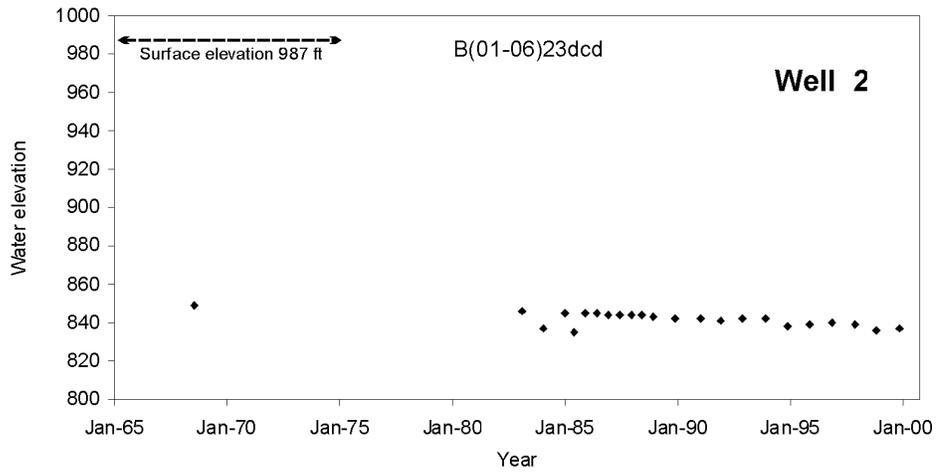
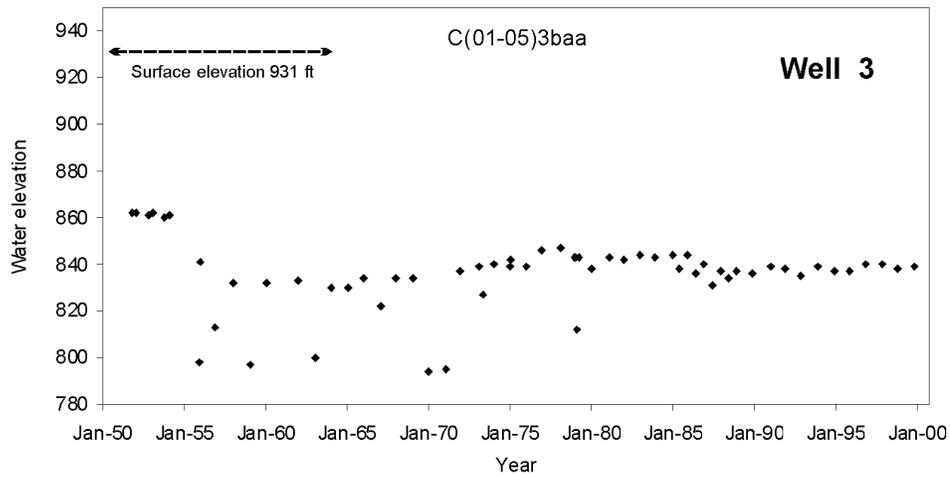
Figure 19. Water level measurements in selected wells near the Palo Verde basin.

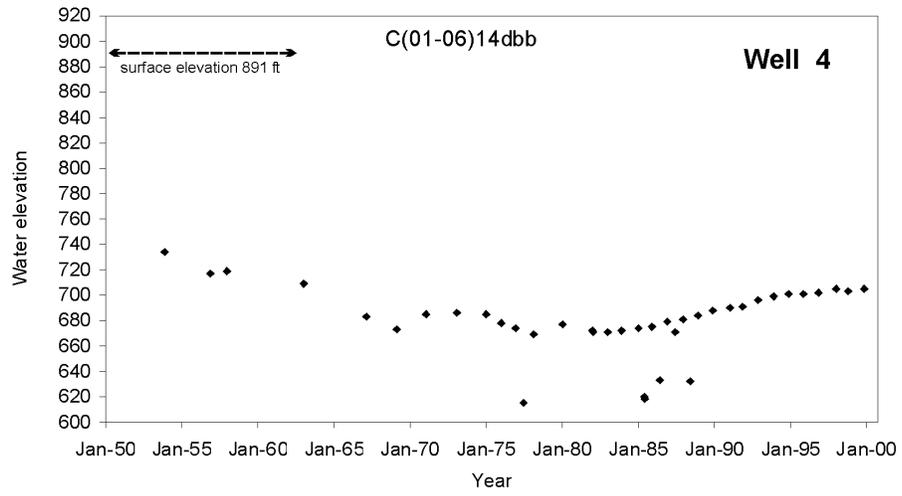
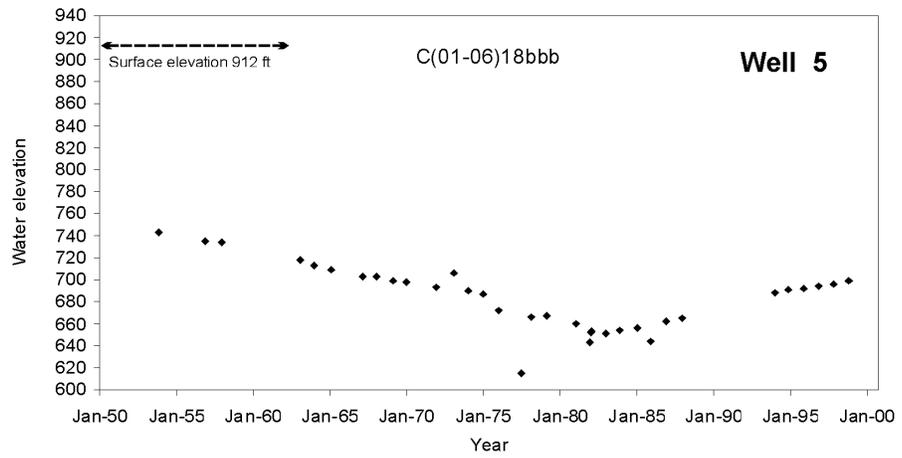
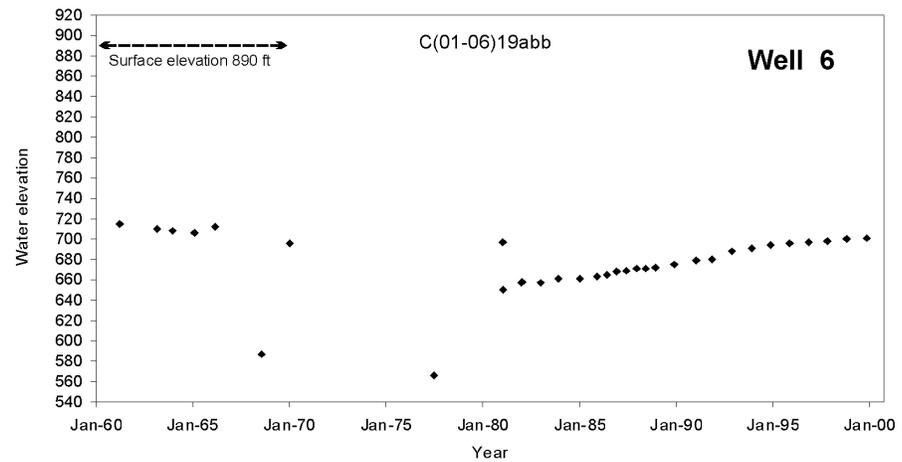
Figure 19 (continued). Water level measurements in selected wells near the Palo Verde basin.
