ADDITIONAL GIANT DESICCATION
CRACKS NEAR WINTERSBURG,
MARICOPA COUNTY, ARIZONA

by
Raymond C. Harris

Arizona Geological Survey
Open-File Report 03-07

November 2003

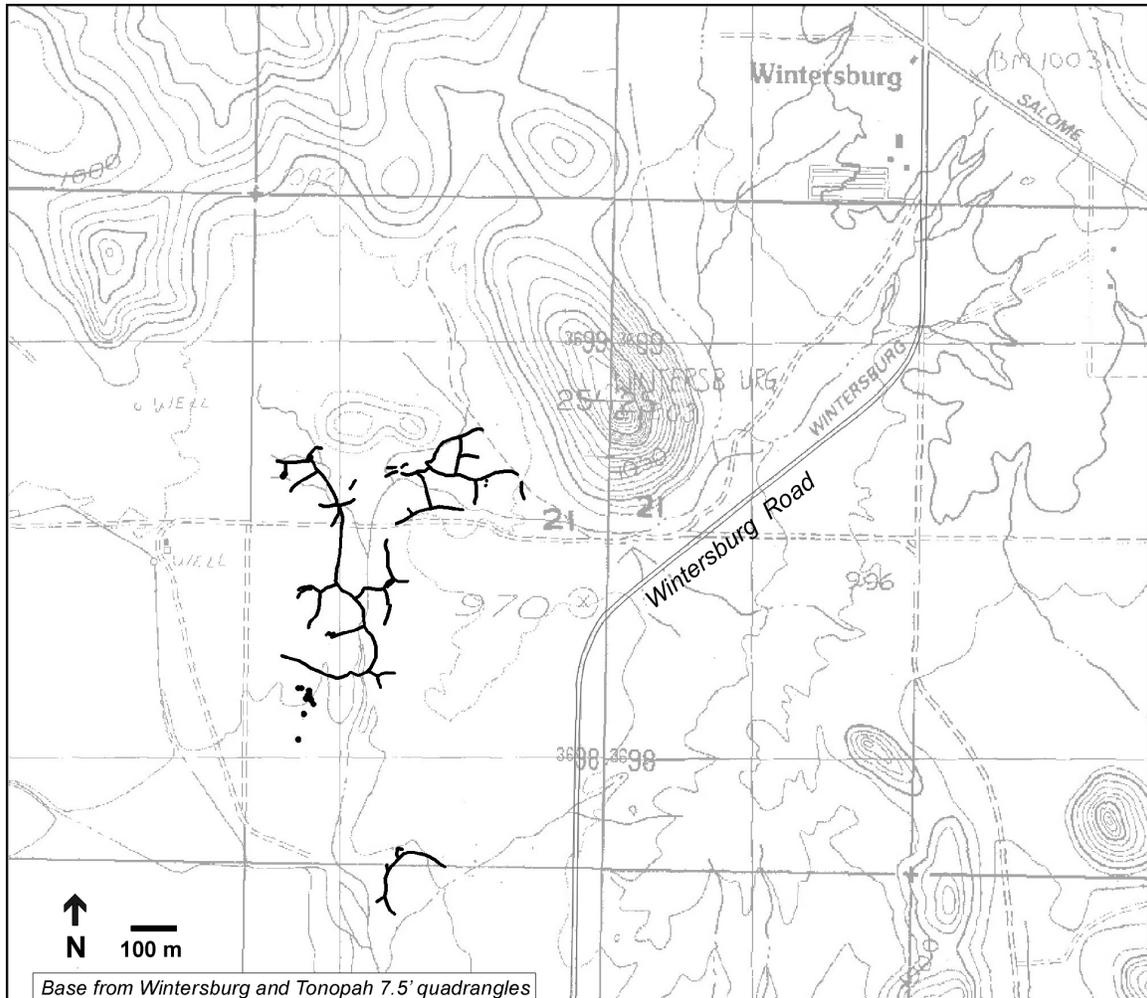
Giant desiccation cracks have been discovered one mile southwest of Wintersburg (Figure 1) on detailed aerial photos obtained from Maricopa County Flood Control District. These cracks are immediately west of Wintersburg Road and south of a small hill (Figures 2 and 3). Previously, a new earth fissure and nearby giant desiccation cracks were reported three miles southeast of Wintersburg in the late Summer 2001 (Harris, 2001).

Figure 2. Location of desiccation cracks one mile southwest of Wintersburg.

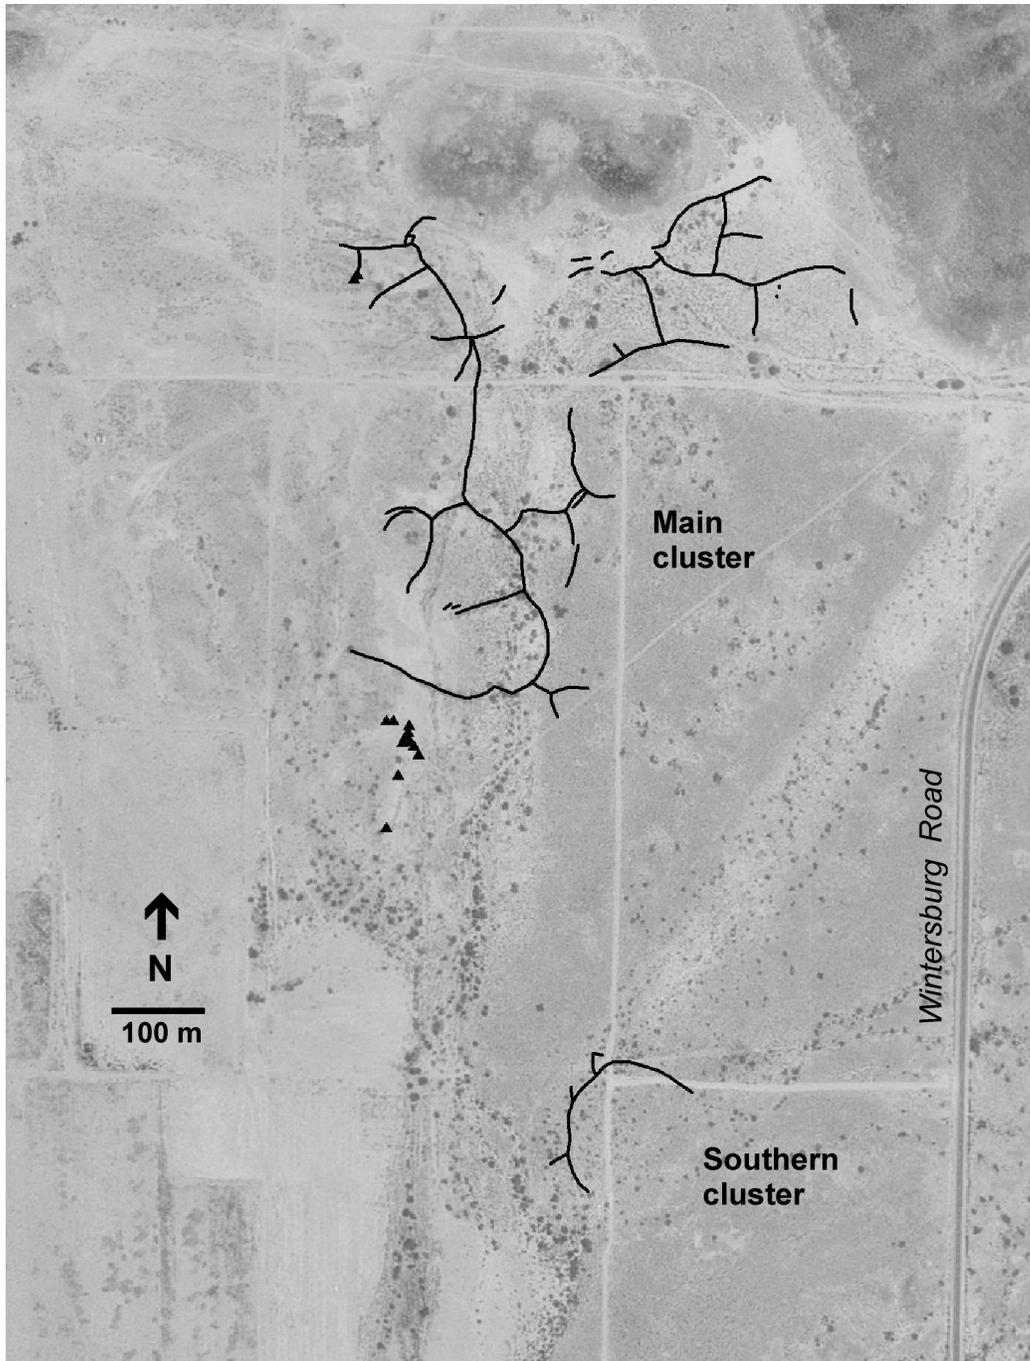
Figure 3. Aerial view of location of desiccation cracks near Wintersburg.

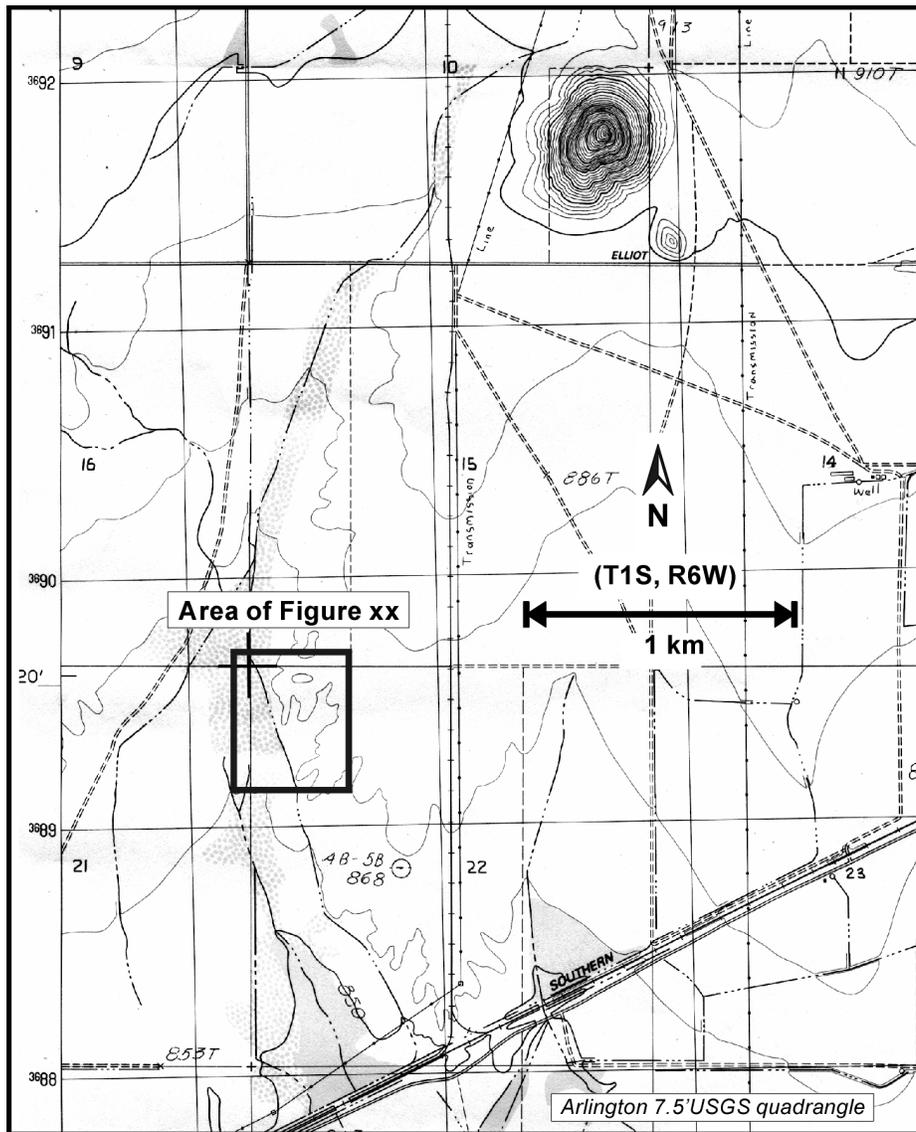
Another area of newly recognized giant desiccation cracks is about one mile south-southeast of the intersection of Wintersburg Road (379th Ave.) and Elliot Road, about six miles south of Wintersburg (Figures 1 and 16). This new cluster is visible on 2001 aerial photos from Maricopa County (Figure 17) but is not apparent on the 1996 USGS DOQQ (Arlington NW). Locations of the new cracks based on photo interpretation (no field checking) are plotted on Figure 18.

Figure 16. Location of desiccation cracks 6 miles south of Wintersburg.
