EARTH FISSURES IN THE
BOWIE - SAN SIMON AREA,
COCHISE COUNTY, ARIZONA

Arizona Geological Survey
Open-File Report 97-19

November, 1997

Produced for the Arizona Department of Environmental Quality

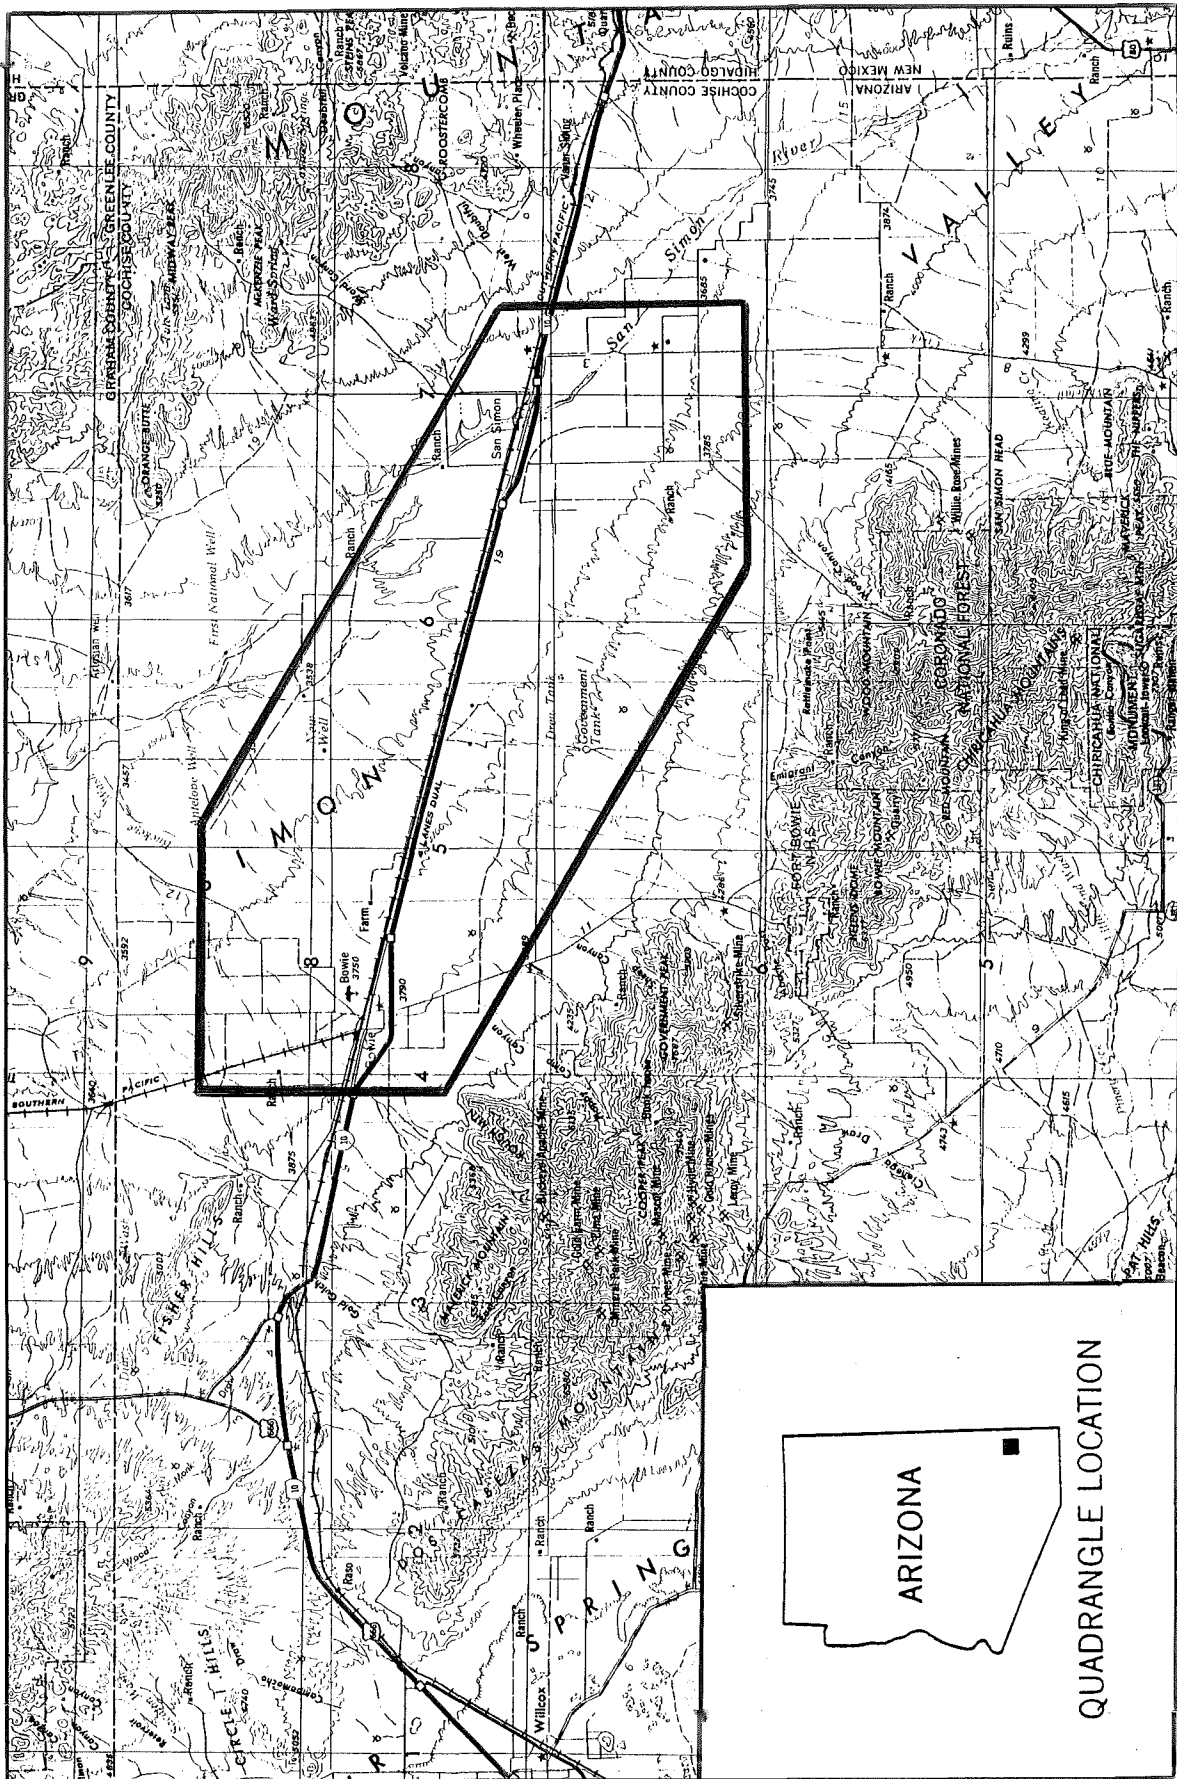
Figure 1. Location of study area

Groundwater pumping, largely for agriculture, has lowered groundwater levels in the Bowie and San Simon areas of Cochise County (Figure 1). Land subsidence is occurring and earth fissures have formed as a result.
