FIELD GUIDE TO
EARTH FISSIONS AND OTHER
LAND SUBSIDENCE FEATURES
IN PICACHO BASIN

Arizona Geological Society
Arizona Hydrological Society
Fall 1999 Field Trip
November 13, 1999

Arizona Geological Survey
Open-File Report 99-26

Leader:
Raymond C. Harris
Arizona Geological Survey

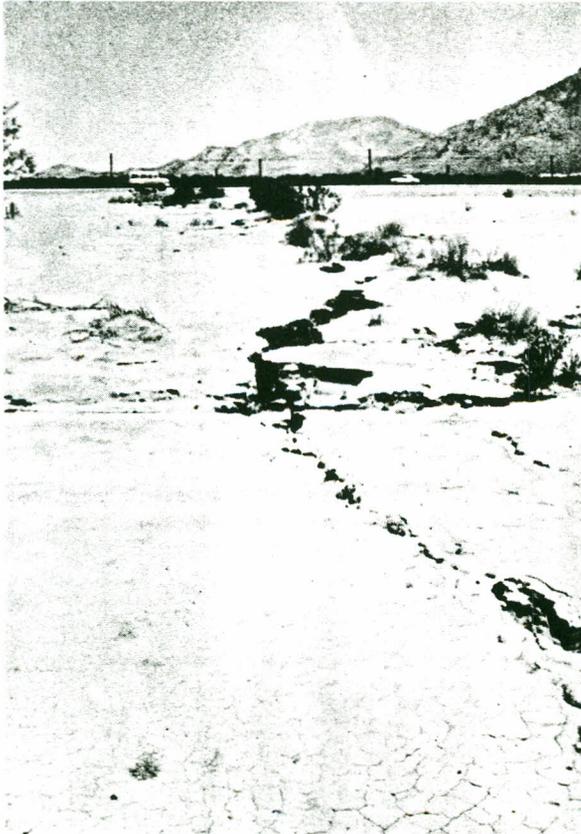
A

The fissure shown at the extreme right in figure 6, at a point on Highway 84 about 3 miles southeast of Picacho, is the one described by Leonard (1929) as having first opened in September 1927. Subsequent filling and reopening of this and other fissures in the general area are described by Heindl and Feth (1955). Leonard's description mentions the fissure length as one-fourth mile; it is now at least 8 miles long. Part of the fissure appears in a photograph (fig. 7A) taken on August 6, 1961, looking northeast across

Figure 7.—Views looking northeast at fissures crossing Arizona Highway 84 near Picacho Mountains. A, Fissure 3 miles southeast of town of Picacho; 2 days previous width appeared less than half an inch; torrential rain on previous day revealed this opening; note vegetal growth along fissure. B, Fissure 1 mile southeast of Picacho. Photographs taken on August 6, 1961, by D. E. Peterson.

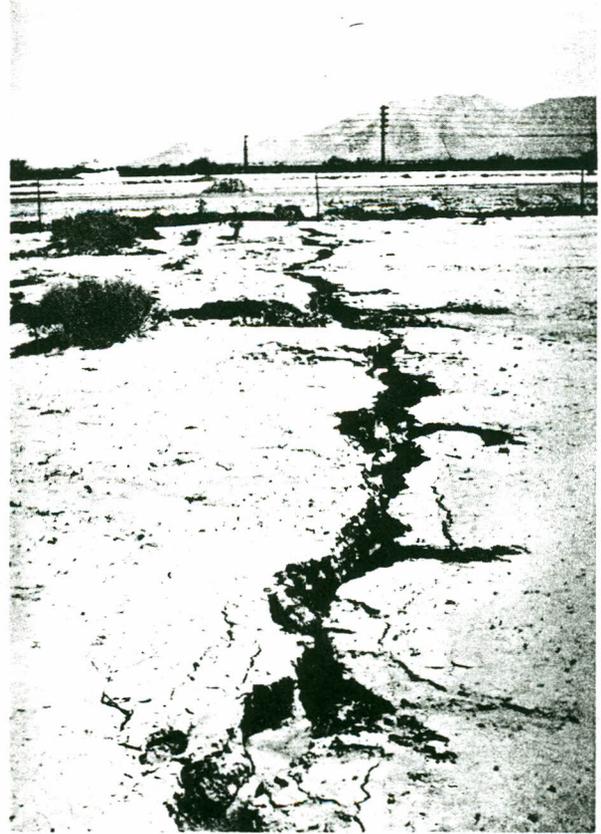
B

Arizona Highway 84 at the distant Picacho Mountains. A second photograph (fig. 7B) shows a similar fissure about 1 mile southeast of Picacho. Again the view is northeastward across Highway 84 with the Picacho Mountains in the distance. Note the absence (figs. 7A and B) of differential vertical or horizontal movement along the two fissures. The openings are characterized by clean breaks and near-vertical walls.
