# RECONNAISSANCE ENVIRONMENTAL GEOLOGY OF TONTO FOOTHILLS, SCOTTSDALE

MARICOPA COUNTY, ARIZONA

1985

## GEOLOGIC HAZARDS

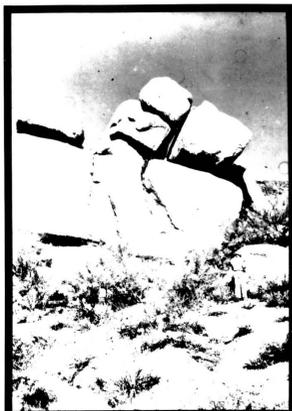
Figure 1 - View west of granite boulders precariously perched above the edge of the cliffs and downhill to the east toward the town of Scottsdale. Movement can be triggered either by blasting, excessive rains, or tectonic activity (Photograph no. 4707 by T. L. Péwé, Sept. 12, 1982).

Evidence that huge granitic boulders have rolled down the steep slopes onto the gentle slopes is clearly indicated by the presence of the large rounded blocks at the base of the hills and on the gentle slopes. Some boulders have moved as much as 100-150 ft (30.5 to 45.7m) horizontally as they tumbled from the cliff. There is no question that boulders have rolled down the slopes in the past; the question is whether the process of boulder rolling is continuing. Evidence that the boulder movement did not take place all at one time and is a continuing process exists. The evidence that many of the boulders moved many years ago is that they are greatly rounded and the sub-surfaces are very rough from deep weathering. Archaeological features indicate that some boulders have been stable for hundreds of years. Elsewhere, the blocks of boulders have fracture surfaces that are not as weathered and the edges of the rocks are angular, indicating breakage and movement at a much later date. Geologically, it is possible to state that where boulders are now unstable they will eventually move, but like earthquakes, it is not possible to state just when this action (boulder movement) will take place. Movement may be tomorrow or 100 years from now.

Boulders and blocks move downslope when forces are such that they overcome the friction holding the rocks in place. This movement may result from forces pushing or rocking the boulders, such as earthquakes or blasting tremors caused by man; or, a steady force of the pull of gravity, aided by the removal or weakening of the friction holding the boulders in place. Although the Phoenix area has been relatively free of earthquakes since historic time, they have occurred in the geologic past and are probably one of the main causes for the movement of boulders downslope in the area.

Granitic bedrock and boulder rollout areas. Erosion along joints forms subrounded masses 1 to 15 ft (0.3 to 5 m) in diameter, capable of rolling downslopes greater than 15° (see Figure 1).

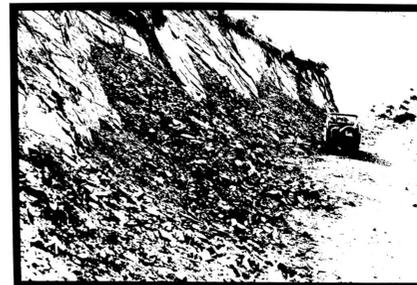
Figure 2 - Rock falls in blocky to platy metamorphic rocks (Zone III) caused by undercutting of steeply dipping, well-foliated rocks (T6N, R5E, Section 6) (Photograph no. 4829 by T. L. Péwé, Feb. 12, 1985).

Blocky to platy metamorphic rocks. Rock falls caused by loss of support provided by underlying rock or material. Pitted slopes greater than 45° (100%), rocks loose underlying surface by erosion, earth vibrations, animal activities, wind, or other causes. Blocks to 10 ft (3 m) in diameter that literally fall and bounce down steep slopes, coming to rest on gentler slopes near base of mountains. Excavations parallel to dip of rock especially susceptible to rock falls and slides (see Figure 2).
