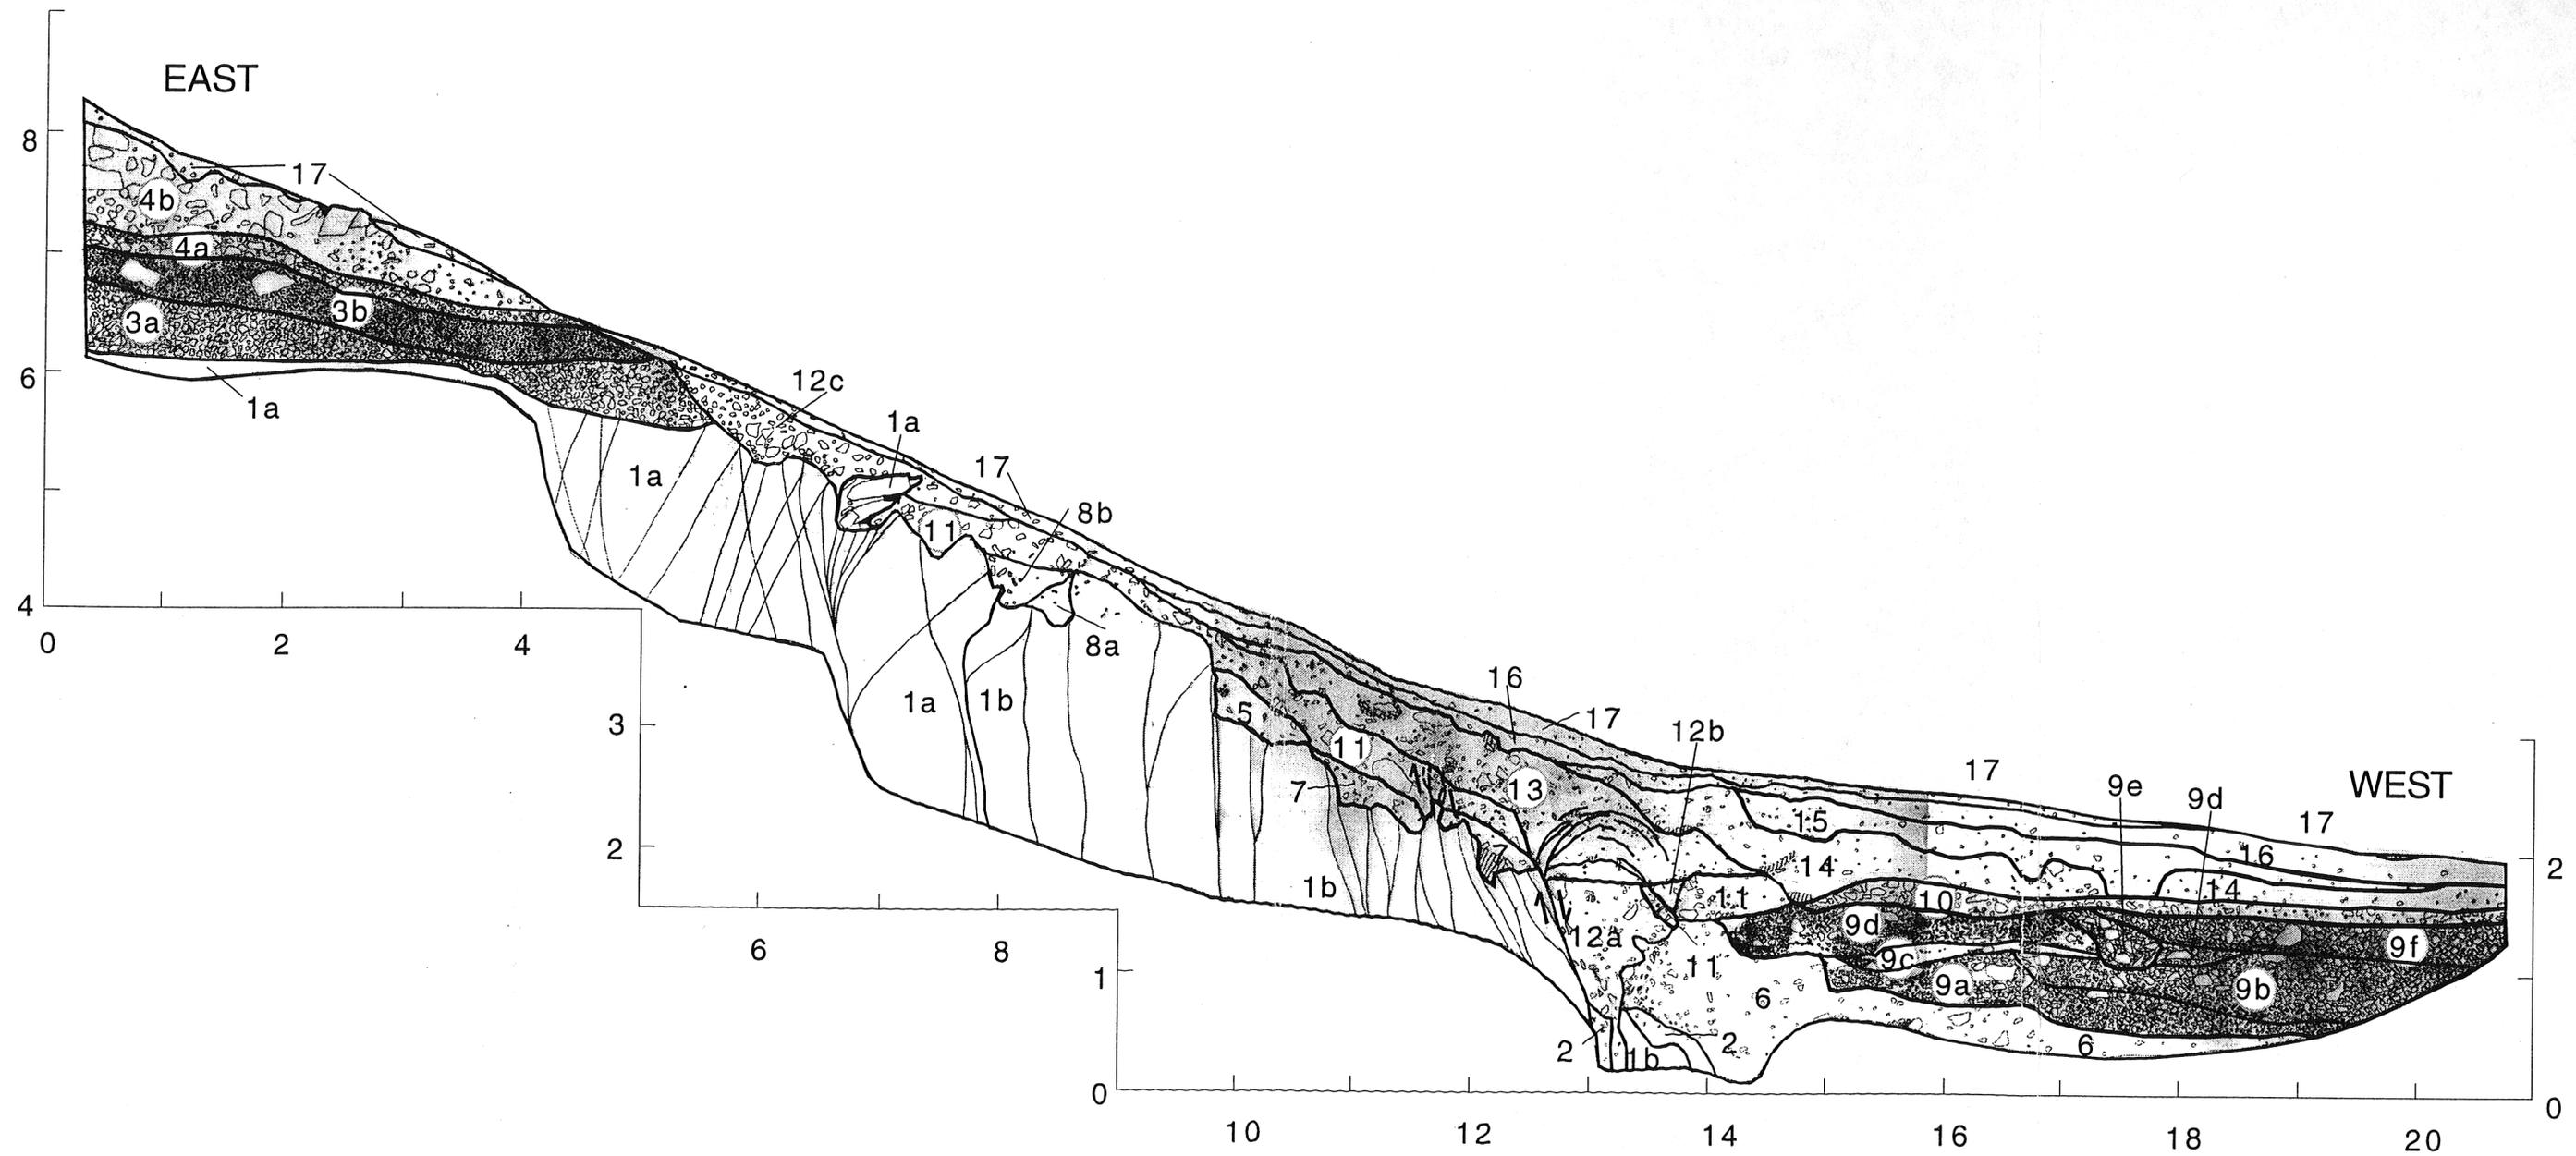
Figure 3-8. Log of Q2 trench, Cottonwood Canyon site, Arizona. Multiple faulting events have fractured the bedrock but clear evidence for only one earthquake exists in the alluvium (the same event as represented by displaced stratigraphy in trench Q1). Appendix 3 contains detailed descriptions of the units.
