Earth Fissure Map of the Chandler Heights Study Area: Pinal and Maricopa Counties, Arizona

August 2008

Arizona Geological Survey

Digital Map Series - Earth Fissure Map 1 (DM-EF-1)

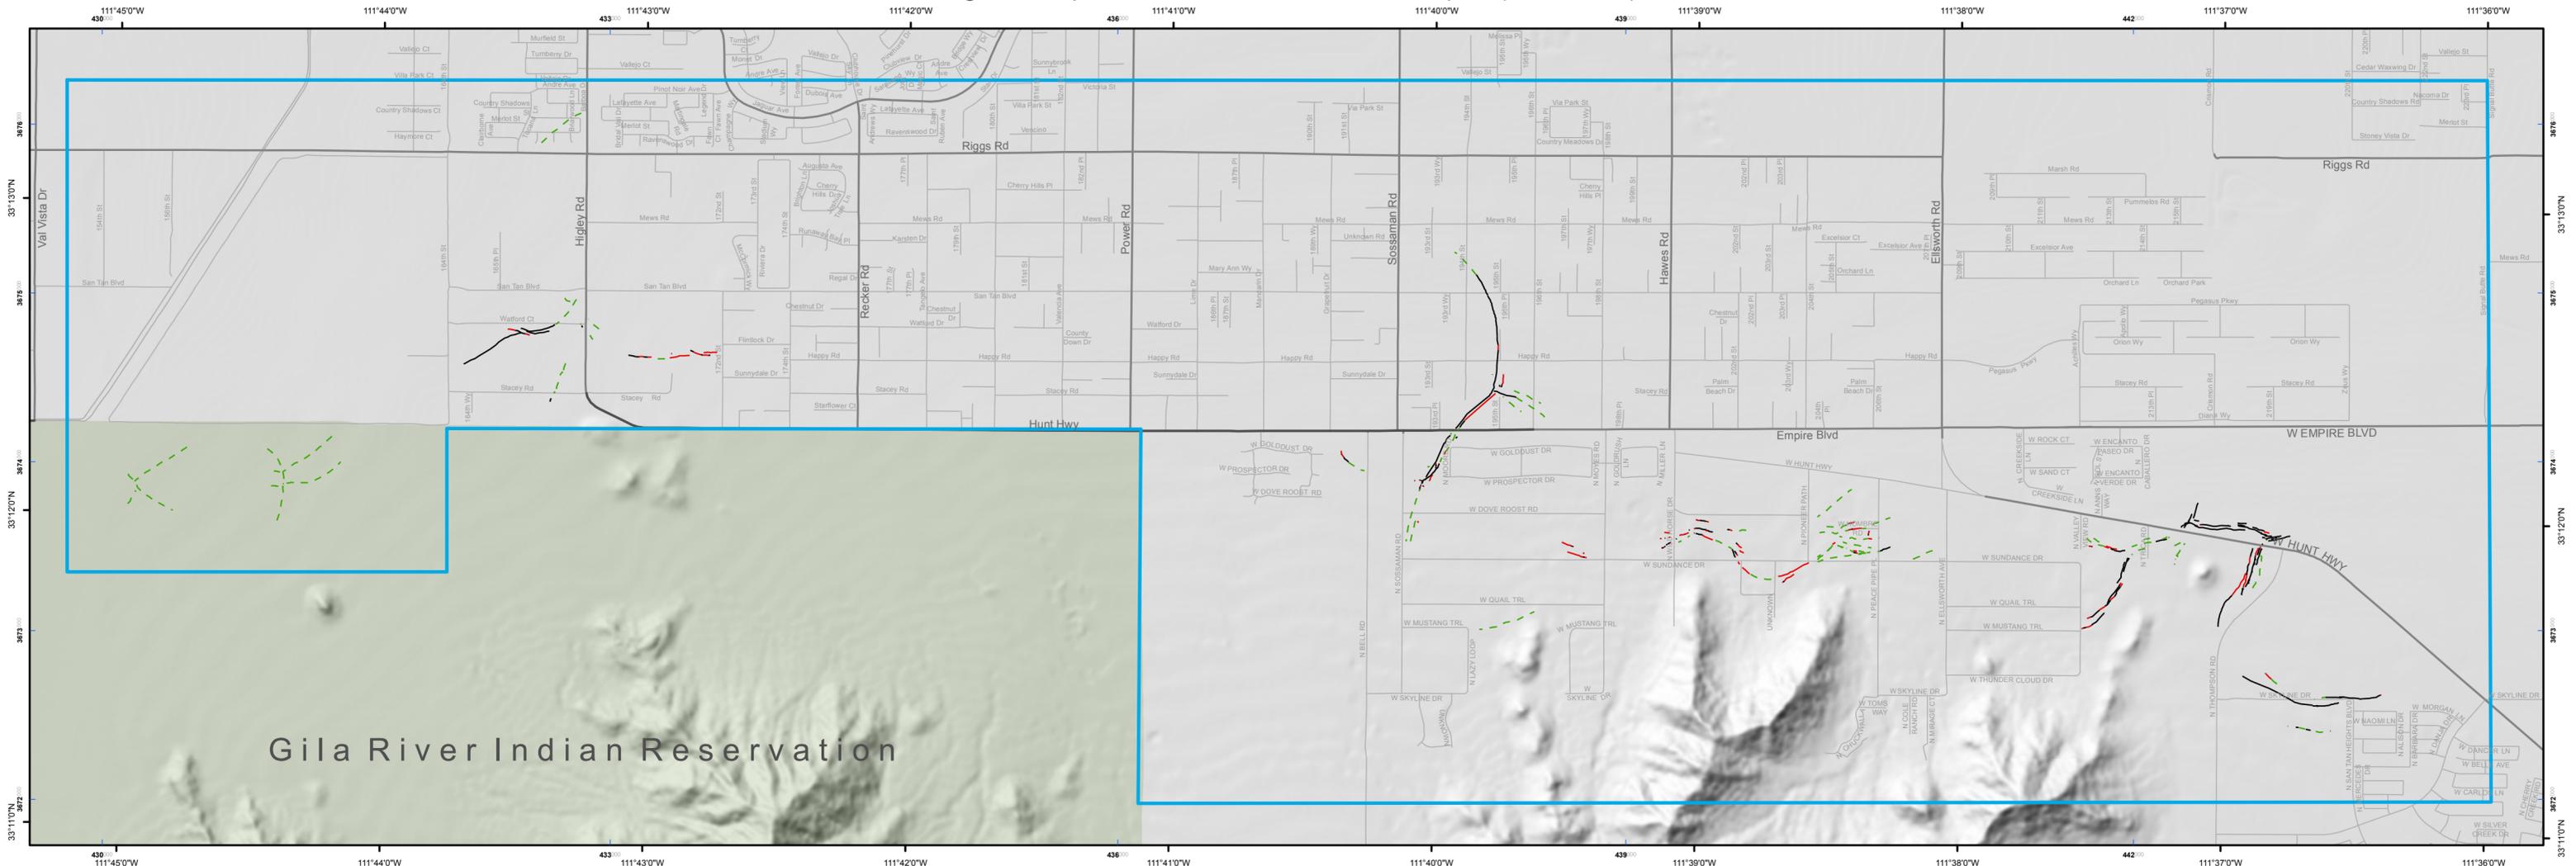
- Solid black lines represent the location of continuous earth fissures manifested as open cracks or gullies.
- Solid red lines represent the location of discontinuous earth fissures manifested as elongated to circular depressions or as abbreviated or irregular linear depressions. These discontinuous surface features frequently represent an incipient surface expression of an earth fissure.

- - - Dashed green lines represent the approximate locations of unconfirmed earth fissures, defined as fissures which could not be confirmed by surface investigations by AZGS geologists, but which have been previously reported by Professional Geologists in published documents or maps.

- The outline of the Chandler Heights Study Area is shown in blue. historical and modern aerial photos taken within this area were searched for anomalous lineaments. These lineaments were then investigated in the field to determine if there was any evidence of earth fissures.

The Gila River Indian Community is not covered by ARS 27-152.01.11, and fissures in this area were not investigated in the field as part of these investigations. Previously reported earth fissures within the Reservation boundary are represented on the map.
