Earth Fissure Map of the Drought Road Study Area: Cochise County, Arizona

June 2019
Arizona Geological Survey

Digital Map Series - Earth Fissure Map 16 (DM-EF-16)
version 3.0

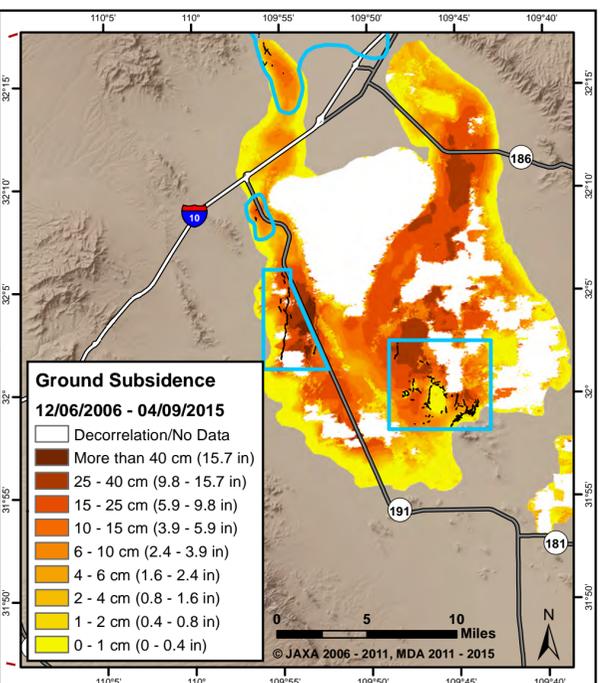
Ground subsidence map

study areas shown in blue

Subsidence data provided by the Arizona Department of Water Resources (ADWR) Interferometric Synthetic Aperture Radar (InSAR), Hydrology, and Geophysics / Surveying Unit. Subsidence data for other locations and time periods is accessible at <http://www.azwater.gov/AzDWR/Hydrology/GroundwaterandLandSubsidence.htm>

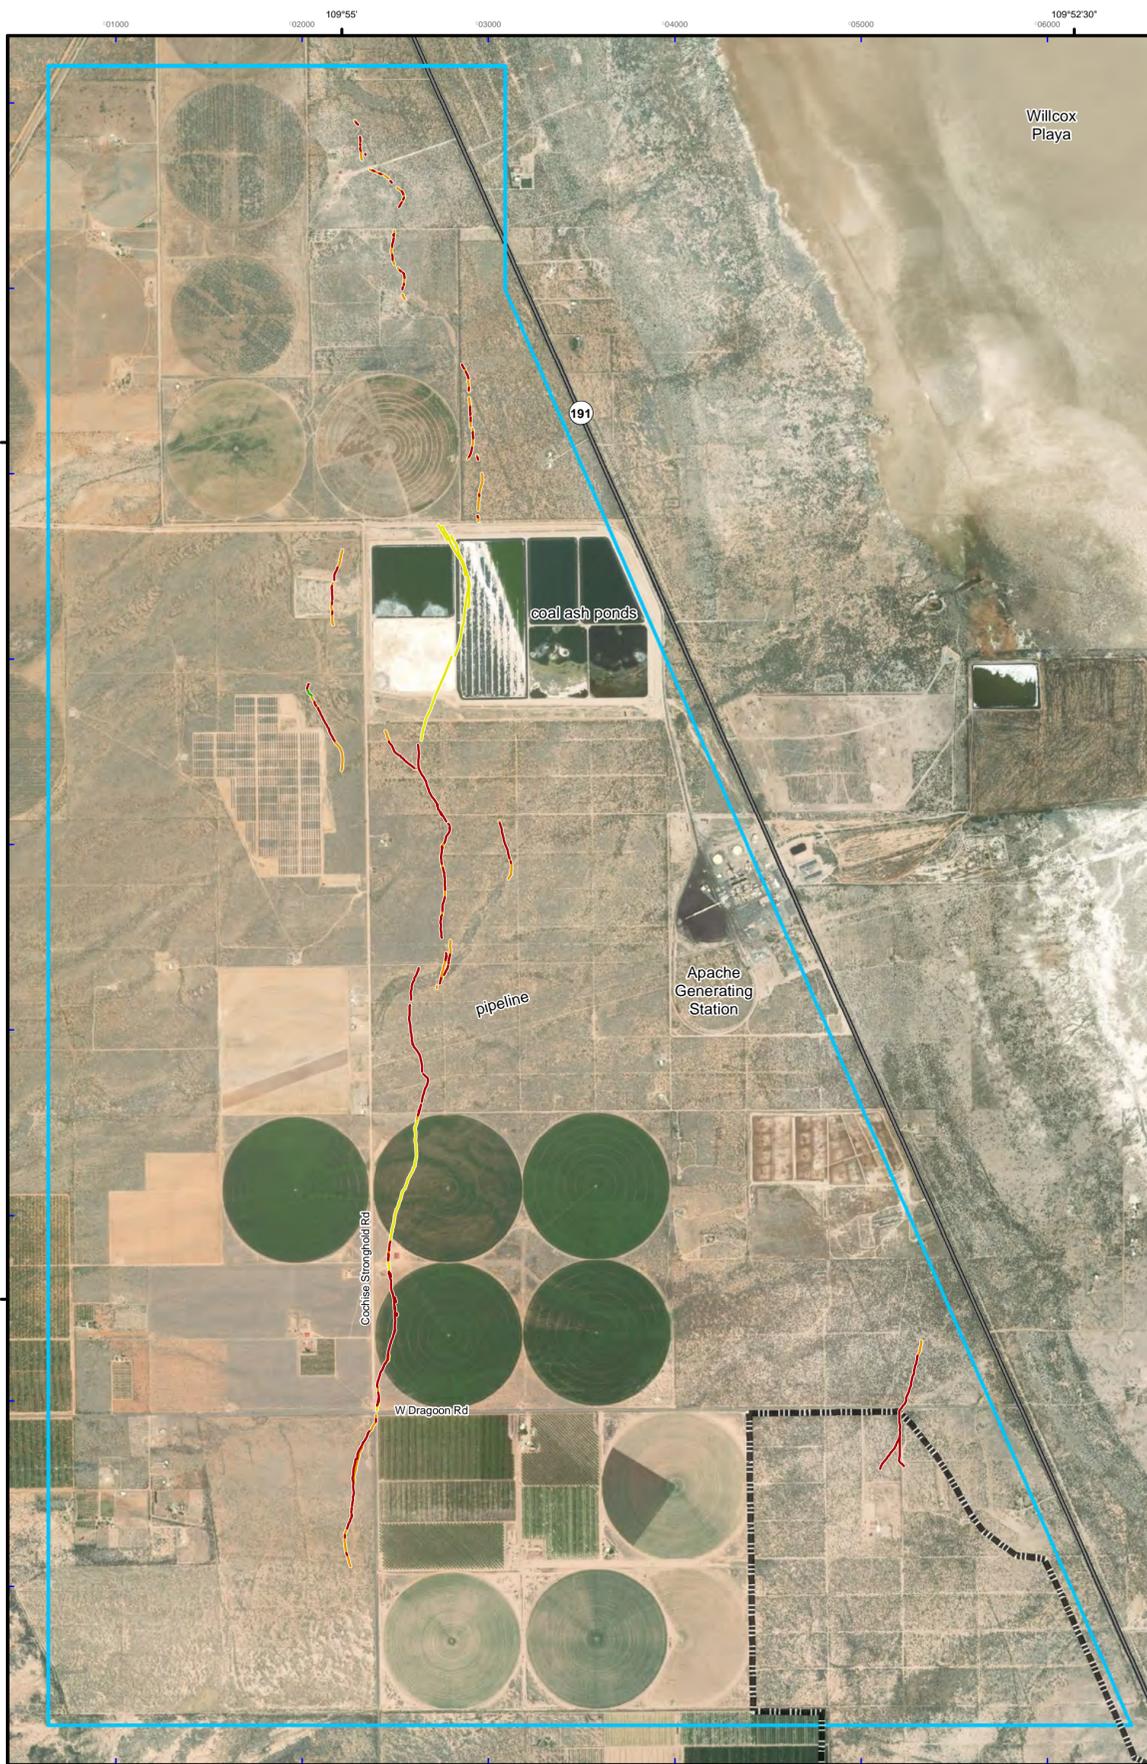
- Red lines represent the location of continuous earth fissures manifested as open cracks or gullies.
- Orange lines represent the location of discontinuous earth fissures manifested as elongated to circular depressions or as abbreviated or irregular linear depressions. These discontinuous surface features frequently represent an incipient surface expression of an earth fissure.

- Yellow lines represent the location of fissures confirmed by non-AZGS personnel or clear evidence of earth fissures on aerial imagery. Traditional field investigation of these features by AZGS was hindered by agricultural or urban modification of the land surface.

- Green lines represent the approximate locations of unconfirmed earth fissures, defined as fissures which could not be confirmed by surface investigations by AZGS geologists, but which have been previously reported by Professional Geologists in published documents or maps.

- The outline of the Study Area is shown in blue. The limits of the study area are based on interpretation of modern and recent ground subsidence data provided by the Arizona Department of Water Resources. Historical and modern aerial photos taken within this area were searched for anomalous lineaments. These lineaments were then investigated in the field to determine if there was any evidence of earth fissures.

- Zones of giant desiccation cracks (GDCs) are indicated by thick dashed lines. GDC zones consist of soil cracks forming broad polygonal networks up to several hundred feet across. These cracks are a result of long-term drying of surface soils. GDC depth in this area is typically several feet deep or less but may become deeply eroded if intersected by a much deeper earth fissure.

Air photo base compiled from 2017, 1 meter NAIP (National Agriculture Imagery Program) digital ortho imagery.
