Earth Fissure Map of the Drought Road Study Area: Cochise County, Arizona

January 2016
Arizona Geological Survey

Digital Map Series - Earth Fissure Map 16 (DM-EF-16)
version 2.0

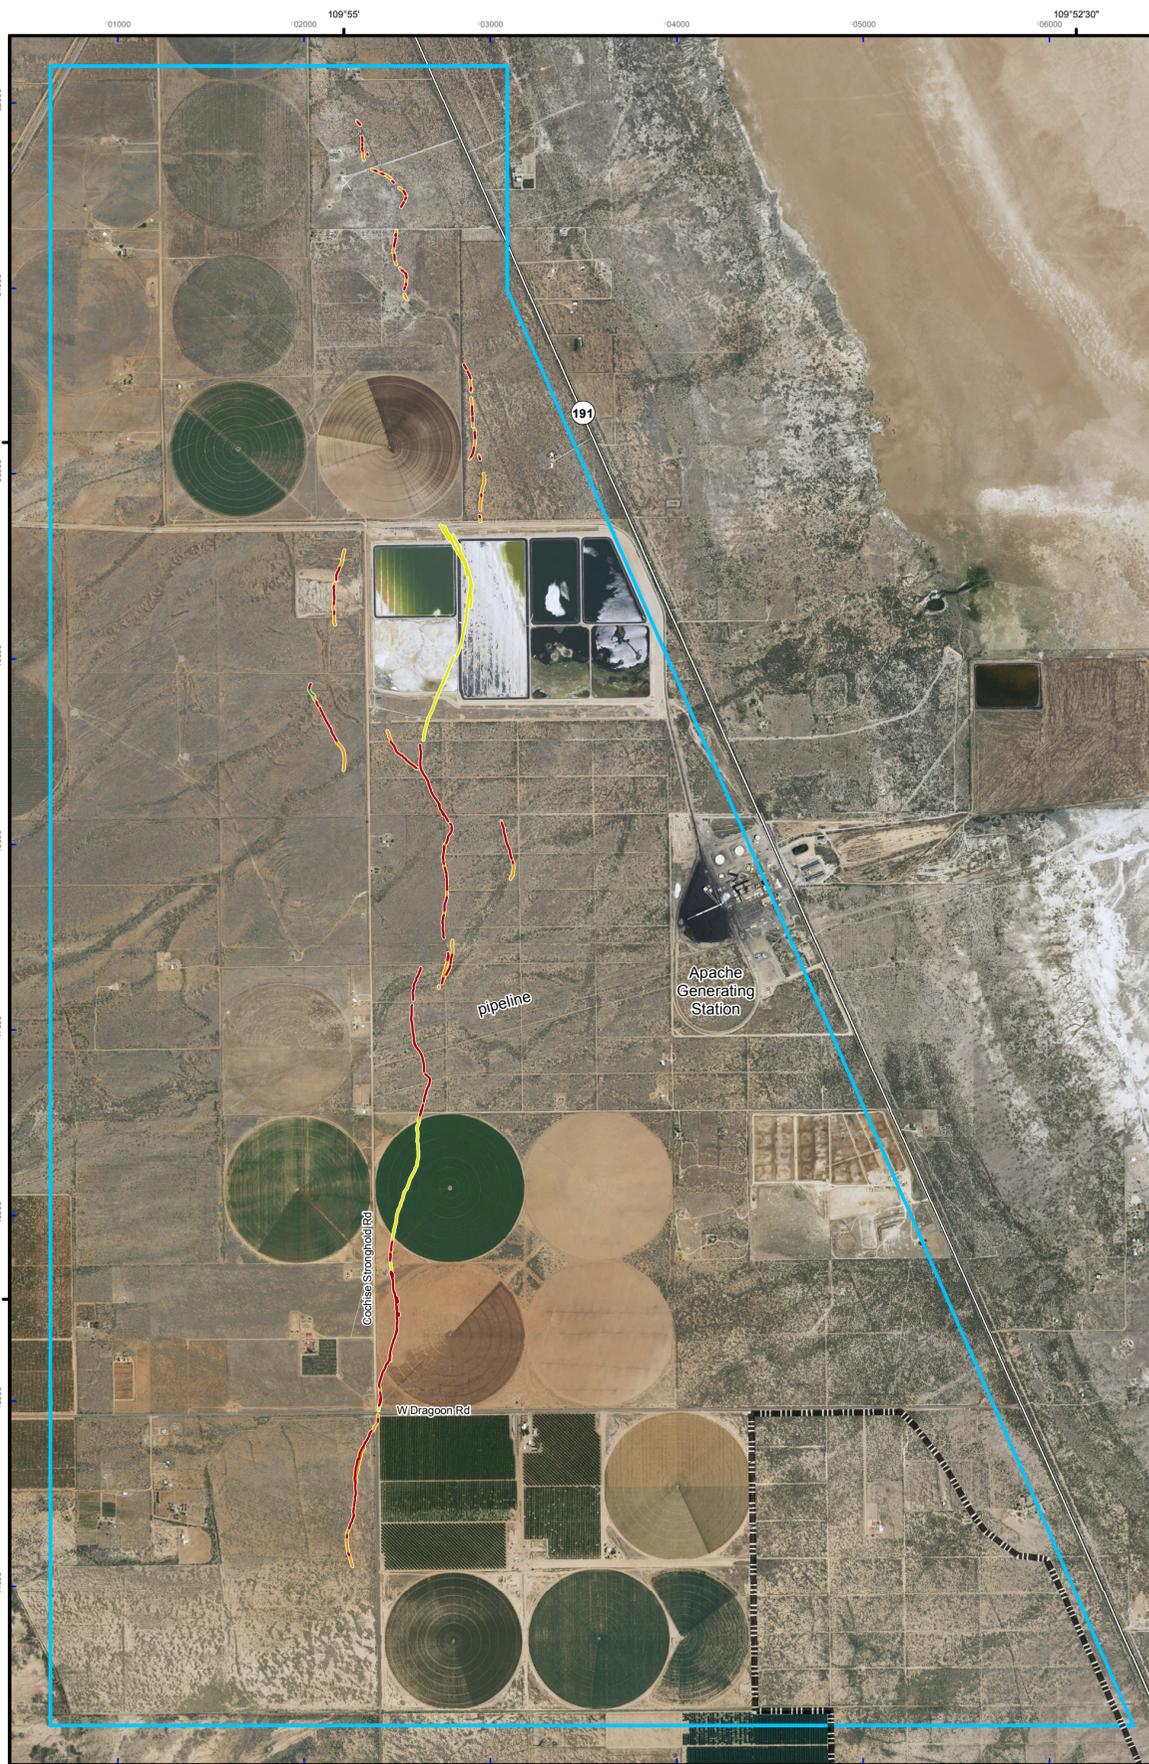
1:24,000 Scale

- Red lines represent the location of continuous earth fissures manifested as open cracks or gullies.
- Orange lines represent the location of discontinuous earth fissures manifested as elongated to circular depressions or as abbreviated or irregular linear depressions. These discontinuous surface features frequently represent an incipient surface expression of an earth fissure.

- Yellow lines represent the location of fissures confirmed by non-AZGS personnel or clear evidence of earth fissures on aerial imagery. Traditional field investigation of these features by AZGS was hindered by agricultural or urban modification of the land surface.

- Green lines represent the approximate locations of unconfirmed earth fissures, defined as fissures which could not be confirmed by surface investigations by AZGS geologists, but which have been previously reported by Professional Geologists in published documents or maps.

- The outline of the Study Area is shown in blue. The limits of the study area are based on interpretation of modern and recent ground subsidence data provided by the Arizona Department of Water Resources. Historical and modern aerial photos taken within this area were searched for anomalous lineaments. These lineaments were then investigated in the field to determine if there was any evidence of earth fissures.

- Zones of giant desiccation cracks (GDCs) are indicated by thick dashed lines. GDC zones consist of soil cracks forming broad polygonal networks up to several hundred feet across. These cracks are a result of long-term drying of surface soils. GDC depth in this area is typically several feet deep or less but may become deeply eroded if intersected by a much deeper earth fissure.

Air photo base compiled from 2015, 1 meter NAIP (National Agriculture Imagery Program) digital ortho imagery.

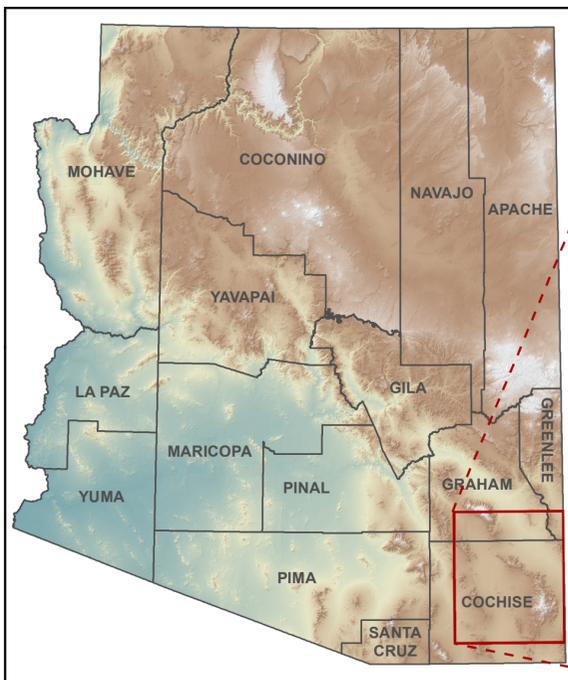
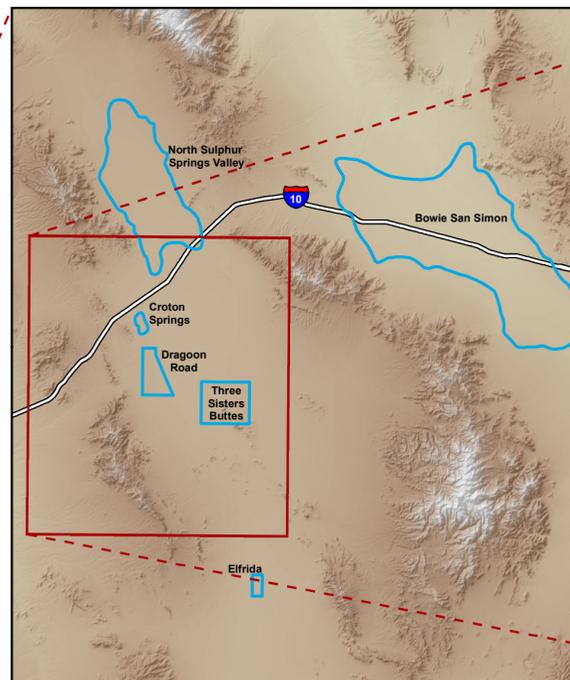
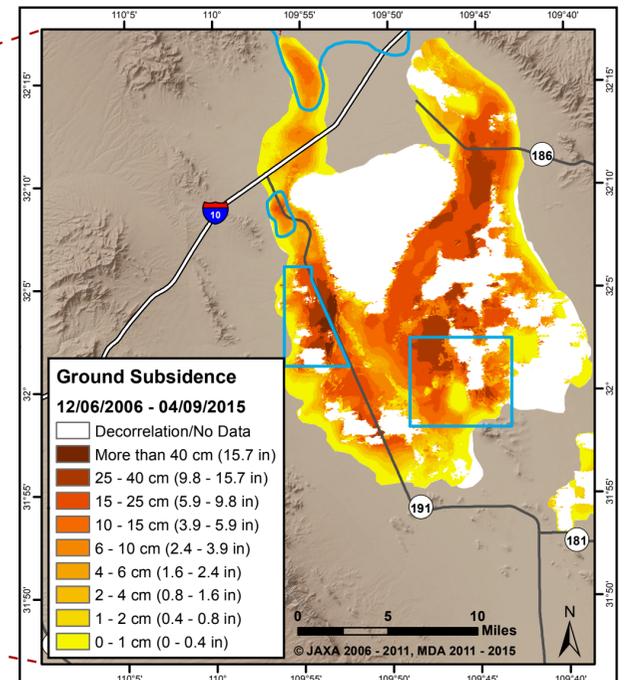
Ground Subsidence Map

Study Areas shown in Blue

Subsidence data provided by the Arizona Department of Water Resources (ADWR) Interferometric Synthetic Aperture Radar (InSAR), Hydrology, and Geophysics / Surveying Unit. Subsidence data for other locations and time periods is accessible at <http://www.azwater.gov/AzDWR/Hydrology/GroundwaterandLandSubsidence.htm>
