# Earth Fissure Map of the Harquahala Plain Study Area: Maricopa County, Arizona

June 2019  
Arizona Geological Survey

Digital Map Series - Earth Fissure  
Map 14 (DM-EF-14)  
version 2.0

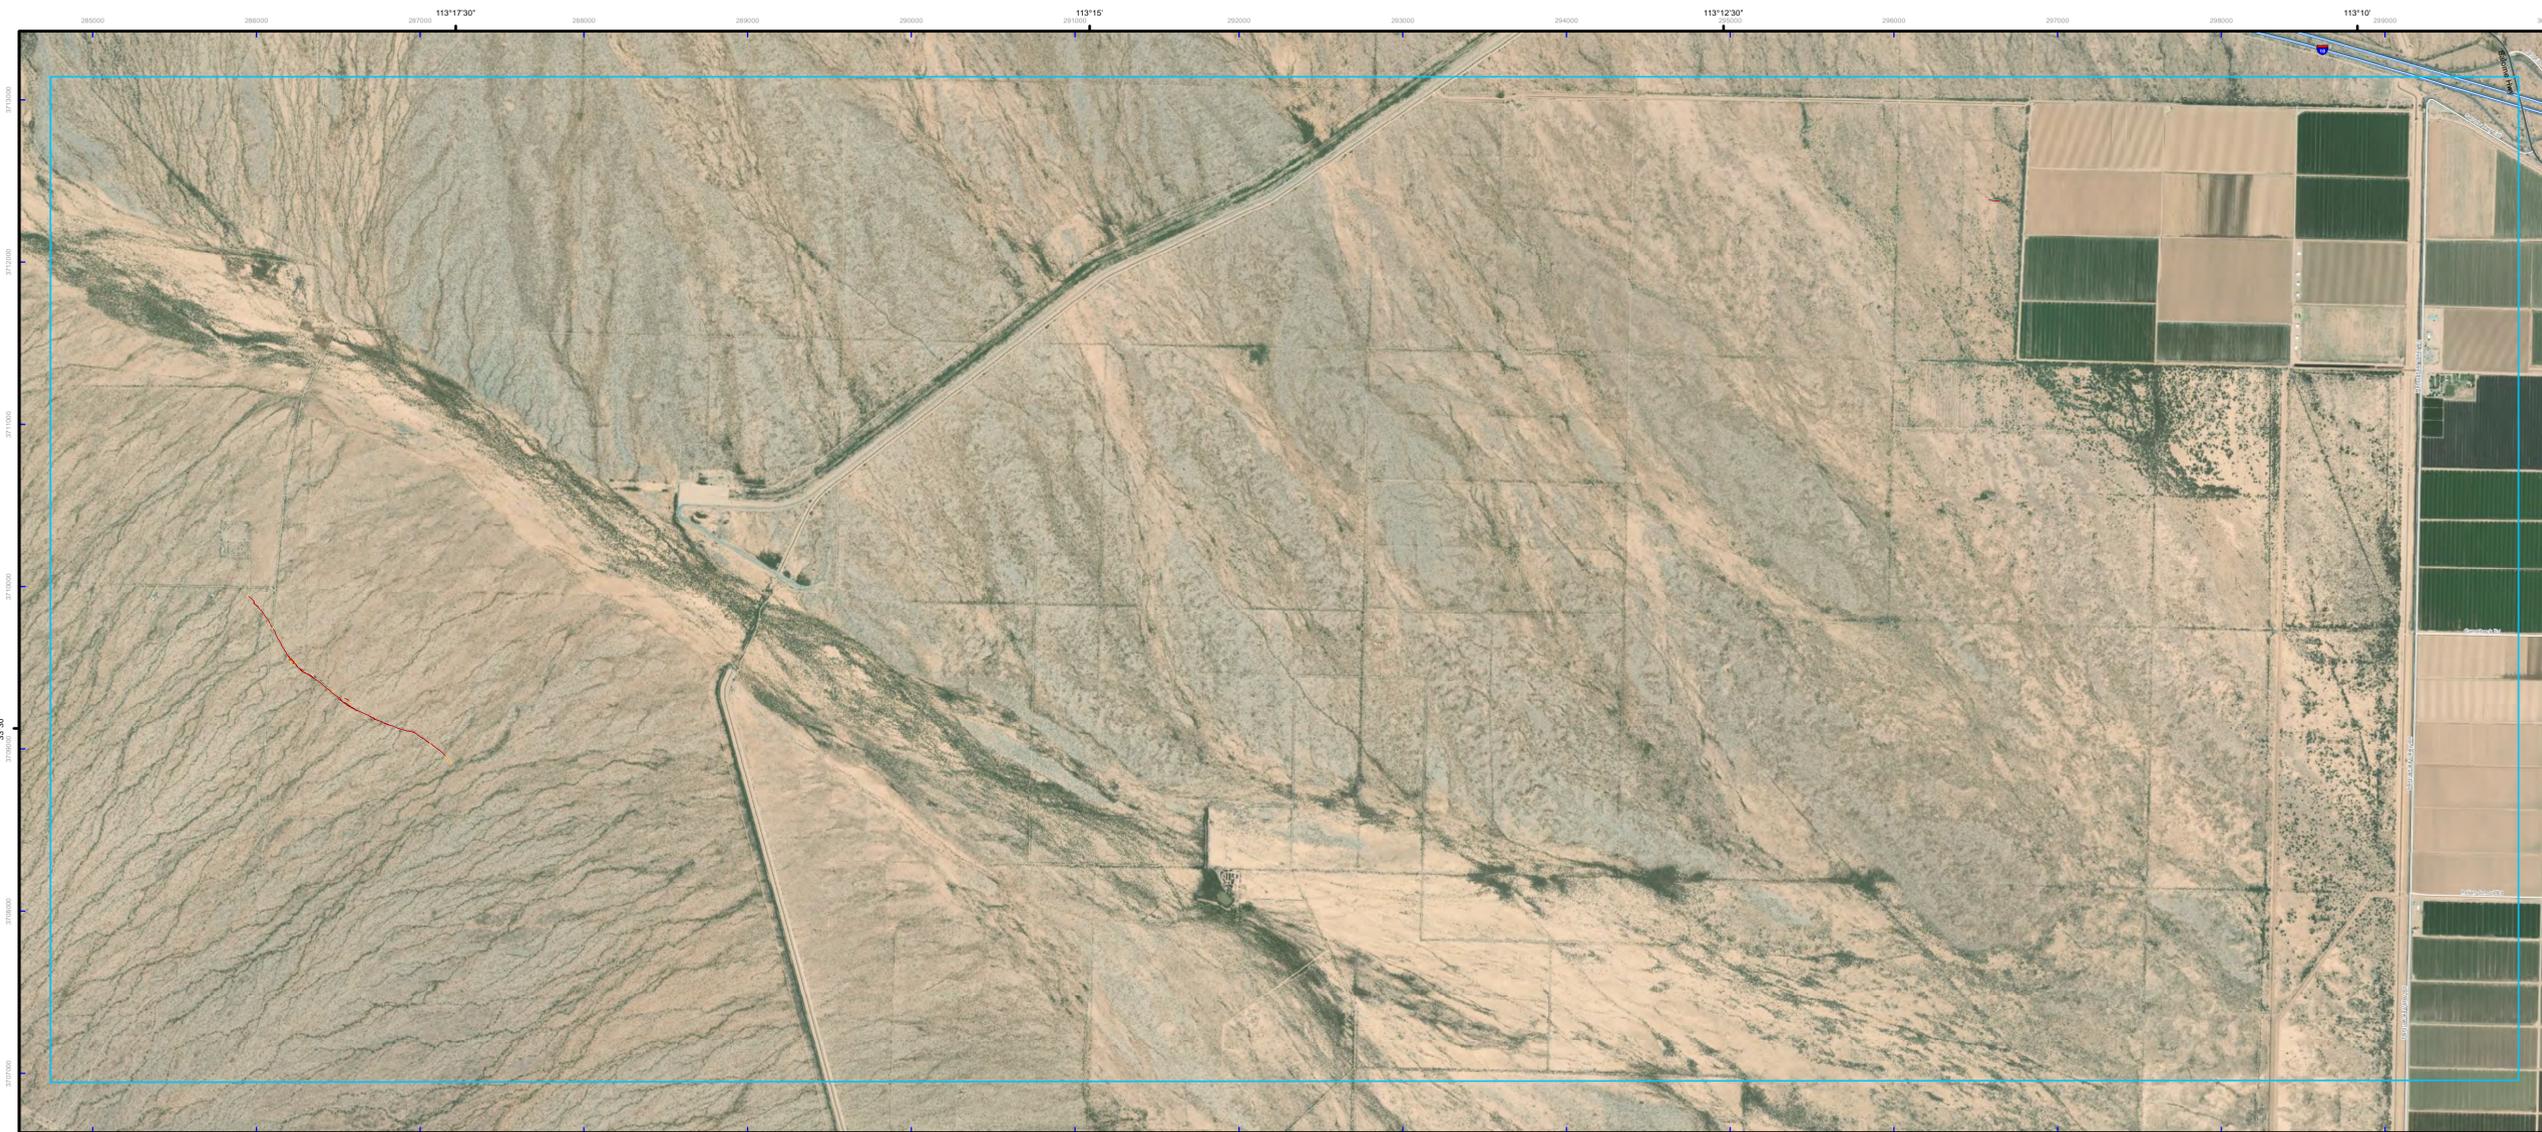
Red lines represent the location of continuous earth fissures manifested as open cracks or gullies.
-

Orange lines represent the location of discontinuous earth fissures manifested as elongated to circular depressions or as abbreviated or irregular linear depressions. These discontinuous surface features frequently represent an incipient surface expression of an earth fissure.

Yellow lines represent the location of fissures confirmed by non-AZGS personnel or clear evidence of earth fissures on aerial imagery. Traditional field investigation of these features by AZGS was hindered by agricultural or urban modification of the land surface.

Green lines represent the approximate locations of unconfirmed earth fissures, defined as fissures which could not be confirmed by AZGS geologists, but which have been previously reported by Professional Geologists in published documents or maps.

The outline of the Study Area is shown in blue. The limits of the study area are based on interpretation of modern and recent ground subsidence data provided by the Arizona Department of Water Resources. Historical and modern aerial photos taken within this area were searched for anomalous lineaments. These lineaments were then investigated in the field to determine if there was any evidence of earth fissures.
