Earth Fissure Map of the Wintersburg Study Area: Maricopa County, Arizona

May 2015
Arizona Geological Survey

Digital Map Series - Earth Fissure Map 10 (DM-EF-10)
version 2.0

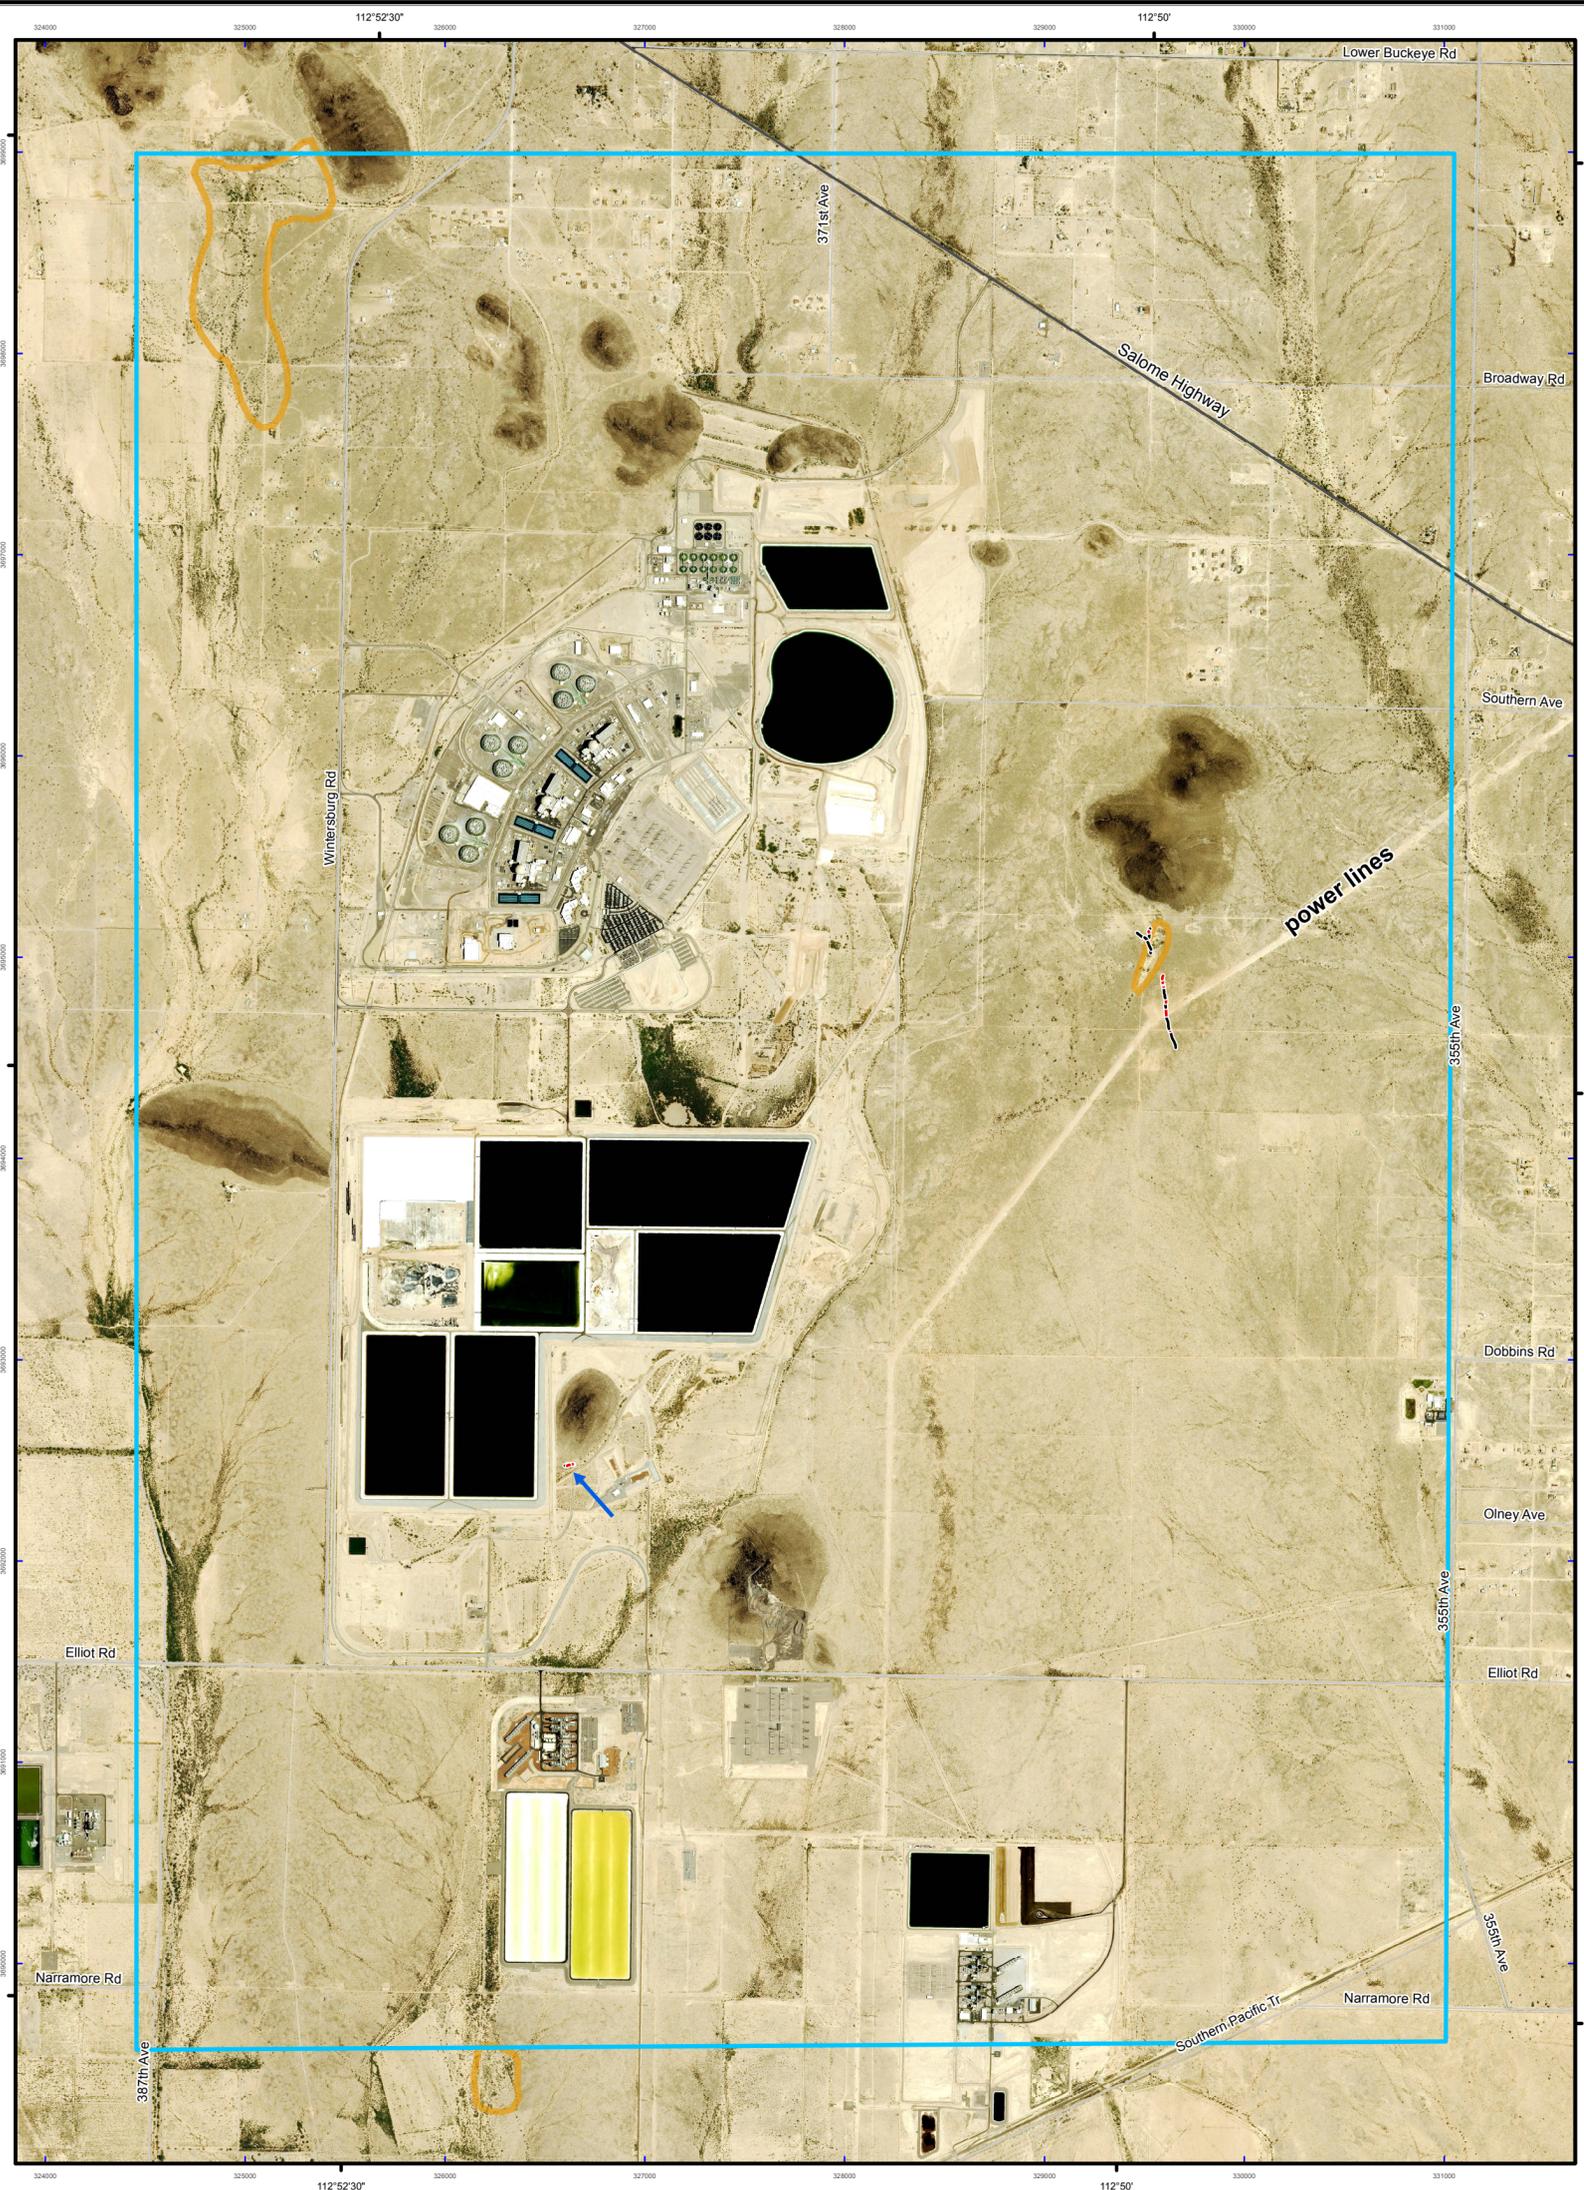
- Solid black lines represent the location of continuous earth fissures manifested as open cracks or gullies.
- Solid red lines represent the location of discontinuous earth fissures manifested as elongated to circular depressions or as abbreviated or irregular linear depressions. These discontinuous surface features frequently represent an incipient surface expression of an earth fissure.

- - - Dashed green lines represent the approximate locations of unconfirmed earth fissures, defined as fissures which could not be confirmed by surface investigations by AZGS geologists, but which have been previously reported by Professional Geologists in published documents or maps.

- Zones of giant desiccation cracks (GDCs) are shown in orange. GDC zones consist of soil cracks forming broad polygonal networks up to several hundred feet across. These cracks are a result of long-term drying of surface soils. Many GDCs in this study area were present prior to the formation of earth fissures and are evident in aerial photographs from the 1930s. GDC depth in this area is typically several feet deep or less but may become deeply eroded if intersected by a much deeper earth fissure.

- The outline of the Study Area is shown in blue. The limits of the study area are based on interpretation of modern and recent ground subsidence data provided by the Arizona Department of Water Resources. Historical and modern aerial photos taken within this area were searched for anomalous lineaments. These lineaments were then investigated in the field to determine if there was any evidence of earth fissures.

Air photo base compiled from 2013, 1 meter NAIP (National Agriculture Imagery Program) digital ortho imagery.

Map projection and blue, 1000-meter grid ticks: Universal Transverse Mercator, zone 12, North American Datum of 1983 HARN
